Use of O-arm With Intraoperative Arteriography for Localization and Stealth Navigation of the Vertebral Arteries During Posterior Cervical Spine Surgery

Int J Spine Surg 2021, 14 (s4) S10-S15 doi: https://doi.org/10.14444/7158

Methods: Here we present the use of intraoperative O-arm-based arteriography for integration with navigation for vertebral artery localization during C1 to C3 posterior instrumentation and fusion of an unstable C2 fracture in a 54-year-old man.

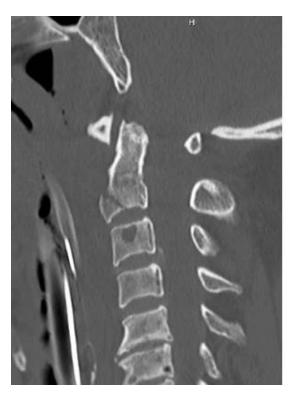
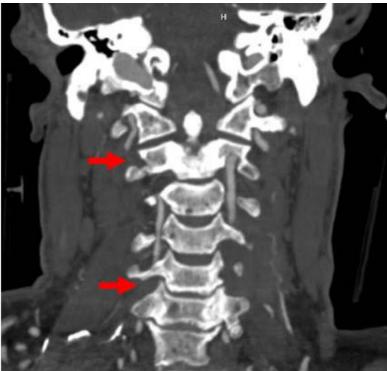
Figure 1. (Left) Sagittal computed tomography (CT) cervical spine demonstrating anterior inferior C2 vertebral body fracture. (Right) Coronal CT angiography of the neck with arrows demonstrating levels of right vertebral artery injury at C2 and C6.

A 54-year-old male bicyclist with unknown past medical history was struck at approximately 50 mph by a vehicle. On exam the patient was awake, albeit agitated, and moving all 4 extremities with no neurologic deficit. Workup revealed a type 3 C2 fracture with mild retrolisthesis of C2 on C3 and extension into the right foramen transversarium as well as destabilizing posterior ligamentous and bilateral C1 to C2 facet injury (Figure 1). Computed tomography angiography (CTA) showed a dominant left vertebral artery that was uninjured. However, the right vertebral artery was found to have occlusion with distal reconstitution noted at C6 and again at the level of injury at C2 (Figure 2). Given the extensive ligamentous injury, the patient was taken to the operating room for planned C1 to C3 posterior instrumentation and fusion. Preoperative planning included the use of O-arm with intraoperative contrast administration to integrate it into the Medtronic Stealth Navigation System (Dublin, Ireland) for intraoperative navigation and localization so as to maximize safety during the surgery for the patient's dominant left vertebral artery. The patient's exam continued to be without neurologic deficit, and the patient had no evidence of stroke.
