# Use of O-arm With Intraoperative Arteriography for Localization and Stealth Navigation of the Vertebral Arteries During Posterior Cervical Spine Surgery

*Department of Neurosurgery, Desert Regional Medical Center, Palm Springs, California*

**Methods:** Here we present the use of intraoperative O-arm–based arteriography for integration with navigation for vertebral artery localization during C1 to C3 posterior instrumentation and fusion of an unstable C2 fracture in a 54-year-old man.

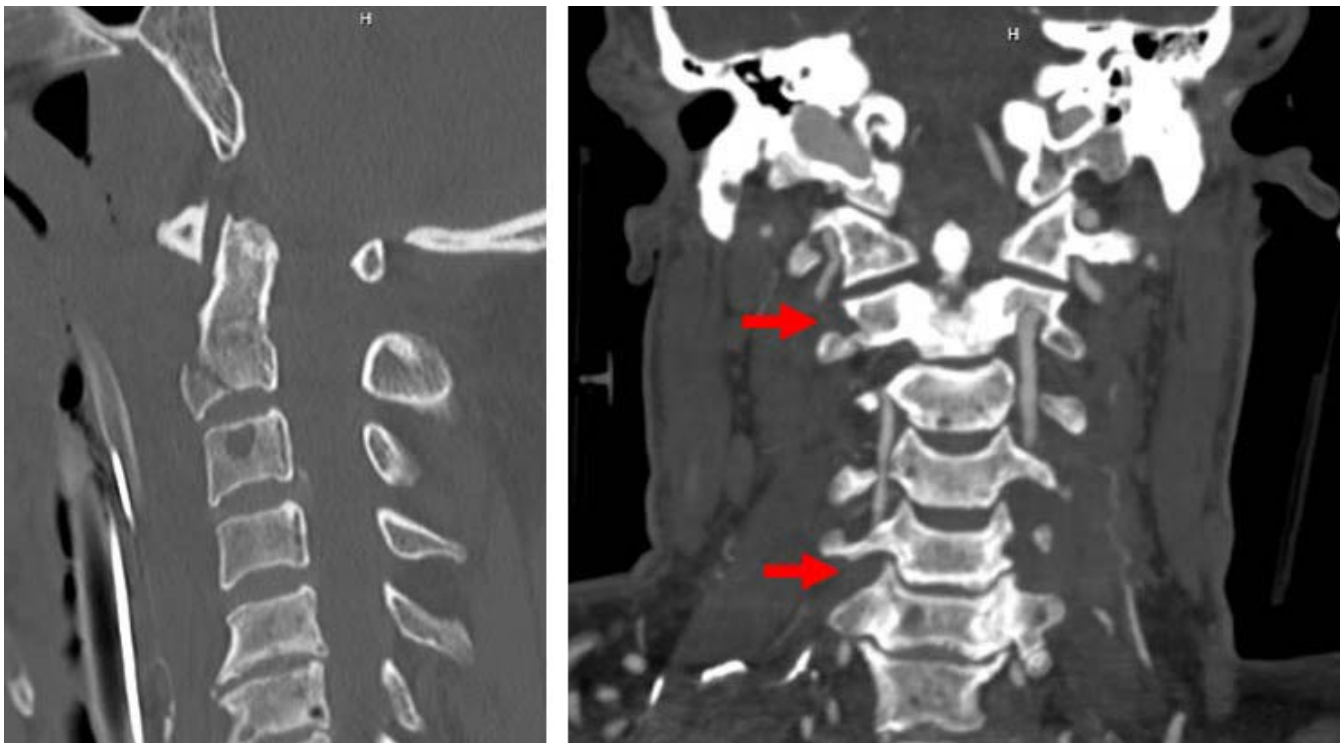
**Figure 1.** (Left) Sagittal computed tomography (CT) cervical spine demonstrating anterior inferior C2 vertebral body fracture. (Right) Coronal CT angiography of the neck with arrows demonstrating levels of right vertebral artery injury at C2 and C6.

A 54-year-old male bicyclist with unknown past medical history was struck at approximately 50 mph by a vehicle. On exam the patient was awake, albeit agitated, and moving all 4 extremities with no neurologic deficit. Workup revealed a type 3 C2 fracture with mild retrolisthesis of C2 on C3 and extension into the right foramen transversarium as well as destabilizing posterior ligamentous and bilateral C1 to C2 facet injury (Figure 1). Computed tomography angiography (CTA) showed a dominant left vertebral artery that was uninjured. However, the right vertebral artery was found to have occlusion with distal reconstitution noted at C6 and again at the level of injury at C2 (Figure 2). Given the extensive ligamentous injury, the patient was taken to the operating room for planned C1 to C3 posterior instrumentation and fusion. Preoperative planning included the use of O-arm with intraoperative contrast administration to integrate it into the Medtronic Stealth Navigation System (Dublin, Ireland) for intraoperative navigation and localization so as to maximize safety during the surgery for the patient's dominant left vertebral artery. The patient's exam continued to be without

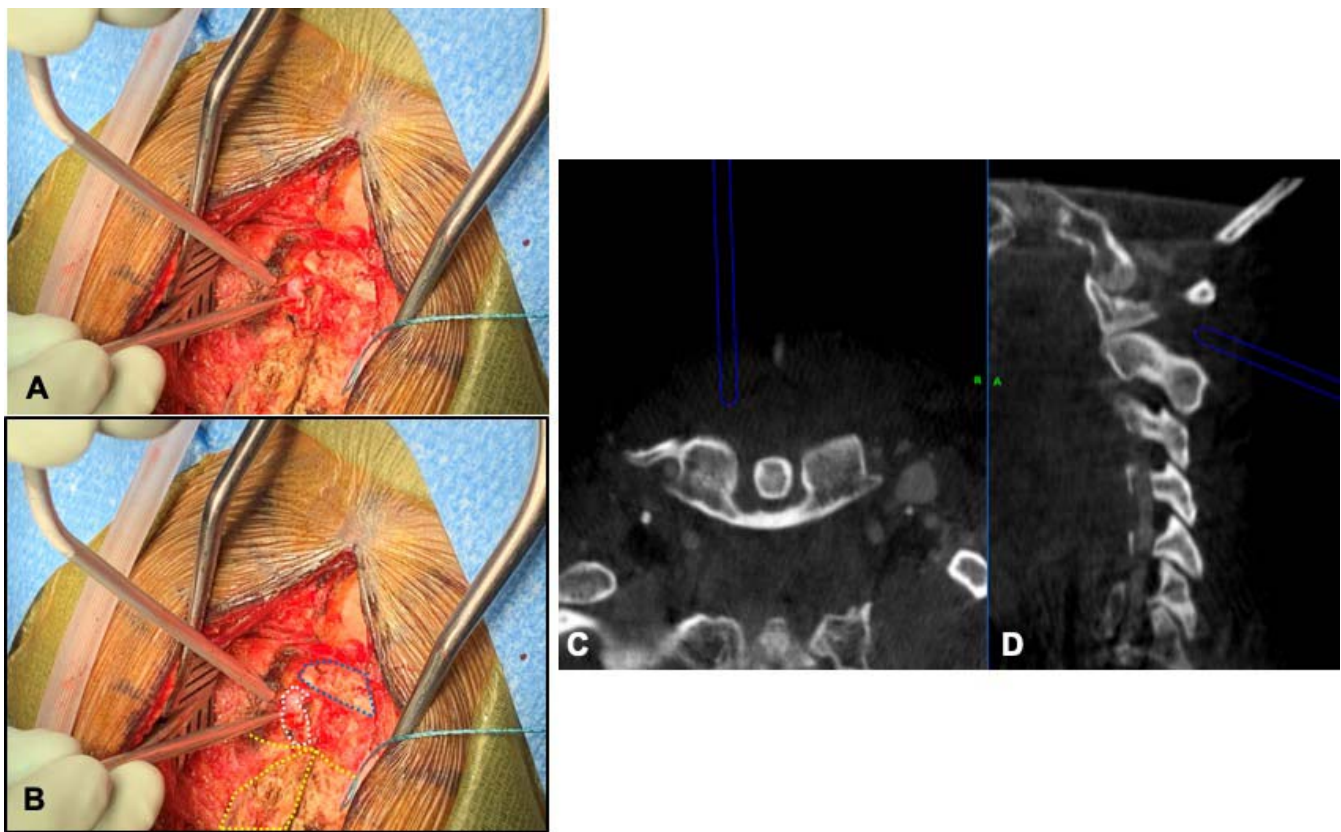
**Figure 2.** Correlation of finding of vascular structure (A and B) intraoperatively. O-arm imaging showing both axial (C) and sagittal (D) navigation. Dashed blue line is C1 posterior arch, dashed yellow line is C2 body, and dashed white line is vascular structure.

After confirmation of appropriate positioning with intraoperative fluoroscopy, the patient then received 100 mL of Isovue 370 contrast intravenously, via an autoinfuser, at the rate of 4 mL/s. The injection was done through a right antecubital 16-gauge IV. On initiation of the O-arm for CT imaging, the time from start to actual imaging processing was 8 seconds. This was an important nuance to consider because the ideal time from contrast injection to imaging was 25 seconds. Thus, the start of the O-arm imaging needed to take this

into account and was initiated 17 seconds after injection.

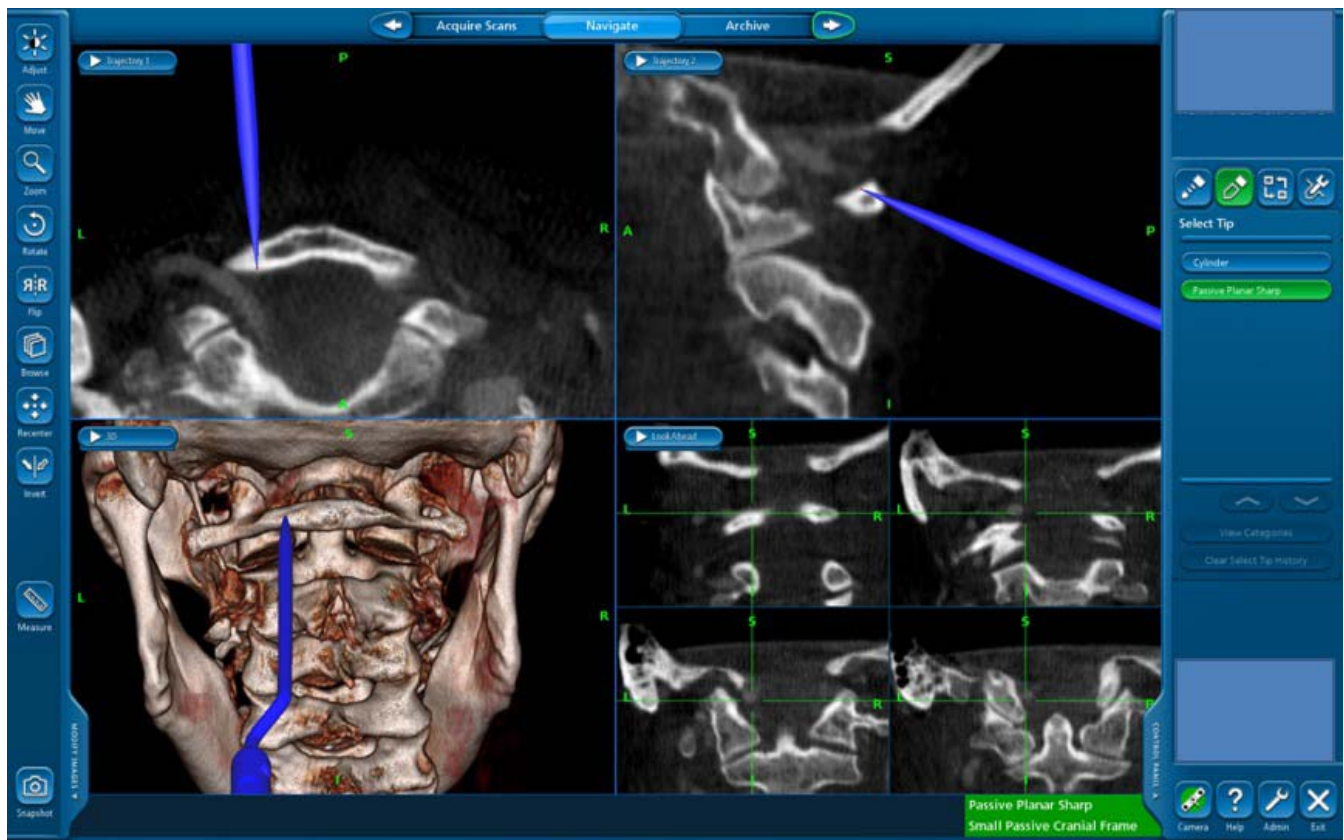
**Figure 3.** Examples of intraoperative navigation after intraoperative arteriography to find location of the vertebral artery.

Once completed, 3D reconstruction of the bilateral vertebral arteries was able to be constructed and viewed with the O-arm, and the arteriography was integrated into the CT images for real-time localization with Medtronic Stealth Navigation System intraoperatively. Thus, prior to incision, the course of the vertebral arteries could be easily assessed for any abnormal course prior to incision. In addition, real-time localization of the vertebral arteries could be obtained at any time and through the entire surgery. This was used to help guide microdropper assessment and interpretation during the surgery as well (Figures 3 and 4).

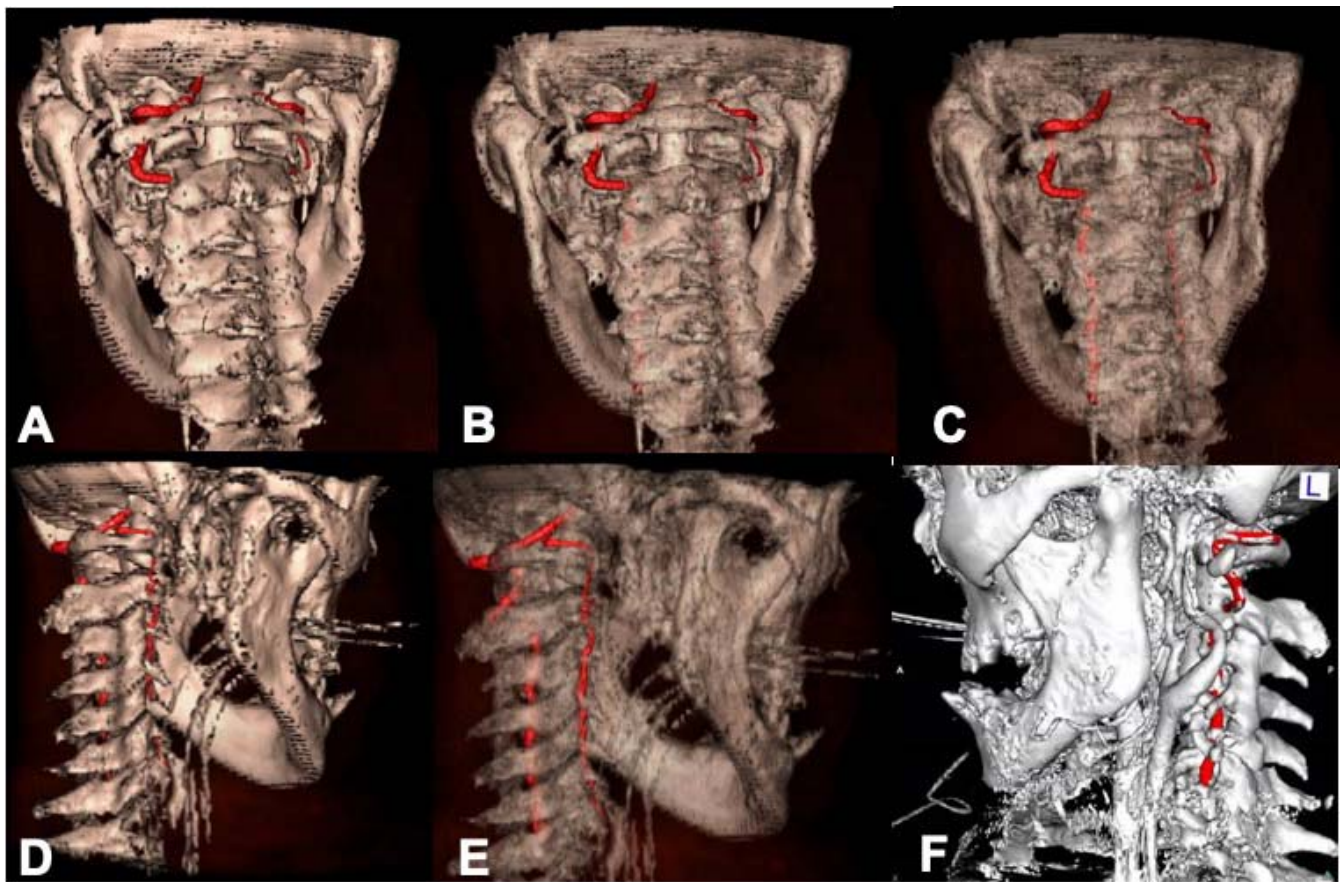
**Figure 4.** Three-dimensional (3D) reconstructions performed with O-arm intraoperatively displaying vertebral artery course. (A) Original 3D reconstruction on O-arm. (B and C) Progressive intraoperative image alterations made so as to see the entire course of the vertebral arteries with the cervical spine. (D) In comparison with the intact, dominant, left vertebral artery, the injured right vertebral artery and its course are imaged. (E) Once again, the entire course of the right vertebral artery can be merged and reconstructed from the O-arm arteriography. (F) High-resolution reconstruction showing the course of the left vertebral artery in the upper cervical spine.
