Air Crash Investigation: Pattern of Spinal Injuries, Management During the COVID-19 Pandemic, and Outcomes

Int J Spine Surg 2022, 16 (5) 899-907

Methods: An analysis was performed on the spinal injuries of victims of the Boeing 737 crash landing at the Karipur Airport (Calicut International Airport, Kerala, India) who were treated at a tertiary care referral hospital in August 2020. Details of the initial triage, patterns of injury, morphologies, mechanisms, management principles, and outcomes at 9 months postinjury were recorded and analyzed.

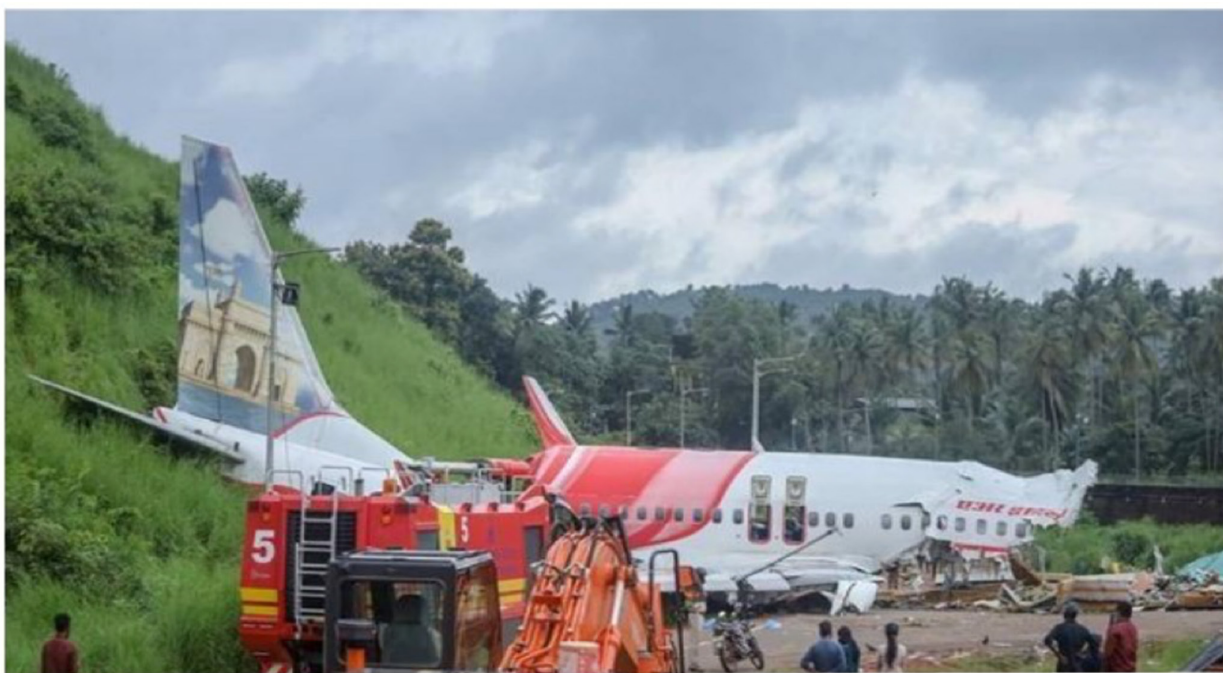
Figure 1. Scene at the site of the accident showing the crashed aircraft split into pieces.

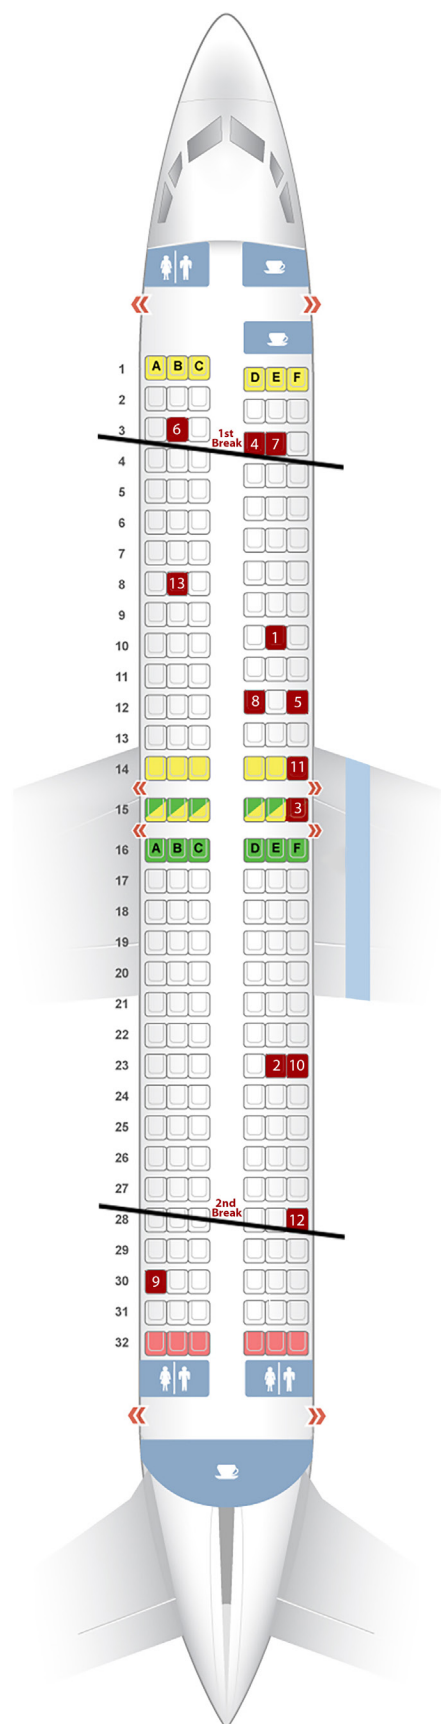
Figure 2. Seat layout of the flight showing the sections of the aircraft (marked in black lines as first and second break) and seat numbers of passengers who sustained spinal injuries (marked in red, patient ID as given in Table 1).

165 passengers who survived. More than 100 of them were injured and taken to multiple hospitals and major tertiary care centers around the vicinity of the site of accident. Our center received 47 patients, including both of the pilots who were brought dead. Of the 44 survivors, 13 patients (29.5%), including 4 women and 9 men, were identified to have spinal injuries of varying severity (Table 2). In our case series, almost all of the patients were wearing a seat belt at the time of the accident, and their seat layout is shown in Figure 2.

at the time of incident or secondary as the patients were pulled out of the jammed seats and shifted to hospital in available vehicles other than ambulances without spine board is something to ponder upon. Analyzing the severity of injury with the seating position, it was found that majority of patients with severe injuries were seated in the front third of the plane. Though conclusions cannot be made with this evidence, suggestions to improve the energy absorbing capacity of the seats in the front half of the plane could help in preventing severe injuries in future air crash events. Attempts by flight engineers to design better seat belts, similar to the crew seat supports with 4-point contact rather than the present 2-point contact seat belts would be helpful in prevention of flexion distraction injuries. Trials to lower the gravitational force in vertical deceleration phase of accident could be game changing in the future.

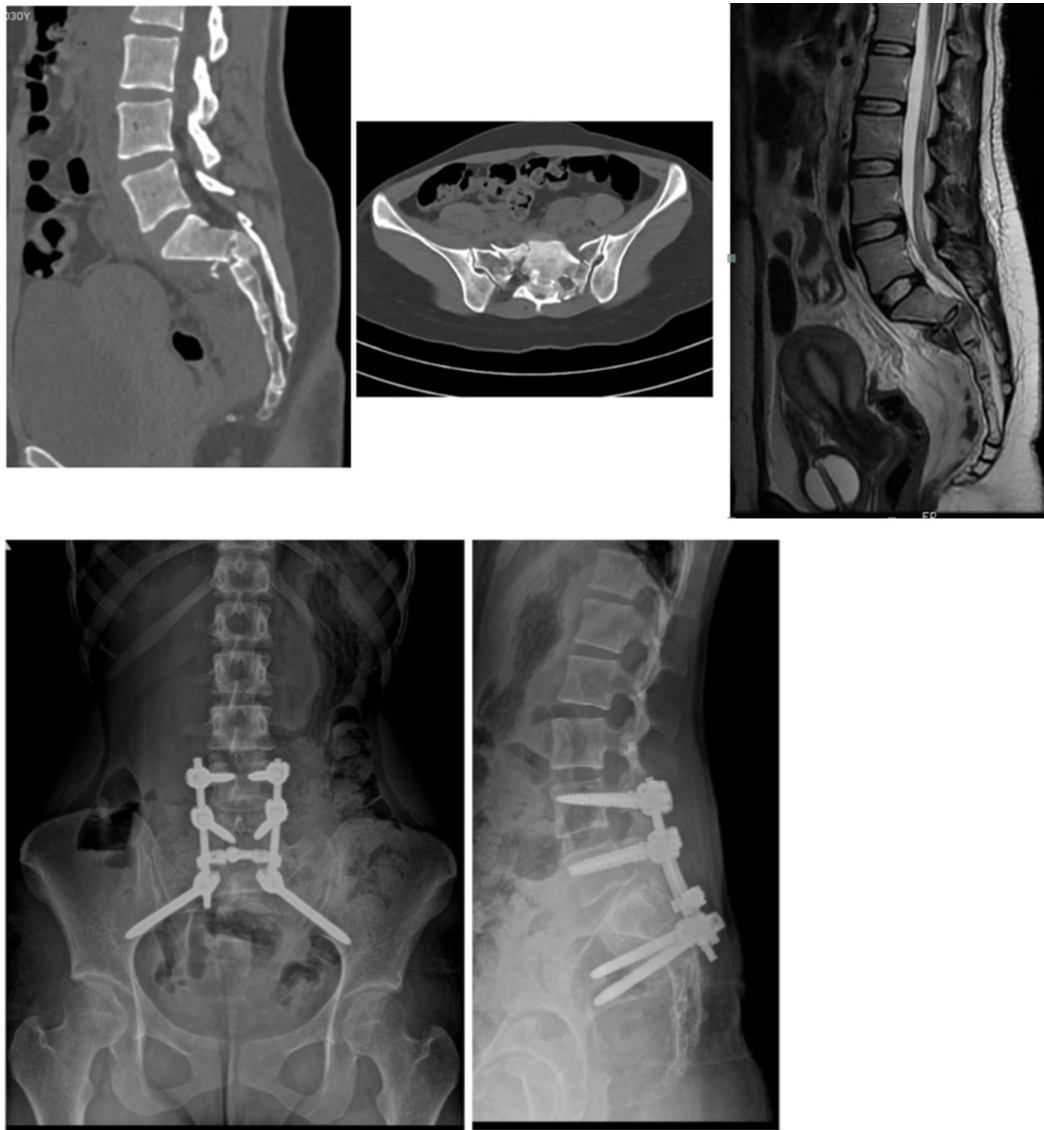
Figure 3. A 26-year-old woman sustained an uncommon injury (patient ID No. 2) and presented with American Spinal Injury Association (ASIA) grade B injury including bowel and bladder deficits. Computed tomography image/magnetic resonance imaging showed “H”-shaped fracture of the sacrum with sacropelvic dissociation. She underwent spinopelvic fixation with decompression of S2 foramina. She started weight-bearing mobilization at as early as 4 weeks and recovered completely to ASIA grade E, including full recovery of bowel and bladder control.

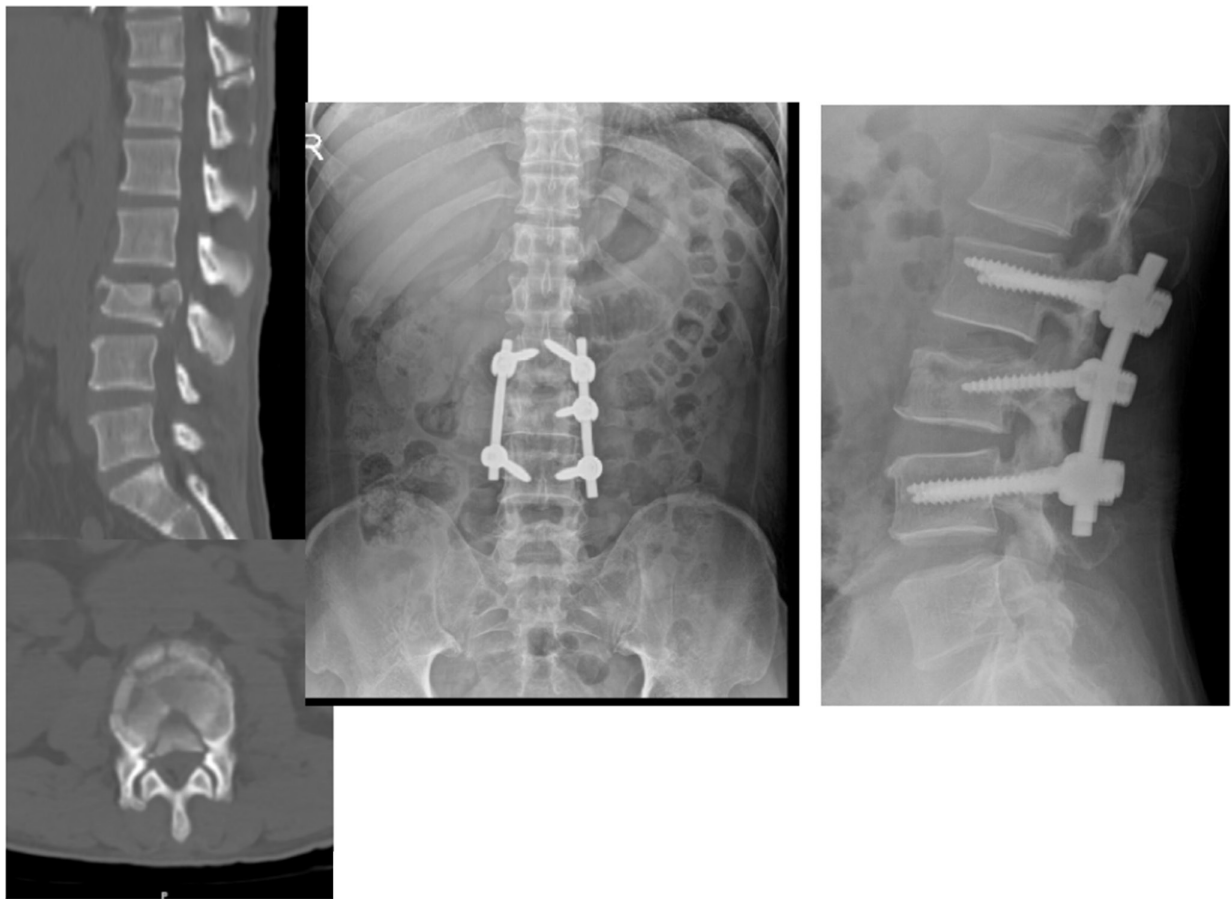
Figure 4. Case illustration of surgically managed patient (patient ID No. 5): 52-year-old man with L3 burst fracture, American Spinal Injury Association grade C injury. Short segment fixation with intermediate screw was performed with decompression.

5	L3 burst fracture with paraparesis, fractures of left lamina and body of C7, left transverse process of L2 and L3 and spinous process and bilateral transverse process of T11 (Figure 4)	A4	L2-L4 stabilization and decompression	Day 2	31	ASIA grade C	ASIA grade D	Walks with support, not able to climb stairs, not able to do job
6	L3 chance fracture with burn injury over the back, L1-L4 spinous process fracture	B1	L2-L4 stabilization and decompression	Day 3	75	ASIA grade E	ASIA grade E	Mobilization out of bed starting with walker, functionally dependent
7	T3 chance fracture	B1	Advised to have surgery but refused, managed conservatively	-	4	ASIA grade E	ASIA grade E	Able to do all activities, mild back pain on prolonged activities
8	Fracture T3 vertebral body, fracture spinous process of T1, T2	A3	Conservative	-	6	ASIA grade E	ASIA grade E	Able to do all activities, back pain during prolonged standing

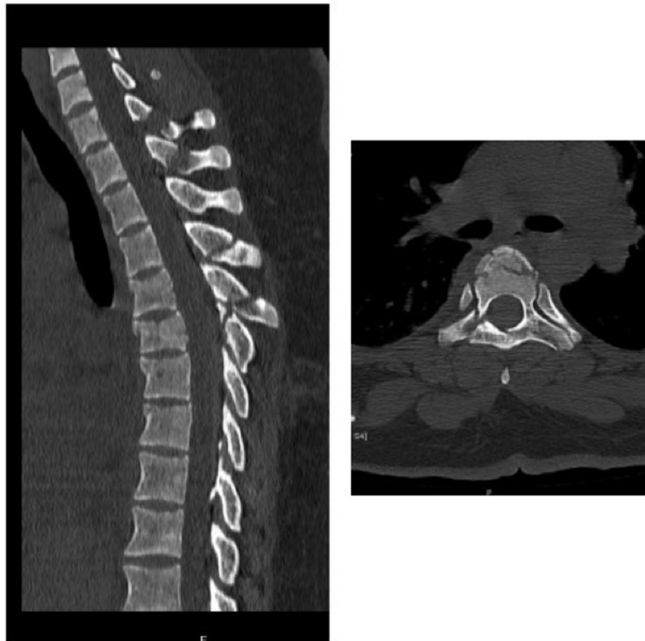
Figure 5. Case illustration of conservatively managed patient (patient ID No. 9 in Table 1): 24-year-old woman with multilevel dorsal level compression fractures with injuries of spinous processes, American Spinal Injury Association grade E.

9	Compression fracture T3, T4, T5, T6, and T7, spinous process fracture C7, T1, T2, T5, and T6 (Figure 5)	B1	Conservative	-	6	ASIA grade E	ASIA grade E	Mild back pain while lifting weight
10	T12 superior endplate impacted compression fracture	A1	Conservative	-	8	ASIA grade E	ASIA grade E	Able to do all activities, returned to work
11	Fracture right transverse process of L5	A1	Conservative	-	5	ASIA grade E	ASIA grade E	Able to do all activities, returned to work
12	Contusion cervical spine, traumatic upper trunk brachial plexopathy (C5, C6)	-	Conservative physiotherapy	-	18	Left shoulder abduction grade 0/5, grip strength weak	Good motor recovery	On physiotherapy, difficulty in lifting object with left upper limb
13	L5 vertebrae body burst fracture	A3	Conservative	-	21	ASIA grade E	ASIA grade E	Started walking with support, not able to do job
