## **Air Crash Investigation: Pattern of Spinal Injuries, Management During the COVID-19 Pandemic, and Outcomes**

*Int J Spine Surg* published online 9 September 2022 https://www.ijssurgery.com/content/early/2022/09/07/8342

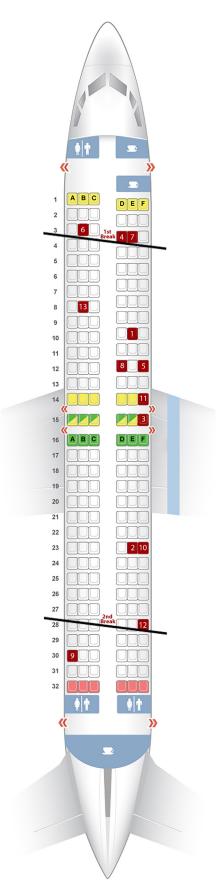
**Figure 2.** Seat layout of the flight showing the sections of the aircraft (marked in black lines as first and second break) and seat numbers of passengers who sustained spinal injuries (marked in red, patient ID as given in Table 1).

165 passengers who survived. More than 100 of them were injured and taken to multiple hospitals and major tertiary care centers around the vicinity of the site of accident. Our center received 47 patients, including both of the pilots who were brought dead. Of the 44 survivors, 13 patients (29.5%), including 4 women and 9 men, were identified to have spinal injuries of varying severity (Table 2). In our case series, almost all of the patients were wearing a seat belt at the time of the accident, and their seat layout is shown in Figure 2.

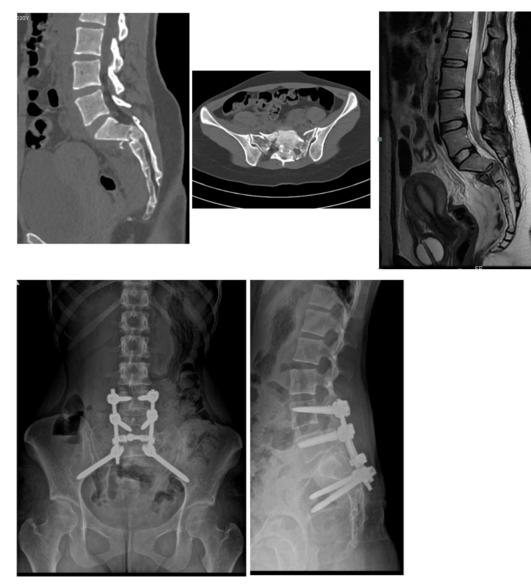
Figure 3. A 26-year-old woman sustained an uncommon injury (patient ID No. 2) and presented with American Spinal Injury Association (ASIA) grade B injury including bowel and bladder deficits. Computed tomography image/magnetic resonance imaging showed "H"-shaped fracture of the sacrum with sacropelvic dissociation. She underwent spinopelvic fixation with decompression of S2 foramina. She started weight-bearing mobilization at as early as 4 weeks and recovered completely to ASIA grade E, including full recovery of bowel and bladder control.

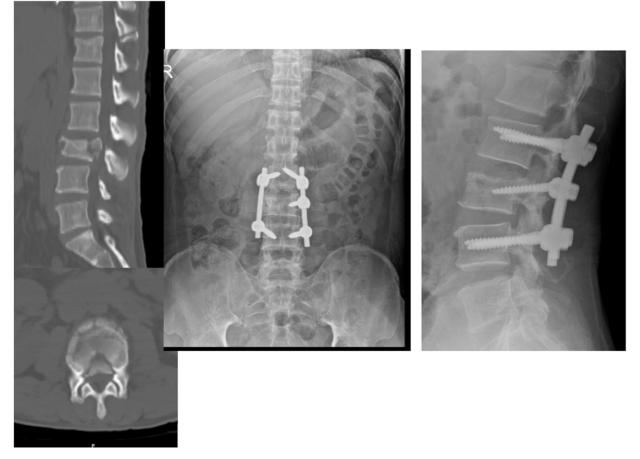
Figure 4. Case illustration of surgically managed patient (patient ID No. 5): 52-year-old man with L3 burst fracture, American Spinal Injury Association grade C injury. Short segment fixation with intermediate screw was performed with decompression.

5	L3 burst fracture with paraparesis, fractures of left lamina and body of C7, left transverse process of L2 and L3 and spinous process and bilateral transverse process of T11 (Figure 4)	A4	L2-L4 stabilization and decompression	Day 2	31	ASIA grade C	ASIA grade D	Walks with support, not able to climb stairs, not able to do job
6	L3 chance fracture with burn injury over the back, L1-L4 spinous process fracture	B1	L2-L4 stabilization and decompression	Day 3	75	ASIA grade E	ASIA grade E	Mobilization out of bed starting with walker, functionally dependent
7	T3 chance fracture	B1	Advised to have surgery but refused, managed conservatively	-	4	ASIA grade E	ASIA grade E	Able to do all activities, mild back pain on prolonged activities
8	Fracture T3 vertebral body, fracture spinous process of T1, T2	A3	Conservative	-	6	ASIA grade E	ASIA grade E	Able to do all activities, back pain during prolonged standing

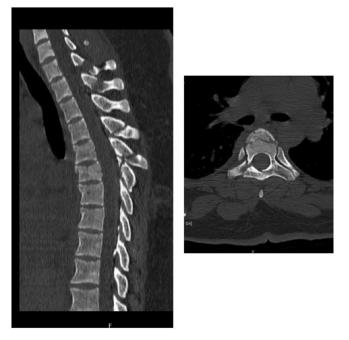
Figure 5. Case illustration of conservatively managed patient (patient ID No. 9 in Table 1): 24-year-old woman with multilevel dorsal level compression fractures with injuries of spinous processes, American Spinal Injury Association grade E.

9	Compression fracture T3, T4, T5, T6, and T7, spinous process fracture C7, T1, T2, T5, and T6 (Figure 5)	B1	Conservative	-	6	ASIA grade E	ASIA grade E	Mild back pain while lifting weight
10	T12 superior endplate impacted compression fracture	A1	Conservative	-	8	ASIA grade E	ASIA grade E	Able to do all activities, returned to work
11	Fracture right transverse process of L5	A1	Conservative	-	5	ASIA grade E	ASIA grade E	Able to do all activities, returned to work
12	Contusion cervical spine, traumatic upper trunk brachial plexopathy (C5, C6)	-	Conservative physiotherapy	-	18	Left shoulder abduction grade 0/5, grip strength weak	Good motor recovery	On physiotherapy, difficulty in lifting object with left upper limb
13	L5 vertebrae body burst fracture	A3	Conservative	-	21	ASIA grade E	ASIA grade E	Started walking with support, not able to do job
