Floating Vertebral Body Cement Ball After High-Viscosity-Cement Vertebroplasty for Lytic Defect: Report of 2 Cases

Tarush Rustagi, MD,^{1,2} Eric Bourekas, MD, MBA,¹ Ehud Mendel, MD, MBA¹

¹Ohio State University Wexner Medical Center and Arthur G. James Cancer Hospital, Columbus, Ohio, ²Indian Spinal Injuries Centre, New Delhi, India

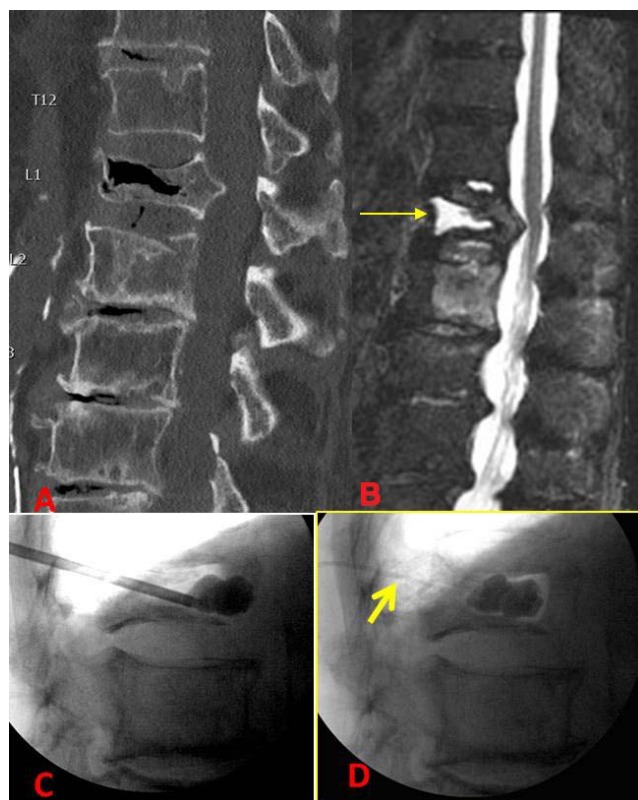
Figure 1. (A) Computed tomography (CT) sagittal image showing the cleft in the L1 vertebrae. (B) Magnetic resonance imaging (MRI) showing fluid-filled lytic cleft (thin yellow arrow). (C) Cement mass stuck to the trocar. (D) Thick Yellow arrow showing the cement tail. The cement mass moved dorsally with removal of the trocar.

scan images showed a severe fracture involving the L1 vertebra with a cleft and mild retropulsion of bone into the spinal canal (Figure 1A). Magnetic resonance imaging (T1 W postcontrast images) suggested metastatic involvement of the vertebra with a large fluid-filled cleft (Figure 1B). Following discussion of the procedure, a PVP was performed using a left-sided, transpedicular approach. After about 11 minutes following the mixing of the cement, the injection was stopped. The stylet of the needle could not be introduced back into the cannula due to

cement within the cannula. We attempted to remove the cannula, but there was resistance. The trocar was then turned to disengage from the cement in preparation to be pulled out. At this time, the cannula of the needle was found stuck to the cement ball, which itself was moving freely within the cleft (Figure 1C, D). Under fluoroscopy control, another attempted rotation of the needle freed it from the cement ball. As the trocar was pulled out, a hardened tail of cement was left behind, emerging through the incision (Figure 1D). The cement tail was attached to the cement ball and was cut as deep as possible. Immediate postoperative CT scan showed that the cement did not interdigitate with the trabeculae and was lying in the cleft, connected through a long tail (Figure 2). Clinically, the patient had marked pain relief in the immediate postoperative period. A repeat CT scan after 3 days showed that the cement ball had moved (Figure 2B). The patient declined any further intervention. At 3 weeks follow-up, following an initial improvement in pain, the pain had again become severe to the extent that it was impeding his ambulation. Repeat x-rays and CT scan at this stage showed further collapse. The cement tail had fractured, and the cement mass had turned horizontally (Figure 2C). Flexion-extension x-rays showed significant intravertebral instability (Figure 3A, B). Following a detailed discussion with the patient, a posterior fusion surgery was done from T10 to L4 (Figure 3C). Afterward, the patient had good pain relief and was able to ambulate well.

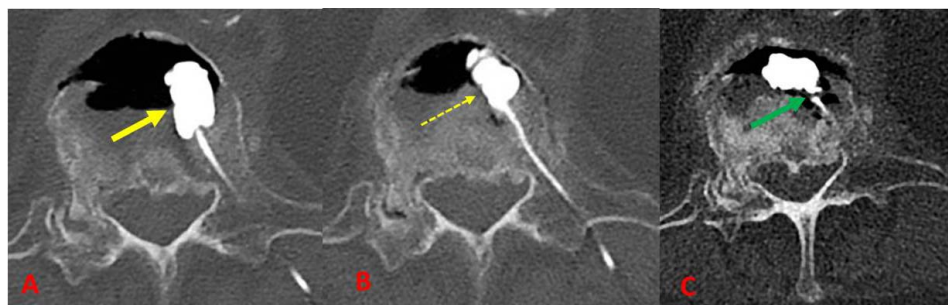
Figure 2. (A) Computed tomography (CT) scan axial images showing cement mass lying in the lytic cleft (bold yellow arrow). (B) CT scan axial images after 3 d showing ventral movement of the cement (dashed yellow arrow). (C) CT scan sagittal and axial images before surgery showing further rotation of the cement mass and fracture of the tail (green arrow).
