# Comparison of in vivo and simulator-retrieved metal-on-metal cervical disc replacements

*Int J Spine Surg* 2012, 6 () 145-156 doi: https://doi.org/10.1016/j.ijsp.2012.03.002 https://www.ijssurgery.com/content/6/145

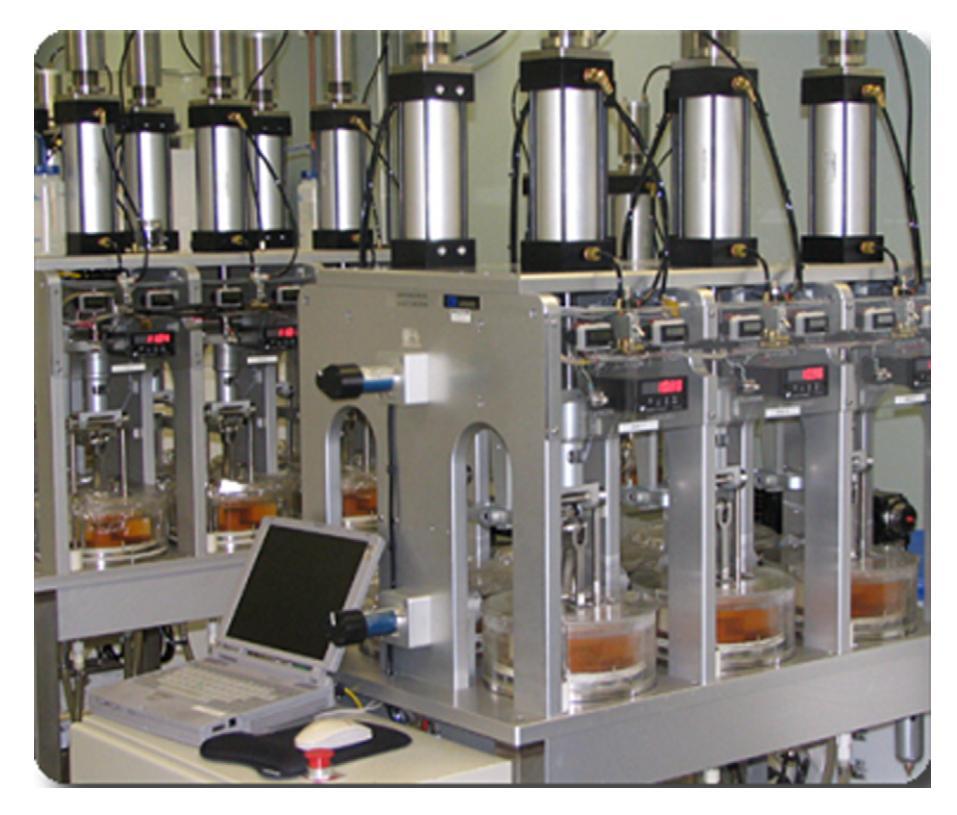
Fig. 1. Laveen wear test machine. Downloaded from https://www.ijssurgery.com/ by guest on September 21, 2024

Two 15 MC series of wear tests were performed on a custom-built, multistation apparatus (Laveen Machine, Burnsville, Minnesota) (Fig. 1). The protocol for the first series of wear tests with 3 specimens has been described previously,<sup>8</sup> consisting of 5 MC of coupled lateral bending  $(\pm 4.7^{\circ})$  and axial rotation  $(\pm 3.8^{\circ})$ , followed by 10 MC of flexion-extension  $(\pm 9.7^{\circ})$  (Fig. 2). There was no axial rotation during the flexion-extension phase of the test. The motions were all performed at a rate of 2 Hz. Static preloads of 49 N and 148 N were applied during the coupled motion and flexion-extension stages of the test, respectively. An additional 3 specimens underwent wear tests where the sequential order of the coupled motion and flexion-extension was reversed; none of the other test parameters were altered. All the testing was performed at body temperature  $(37^{\circ}C \pm 3^{\circ}C)$  using Alpha Calf Fraction (HyClone, Logan, Utah) at a concentration of 25% (protein concentration of approximately 11.5 g/L) as the lubricant. Sodium Azide

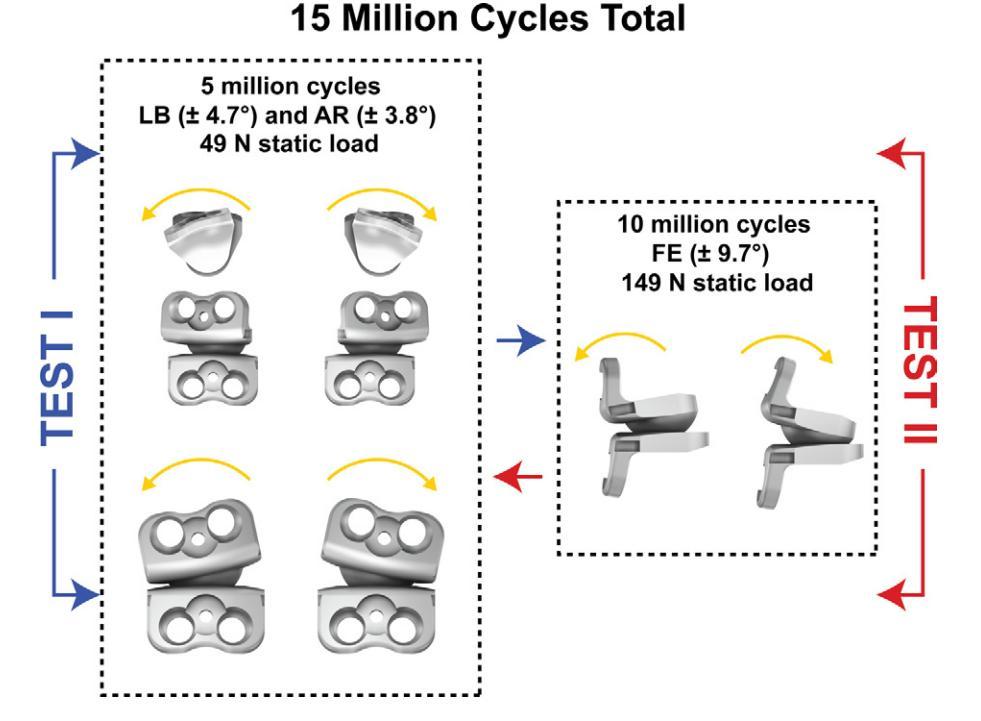
Fig. 2. Schematic of the wear tests. Wear test I was conducted with 5 MC of coupled lateral bending (LB) and axial rotation (AR), followed by 10 MC of flexion-extension (FE). Wear test II was performed in the reverse order, with 10 MC of FE, followed by 5 MC of coupled motion.

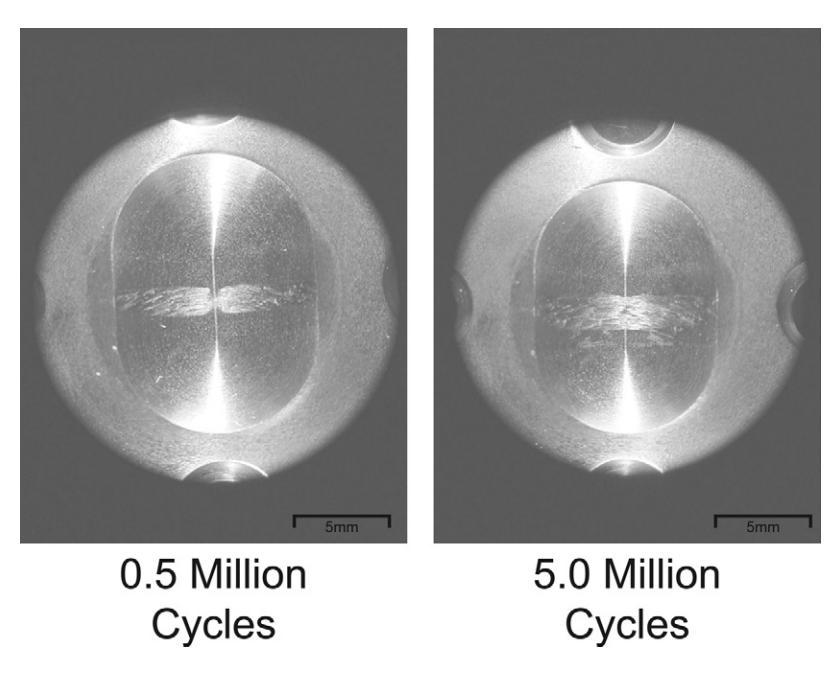
Fig. 3. Photomicrograph of inferior (trough) component after 0.5 and 5.0 MC of in vitro wear testing in coupled motion.

Each wear-tested component exhibited a slightly discolored, macroscopically visible wear scar, which was apparent within the first 0.5 MC of testing and appeared to grow in size as the test progressed (Fig. 3). In both the early and later phases of the test, the wear scar was dominated by curvilinear scratches, characteristic of an abrasive wear process (Fig. 3). Thus the wear mechanisms evident on the final wear-tested components were consistent throughout the test.

between spine wear simulator cycles and the implantation time for the retrievals is not possible at this time. As illustrated in Fig. 3, as early as after 500,000 cycles of testing, the abrasive wear scars of the simulator-tested components already appeared harsher than those retrieved from patients after up to 4.1 years. Additional retrievals, with longer implantation times and greater magnitudes of clinical wear, will be needed to more clearly establish the association between time in the simulator and the implantation time within patients.

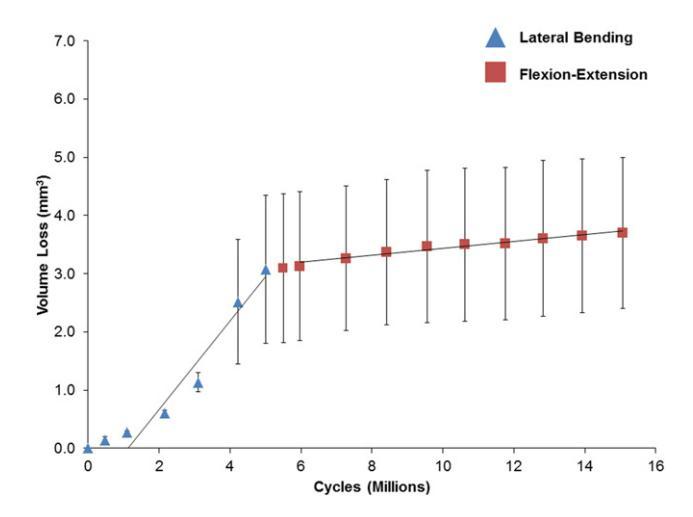
Fig. 4. Mean volume loss (in cubic millimeters) as a function of the number of cycles for samples undergoing lateral bending and axial rotation followed by flexion-extension (n = 3 samples). The wear rate for lateral bending and axial rotation was 0.760 mm<sup>3</sup>/MC ( $R^2 = 0.95$ ), and the wear rate for flexion-extension was 0.059 mm<sup>3</sup>/MC ( $R^2 = 0.96$ ).

Regardless, the wear rate was significantly influenced by the kinematics of the duty cycle. The wear rate was an order of magnitude higher during the coupled-motion phase of the test (n = 6, 0.74 ± 0.30 mm<sup>3</sup>/MC) when compared with the rate during flexion-extension (n = 6, 0.03 ± 0.03 mm<sup>3</sup>/MC) (P = 0.004). No significant difference was observed in the wear rate under coupled motion as a function of its order in the test sequence. In contrast, the wear rate during flexionextension was higher when it was conducted in the second phase of testing after coupled motion (n = 3, 0.059 ± 0.009 mm<sup>3</sup>/MC) compared with tests ordering flexion-extension during the first phase of testing (n = 3, 0.004 ± 0.003 mm<sup>3</sup>/MC) (P = 0.0495). Results of the wear tests are shown in Figs. 4 and 5.

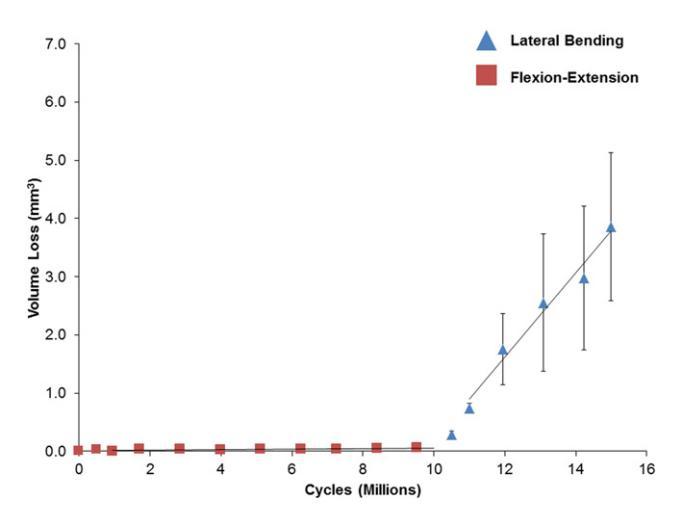
Fig. 5. Mean volume loss (in cubic millimeters) as a function of the number of cycles for samples undergoing flexion-extension followed by lateral bending and axial rotation (n = 3 samples). The wear rate for flexion-extension was 0.004 mm<sup>3</sup>/MC ( $R^2 = 0.64$ ), and the wear rate for lateral bending and axial rotation was 0.720 mm<sup>3</sup>/MC ( $R^2 = 0.97$ ).

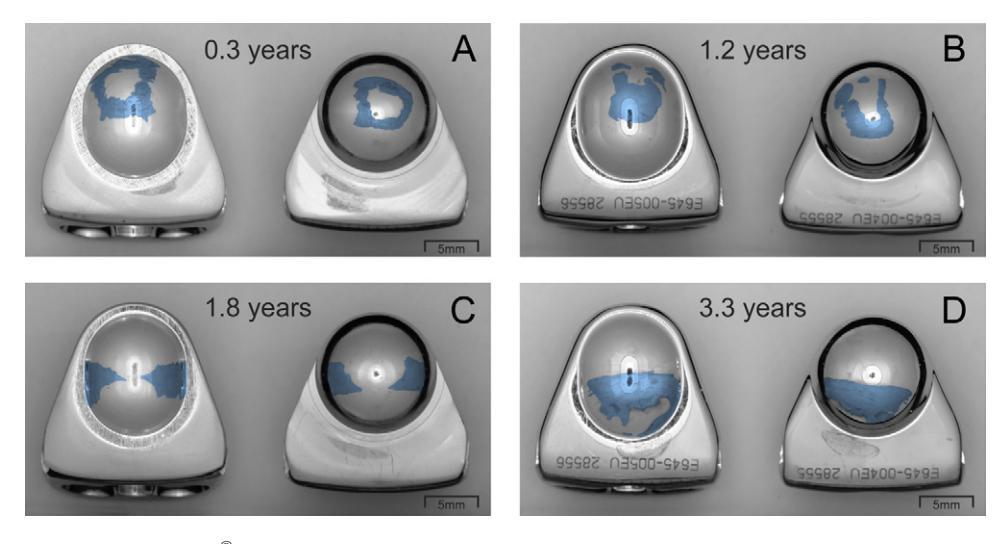
Fig. 6. Photomicrographs of PRESTIGE<sup>®</sup> I and II retrievals. The wear scar on the bearing surface has been highlighted in blue for each retrieval. Downloaded from https://www.ijssurgery.com/ by guest on September 21, 2024

The explants also generally exhibited a slightly discolored wear region of varying dimension and location (Figs. 6 and 7). A summary of the wear and surface damage observations for the retrievals is presented in Table 3. Abrasive wear was found to be the dominant in vivo wear mechanism, with microscopic scratches generally oriented in the medial-lateral direction. All retrievals showed evidence of an abrasive wear mechanism on the bearing surface. The wear maps for the retrievals showed that the most frequently worn location was at the center of the trough and ball but that in several cases the worn area also extended into the posterior region of the bearing (Fig. 8). The anterior bearing surface of the explants was less frequently worn. These

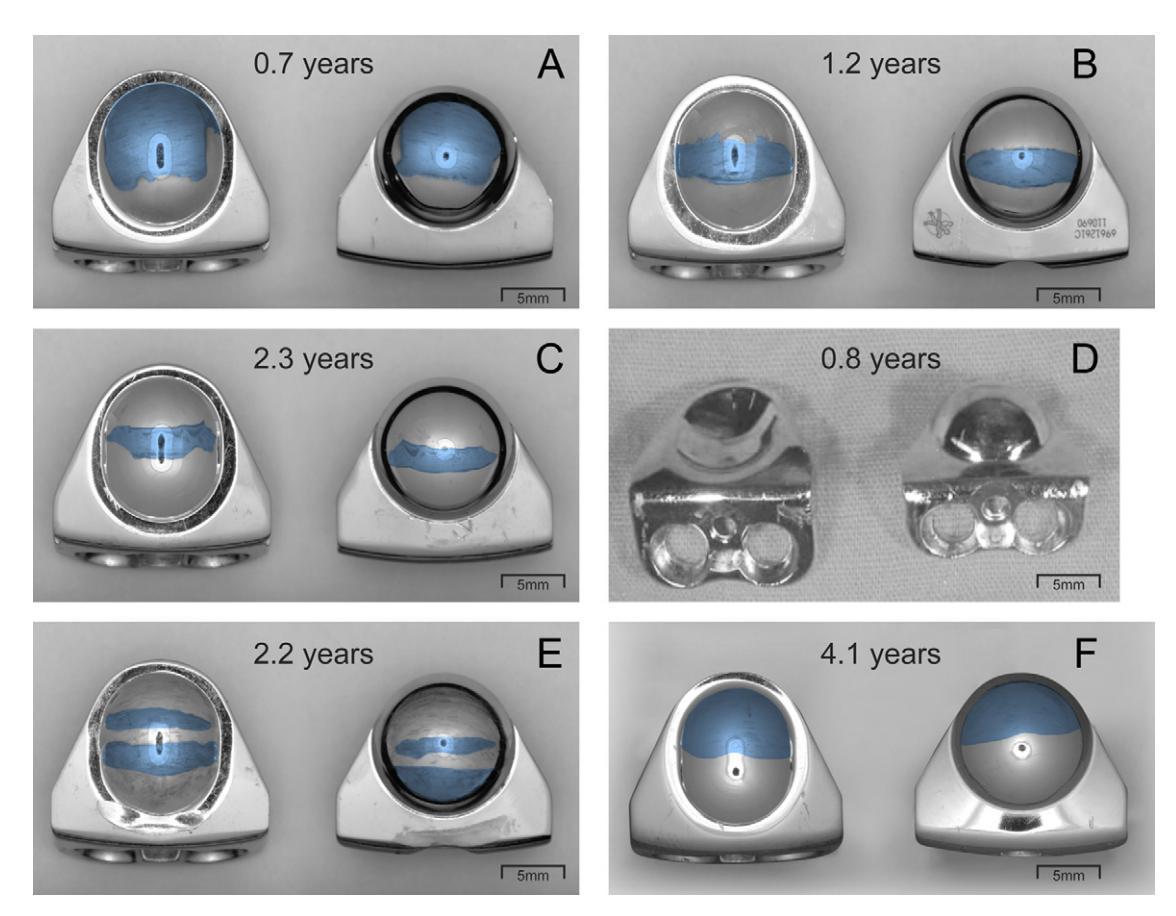
Fig. 7. Photomicrographs of PRESTIGE® retrievals. The wear scar on the bearing surface has been highlighted in blue for each retrieval, when discernible.

superior and inferior endplate rims. Interestingly, the bearing also showed evidence of 2 regions of wear (Fig. 7E), suggesting that it operated in 2 separate configurations for a prolonged duration and consistent with subsidence. Evaluation of the radiographs confirmed posterior subsidence of the superior endplate in this case. The head of the locking screw of the superior component was fractured, with the remaining portion of the screw still within the hole. Examination of these parts under SEM showed a damage mechanism consistent with a fatigue crack propagation caused by the impingement of the head of the locking screw and the rim of the inferior endplate.

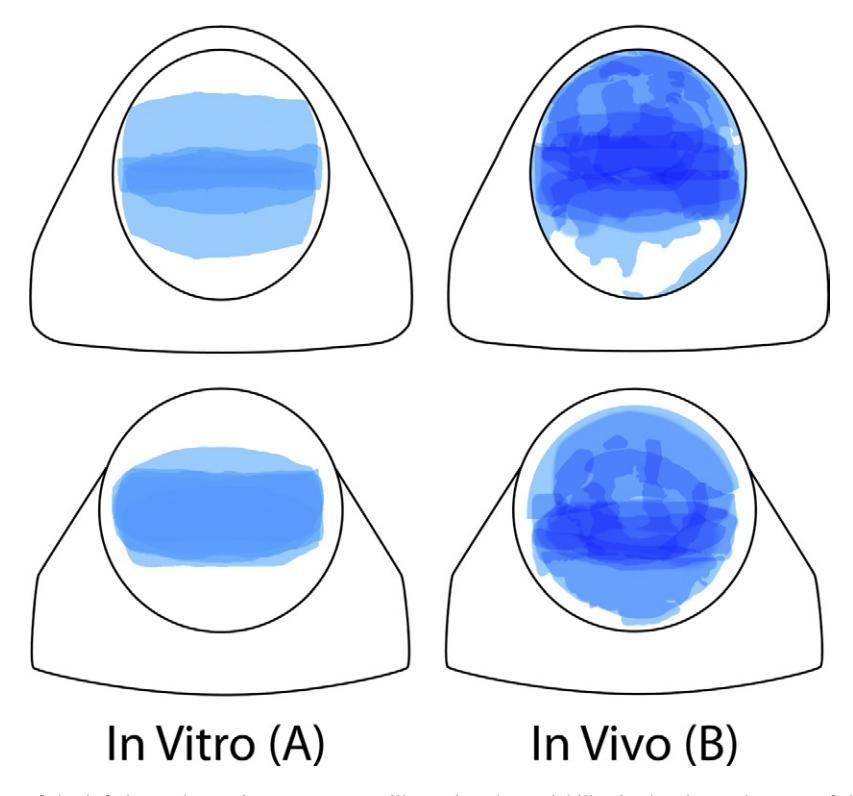
Fig. 8. Composite wear maps of the inferior and superior components, illustrating the variability in the size and extent of the wear scar for (A) in vitro wear-tested components (n = 3) at 15 MC after wear test I (Fig. 1) and (B) explanted components (n = 10).

Although the wear mechanisms from the explants were similar to those of the simulator-tested devices, the in vitro protocol resulted in more severe abrasion than observed in vivo (Figs. 8 and 9). The relative severity of the in vitro protocol was apparent on both optical microscopy and SEM (Fig. 9) and further quantified by WLI. The average surface roughness within the wear scar of the wear-tested components (1.4  $\pm$  1.0  $\mu$ m) was found to be significantly greater than the average surface roughness of the retrieved explanted artificial discs (0.12  $\pm$  0.10  $\mu$ m) (P < 0.0001). Similarly, the average surface waviness within the wear scar of the wear-tested components was found to be significantly greater (0.54  $\pm$  0.47  $\mu$ m for wear-tested components and  $0.10 \pm 0.10 \ \mu m$  for retrieved explanted artificial discs). A summary of different metrics of the wear surface is summarized in Table 3.

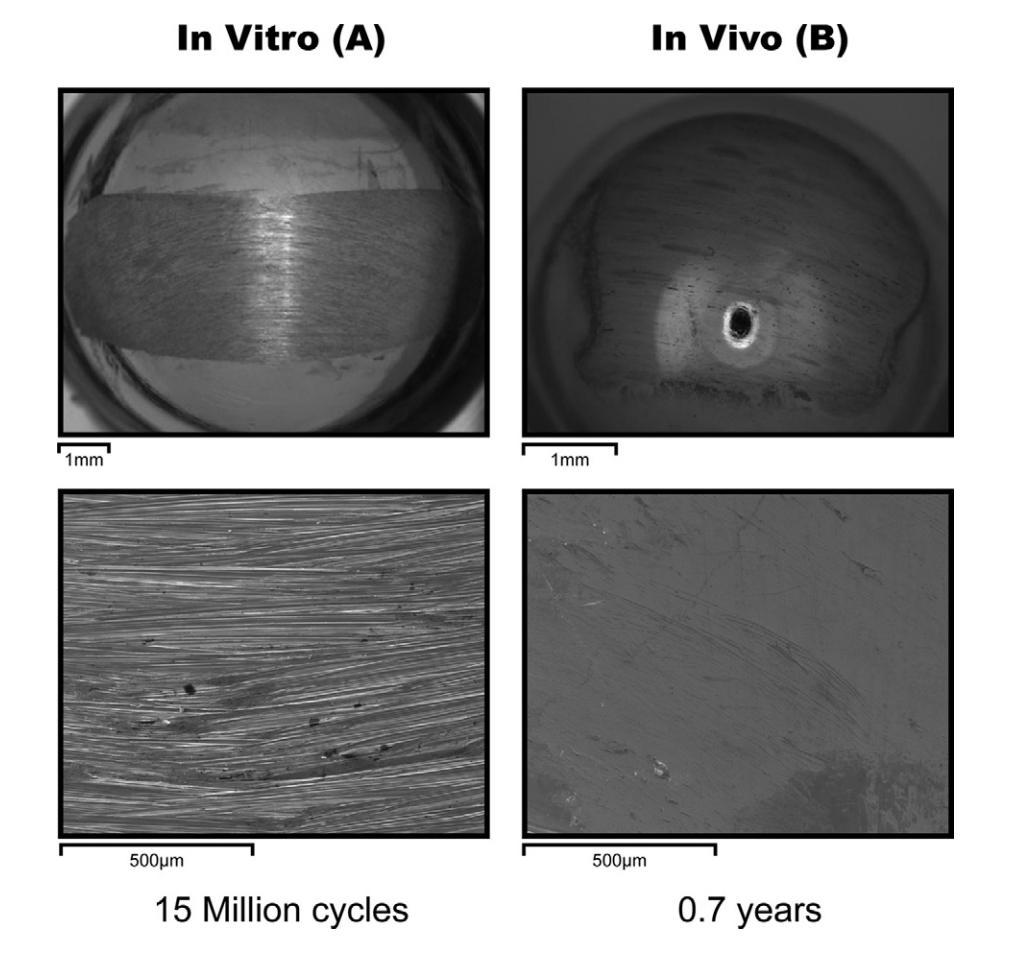
Fig. 9. (A) Photomicrographs and SEM micrographs of the superior (spherical) component at 15 MC after wear test I (Fig. 1). (B) Photomicrographs and SEM micrographs of an explanted, superior (spherical) component after 0.7 years in vivo.

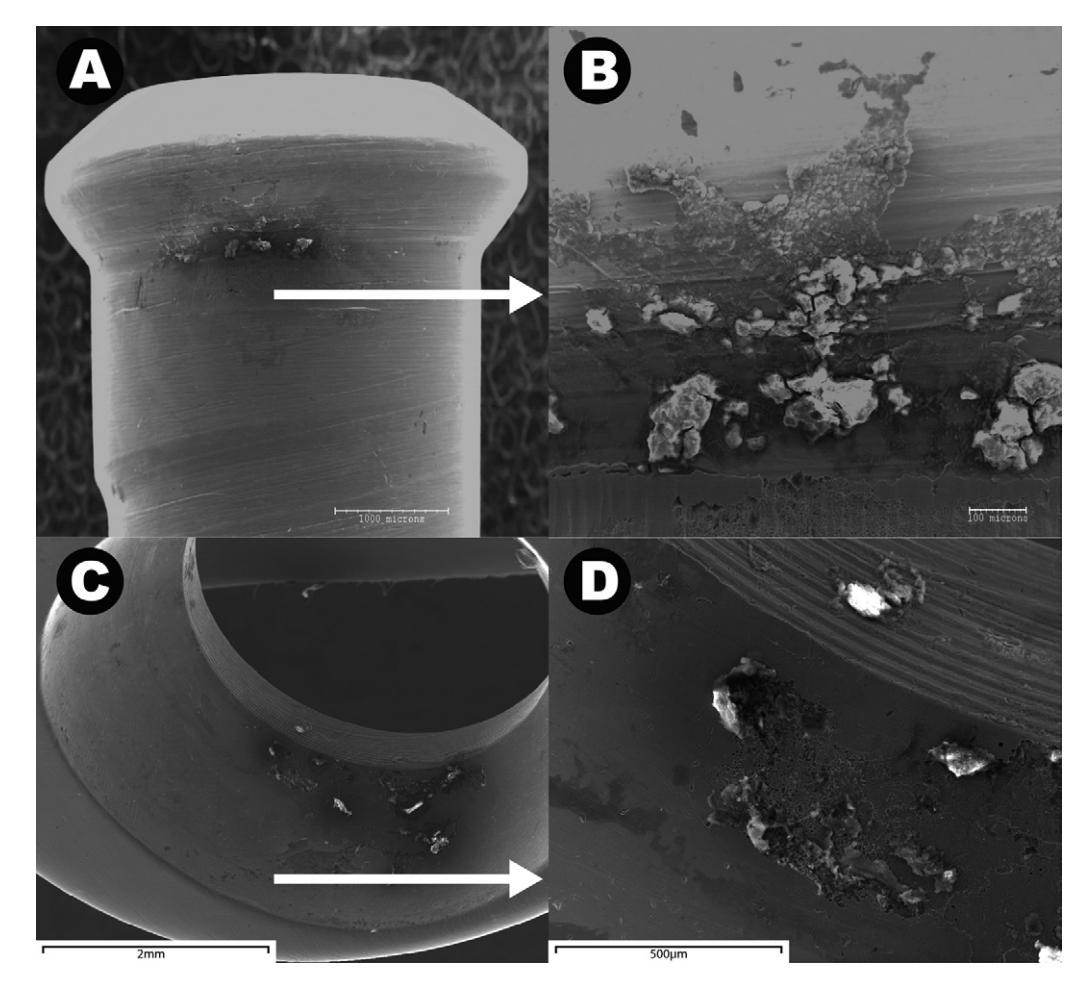
Fig. 10. Scanning electron microscopy of surface deposits on a retrieved screw head and screw hole: (A) screw head ( $20 \times$  magnification), (B) screw head ( $100 \times$  magnification), (C) screw hole ( $20 \times$  magnification), (D) screw hole ( $100 \times$  magnification).

Evidence of localized screw hole fretting and fretting near the heads of bone screws was noted in all cases (Fig. 10). SEM confirmed the presence of biological deposits and ruled out corrosive material removal at these locations. No fractures of any of the bone screws used for fixation were observed in this collection.

Several of the retrievals in this study showed evidence of fretting between the bone screws and the screw holes in the anterior flange of the endplates. Similar observations were made during the previous analysis for 1 of 2 explants.<sup>8</sup> Bone plates and fusion instrumentation using screw fixation and modular connections frequently show signs of fretting damage and/or corrosion.<sup>20,21</sup> Therefore, given its occurrence with the current standard of care, the evidence of similar mechanisms occurring at the screw–screw hole interface of the design is not unexpected.

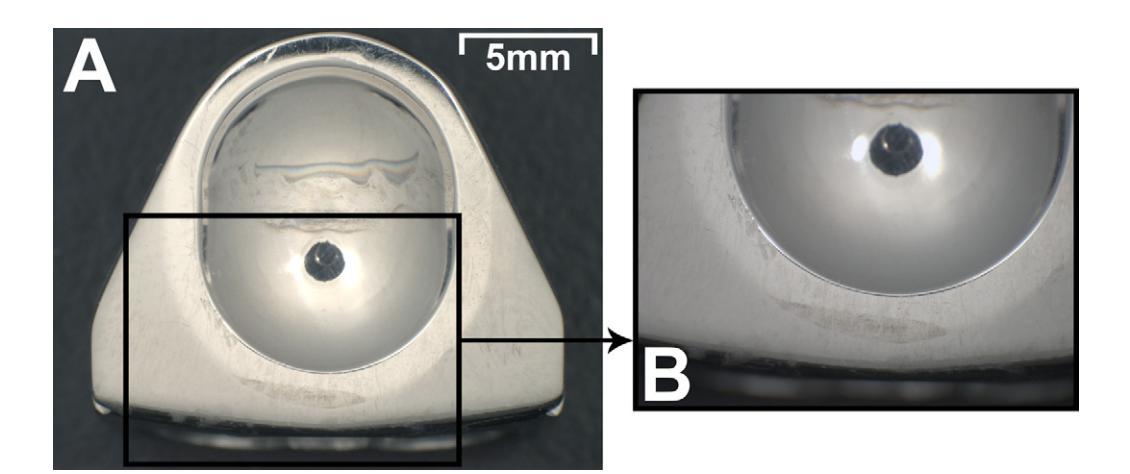
Fig. 11. Anterior impingement in a component retrieved after 2.3 years *in vivo*. (A) Photomicrograph of entire component. (B) Detail of impingement region. Downloaded from https://www.ijssurgery.com/ by guest on September 21, 2024

Evidence of anterior impingement was noted in 5 of the cases. Anterior impingement typically resulted in minor scratching or discoloration (Fig. 11). One explant, revised after 2.2 years because of neck pain after a sporting injury, showed evidence of moderate anterior impingement of the
