## Air Crash Investigation: Pattern of Spinal Injuries, Management During the COVID-19 Pandemic, and Outcomes

*Int J Spine Surg* 2022, 16 (5) 899-907

# Air Crash Investigation: Pattern of Spinal Injuries, Management During the COVID-19 Pandemic, and Outcomes

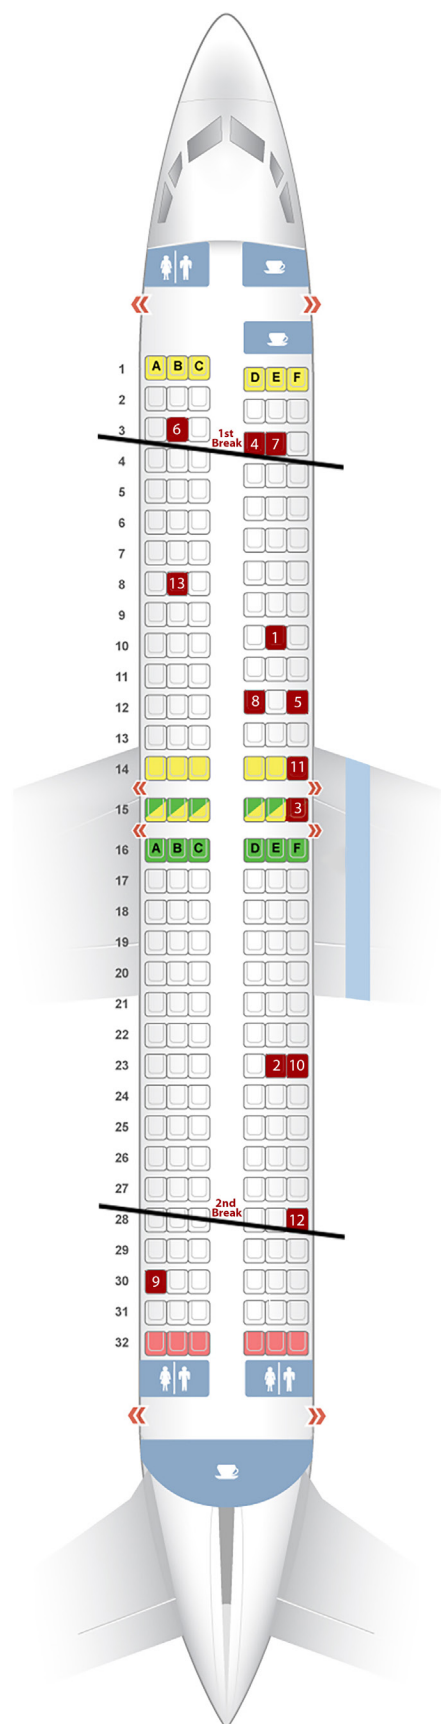
**Figure 2.** Seat layout of the flight showing the sections of the aircraft (marked in black lines as first and second break) and seat numbers of passengers who sustained spinal injuries (marked in red, patient ID as given in Table 1).

165 passengers who survived. More than 100 of them were injured and taken to multiple hospitals and major tertiary care centers around the vicinity of the site of accident. Our center received 47 patients, including both of the pilots who were brought dead. Of the 44 survivors, 13 patients (29.5%), including 4 women and 9 men, were identified to have spinal injuries of varying severity (Table 2). In our case series, almost all of the patients were wearing a seat belt at the time of the accident, and their seat layout is shown in Figure 2.

at the time of incident or secondary as the patients were pulled out of the jammed seats and shifted to hospital in available vehicles other than ambulances without spine board is something to ponder upon. Analyzing the severity of injury with the seating position, it was found that majority of patients with severe injuries were seated in the front third of the plane. Though conclusions cannot be made with this evidence, suggestions to improve the energy absorbing capacity of the seats in the front half of the plane could help in preventing severe injuries in future air crash events. Attempts by flight engineers to design better seat belts, similar to the crew seat supports with 4-point contact rather than the present 2-point contact seat belts would be helpful in prevention of flexion distraction injuries. Trials to lower the gravitational force in vertical deceleration phase of accident could be game changing in the future.

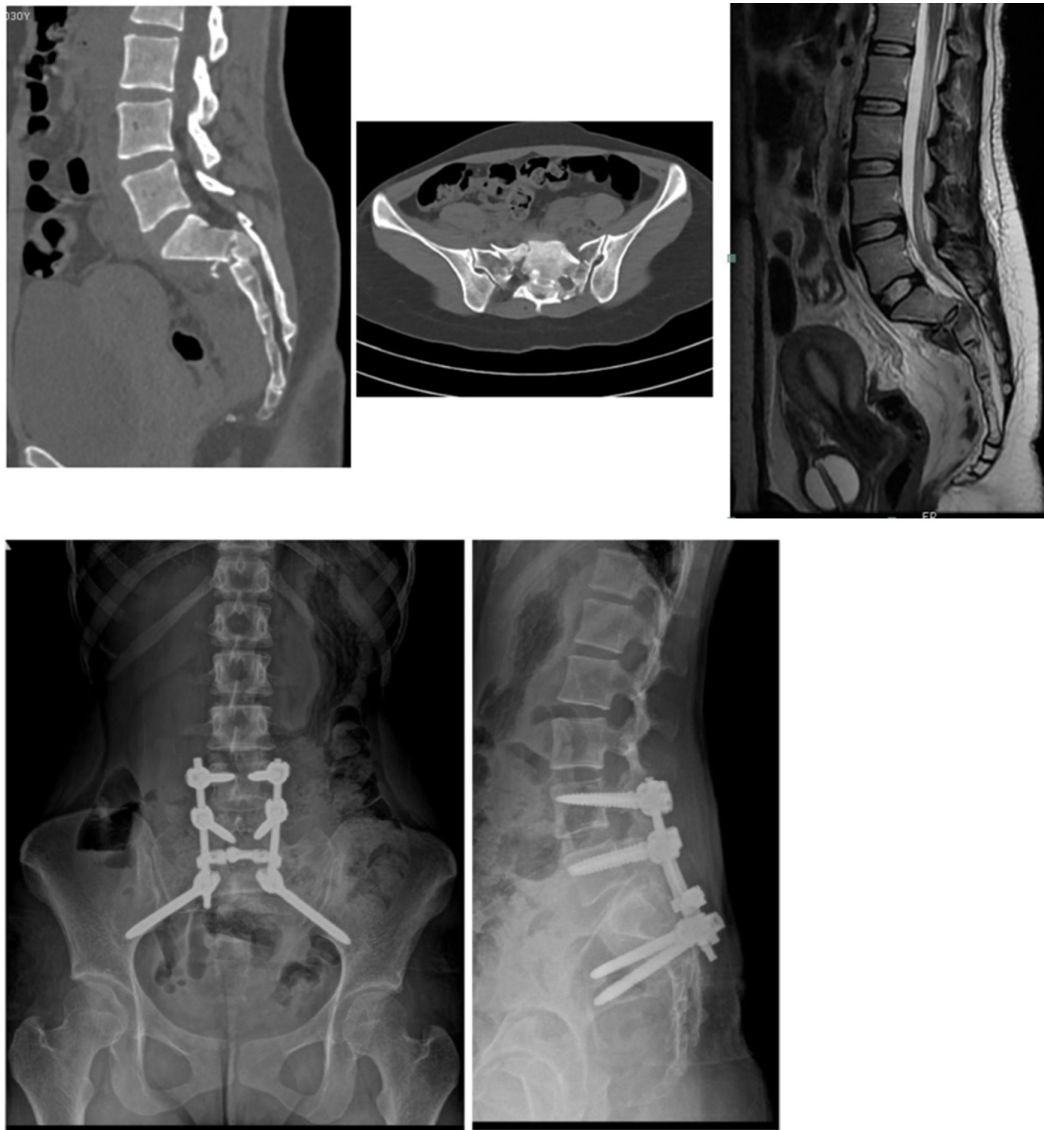
**Figure 3.** A 26-year-old woman sustained an uncommon injury (patient ID No. 2) and presented with American Spinal Injury Association (ASIA) grade B injury including bowel and bladder deficits. Computed tomography image/magnetic resonance imaging showed “H”-shaped fracture of the sacrum with sacropelvic dissociation. She underwent spinopelvic fixation with decompression of S2 foramina. She started weight-bearing mobilization at as early as 4 weeks and recovered completely to ASIA grade E, including full recovery of bowel and bladder control.

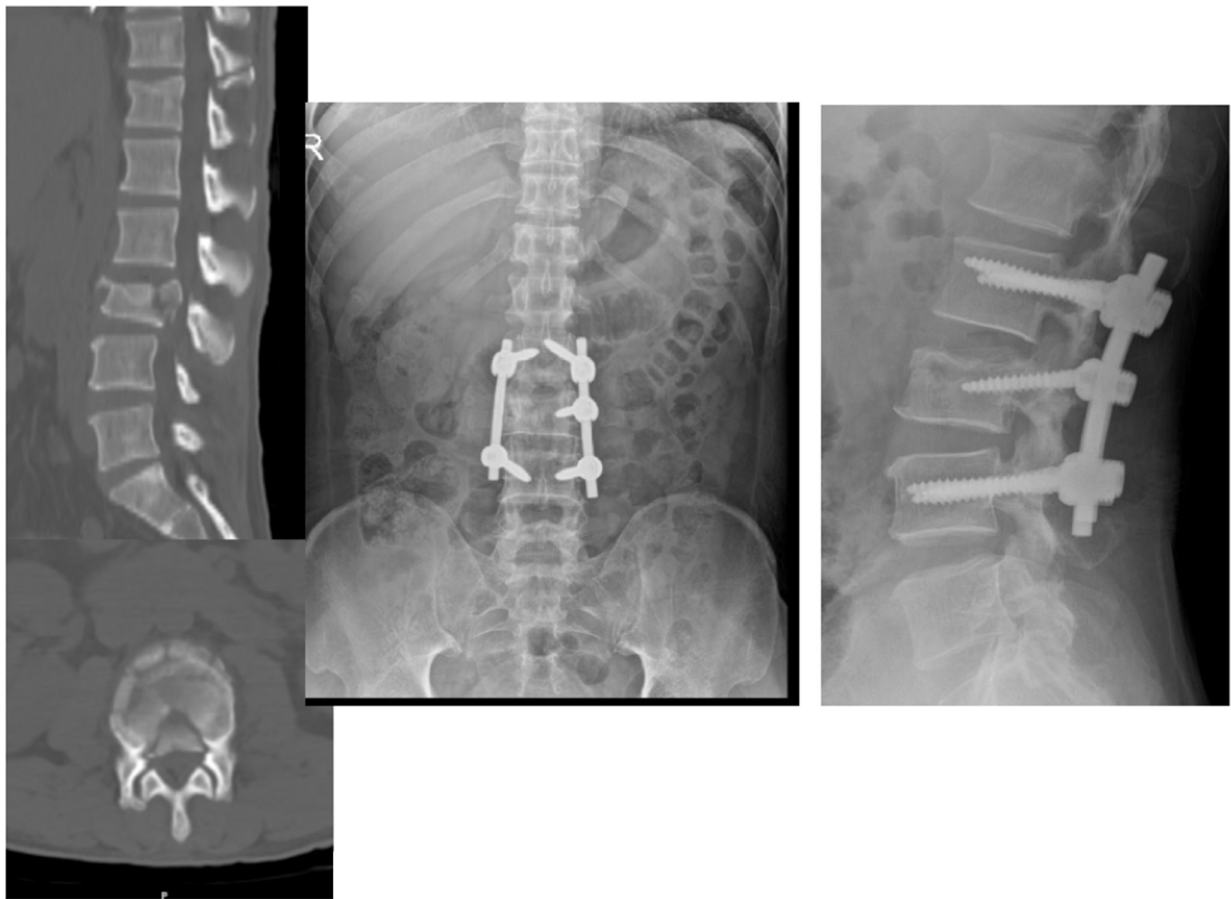
**Figure 4.** Case illustration of surgically managed patient (patient ID No. 5): 52-year-old man with L3 burst fracture, American Spinal Injury Association grade C injury. Short segment fixation with intermediate screw was performed with decompression.

5	L3 burst fracture with paraparesis, fractures of left lamina and body of C7, left transverse process of L2 and L3 and spinous process and bilateral transverse process of T11 (Figure 4)	A4	L2-L4 stabilization and decompression	Day 2	31	ASIA grade C	ASIA grade D	Walks with support, not able to climb stairs, not able to do job
6	L3 chance fracture with burn injury over the back, L1-L4 spinous process fracture	B1	L2-L4 stabilization and decompression	Day 3	75	ASIA grade E	ASIA grade E	Mobilization out of bed starting with walker, functionally dependent
7	T3 chance fracture	B1	Advised to have surgery but refused, managed conservatively	-	4	ASIA grade E	ASIA grade E	Able to do all activities, mild back pain on prolonged activities
8	Fracture T3 vertebral body, fracture spinous process of T1, T2	A3	Conservative	-	6	ASIA grade E	ASIA grade E	Able to do all activities, back pain during prolonged standing

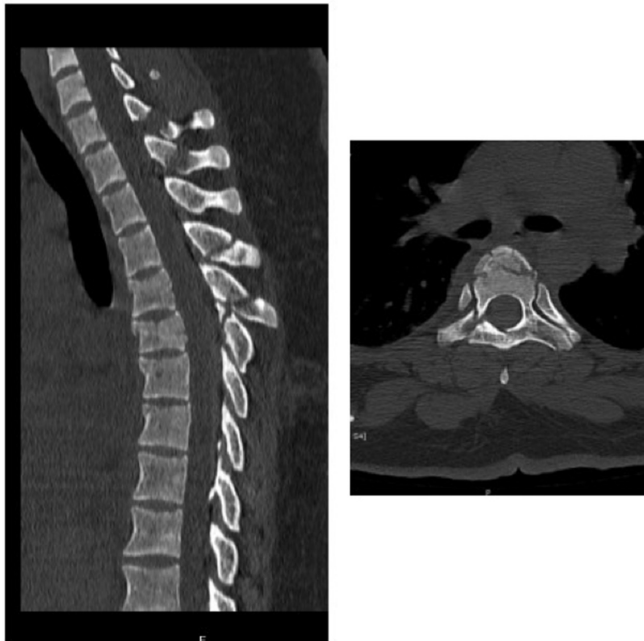
**Figure 5.** Case illustration of conservatively managed patient (patient ID No. 9 in Table 1): 24-year-old woman with multilevel dorsal level compression fractures with injuries of spinous processes, American Spinal Injury Association grade E.

9	Compression fracture T3, T4, T5, T6, and T7, spinous process fracture C7, T1, T2, T5, and T6 (Figure 5)	B1	Conservative	-	6	ASIA grade E	ASIA grade E	Mild back pain while lifting weight
10	T12 superior endplate impacted compression fracture	A1	Conservative	-	8	ASIA grade E	ASIA grade E	Able to do all activities, returned to work
11	Fracture right transverse process of L5	A1	Conservative	-	5	ASIA grade E	ASIA grade E	Able to do all activities, returned to work
12	Contusion cervical spine, traumatic upper trunk brachial plexopathy (C5, C6)	-	Conservative physiotherapy	-	18	Left shoulder abduction grade 0/5, grip strength weak	Good motor recovery	On physiotherapy, difficulty in lifting object with left upper limb
13	L5 vertebrae body burst fracture	A3	Conservative	-	21	ASIA grade E	ASIA grade E	Started walking with support, not able to do job
