Retrieval analysis of motion preserving spinal devices and periprosthetic tissues

Int J Spine Surg 2009, 3 (4) 161-177

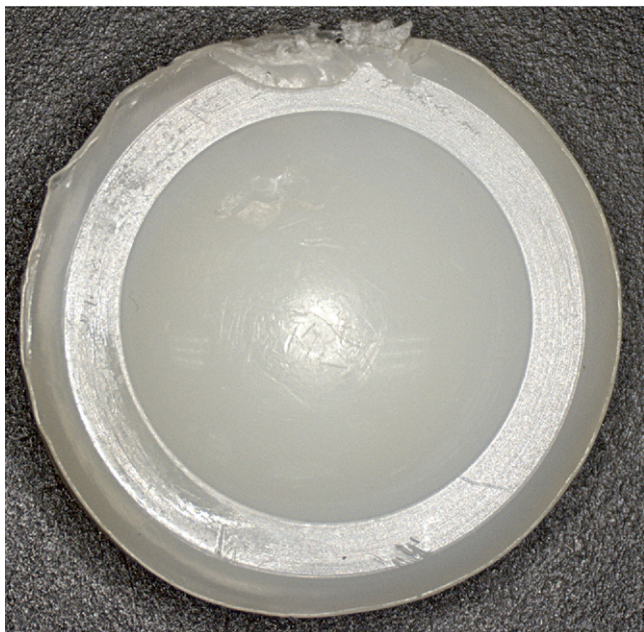
Fig. 4. Microscopic, multidirectional scratches and crisscrossing wear paths at the dome of a retrieved polyethylene total disc replacement that was implanted 6.2 years.

During retrieval analysis, the pattern of scratches on an implant, whether macroscopic or microscopic, provide clues to the kinematics (motion) of the surfaces while they were in contact *in vivo*. The microscopic multidirectional scratches and crisscrossing wear paths at the dome of a retrieved polyethylene TDR (Fig. 4) are consistent with the type of microscopic abrasive wear mechanisms previously observed in retrieved hip replacement components.^{12,13} By matching comparable regions of damage on 2 opposing bearing surfaces, it is further possible to infer the orientation of the components while they were in contact.

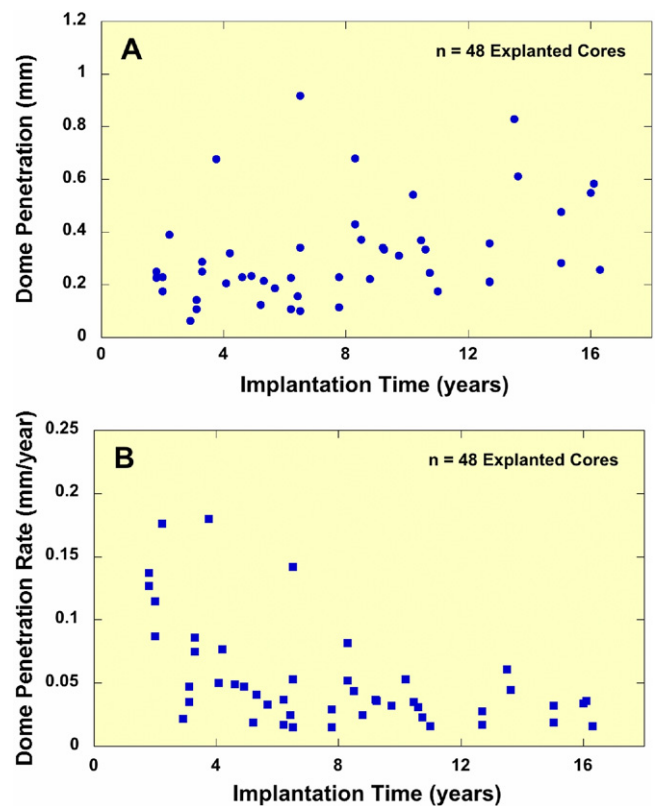
Fig. 17. A significant correlation was observed between implantation time and (A) penetration (Spearman's Rho = 0.42, $p = 0.003$) and (B) penetration rate (Spearman's Rho = -0.53 , $p = 0.0001$) in retrieved Charité implants. (Adapted with permission.¹⁵)

wear patterns.¹⁵ Significant correlations were observed between implantation time and penetration and penetration rate (Fig. 17). The dome of the components typically exhibited burnishing, which was consistent with the multidirectional wear observed in hip replacements, whereas the rim frequently showed evidence of radial and transverse cracking (19/38 and 14/38 retrievals, respectively), often produced by impingement. The rim damage modes of plastic deformation, delamination, and cracking were similar to those associated with knee components. The published Charité retrieval literature provide crucial long-term in vivo wear data for validation of spine wear simulators, as well as for in vitro biomechanical testing.

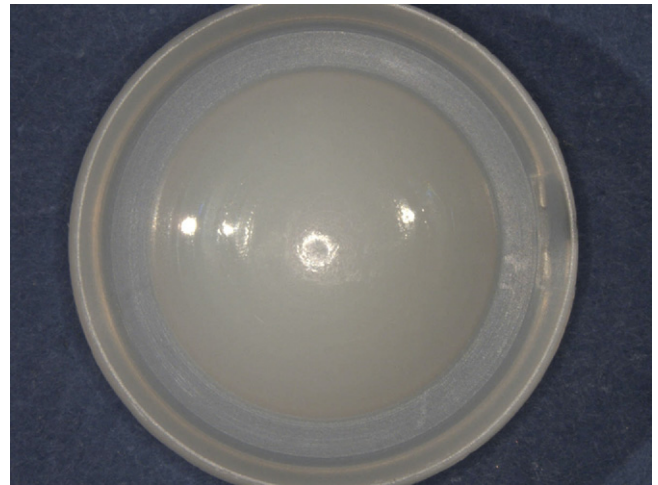
Fig. 18. Charité components tested using ISO wear testing protocols incorporating coupled motions exhibited regional burnishing and wear at a rate of 0.124 mm/Mcycles.

rates of the Charité with simulator wear rates.⁸¹ It was hypothesized that the wear mechanisms of the retrievals would be more accurately simulated by ISO protocols with coupled motion, as compared with ASTM-type protocols that resulted in linear motion. Researchers analyzed dome wear rate and surface morphology of 41 Charité (SBIII) explants from 35 patients (71% female). The cores were implanted for 7.5 years (range, 1.8–16.3). Twelve Charité wear-tested cores and 6 controls were also examined. Six cores were tested according to an ASTM-type protocol for 10 million cycles⁸²; 3 additional cores were unloaded and soaked. Six cores were tested according to the ISO protocol for 2 million cycles with 3 loaded and soaked controls. All of the cores in this study were produced by the same manufacturer (Link, Germany). The explanted cores typically exhibited burnishing or evidence of adhesive/abrasive dome wear, consistent with multidirectional motion. The wear rate of the explants, obtained by correlation of dome height with implantation time, was 0.023 mm/year. The ASTM-tested cores exhibited unidirectional abrasive wear at a rate of 0.007 mm/Mcycles. The ISO-tested cores exhibited regional burnishing and wear at a rate of 0.124 mm/Mcycles (Fig. 18). Thus, the ISO protocol generated wear surface morphology that was closer to the retrievals than the ASTM-type protocol, and 1 million cycles of the ISO protocol corresponded, on average, to about 5.6 years of clinical wear. The findings from this study further suggest that the ISO protocol provides a useful starting point for clinical validation of spine wear simulations incorporating lumbar polyethylene TDRs.
