Painless squeaking following cervical disc replacement: A case report

Abstract

KEYWORDS: SQUEAKING, CERVICAL, TOTAL DISC ARTHROPLASTY, PRESTIGE LP DISC, CASE REPORT
VOLUME 9 ARTICLE 44 DOI: 10.14444/2044

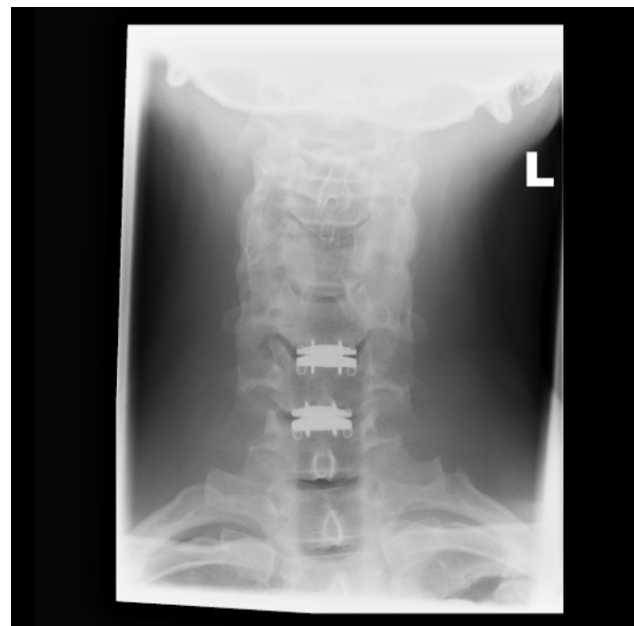
Fig. 1.

We investigated this phenomenon with plain radiographs of the cervical spine, MRI, Focussed CT scan and EMG Studies. These all confirmed excellent implant position and no further nerve root impingement. No explanation as to the cause of squeaking was elicited from these investigations. Below are the AP and Lateral radiographs of the patient at 24 months (Figure 1 & Figure 2).
