## Air Crash Investigation: Pattern of Spinal Injuries, Management During the COVID-19 Pandemic, and Outcomes

*Int J Spine Surg* published online 9 September 2022  
<https://www.ijssurgery.com/content/early/2022/09/07/8342>

<sup>1</sup>Aster MIMS Hospital, Calicut, Kerala, India

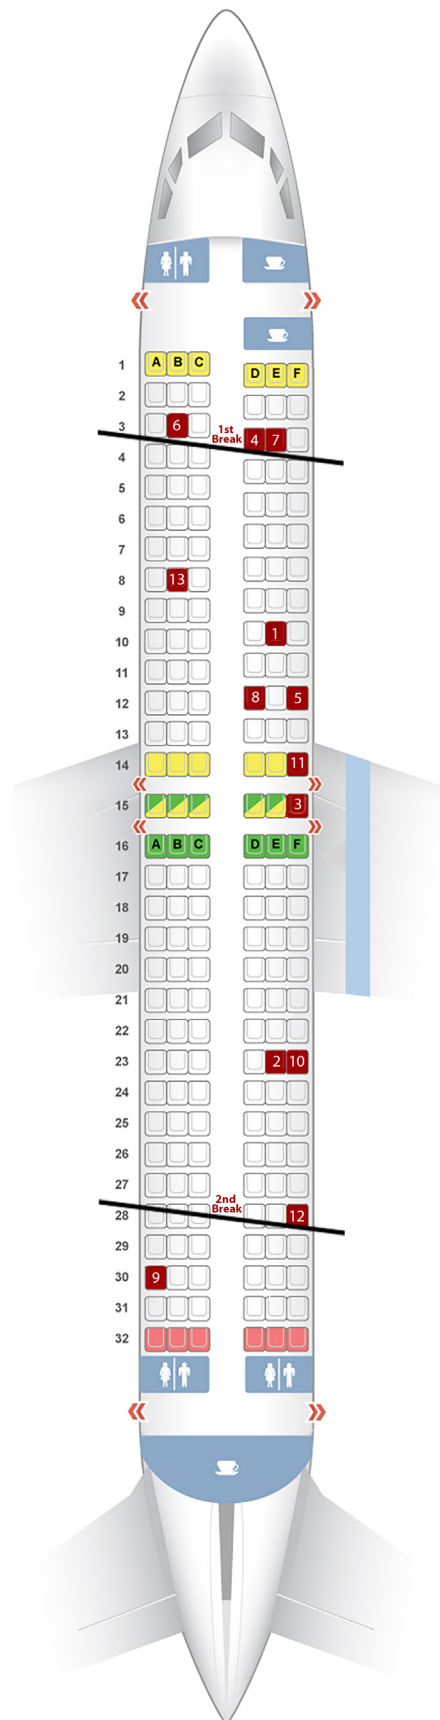
**Figure 2.** Seat layout of the flight showing the sections of the aircraft (marked in black lines as first and second break) and seat numbers of passengers who sustained spinal injuries (marked in red, patient ID as given in Table 1).

165 passengers who survived. More than 100 of them were injured and taken to multiple hospitals and major tertiary care centers around the vicinity of the site of accident. Our center received 47 patients, including both of the pilots who were brought dead. Of the 44 survivors, 13 patients (29.5%), including 4 women and 9 men, were identified to have spinal injuries of varying severity (Table 2). In our case series, almost all of the patients were wearing a seat belt at the time of the accident, and their seat layout is shown in Figure 2.

As observed in our patients, the majority of the severe spinal injuries presented with varying degrees of neurological deficits. Whether the injuries were primary in nature at the time of incident or secondary as the patients were pulled out of the jammed seats and shifted to hospital in available vehicles other than ambulances without spine board is something to ponder upon. Analyzing the severity of injury with the seating position, it was found that majority of patients with severe injuries were seated in the front third of

the plane. Though conclusions cannot be made with this evidence, suggestions to improve the energy absorbing capacity of the seats in the front half of the plane could help in preventing severe injuries in future air crash events. Attempts by flight engineers to design better seat belts, similar to the crew seat supports with 4-point contact rather than the present 2-point contact seat belts would be helpful in prevention of flexion distraction injuries. Trials to lower the gravitational force in vertical deceleration phase of accident could be game changing in the future.
