*Int J Spine Surg* 2022, 16 (5) 899-907

# Air Crash Investigation: Pattern of Spinal Injuries, Management During the COVID-19 Pandemic, and Outcomes

**Methods:** An analysis was performed on the spinal injuries of victims of the Boeing 737 crash landing at the Karipur Airport (Calicut International Airport, Kerala, India) who were treated at a tertiary care referral hospital in August 2020. Details of the initial triage, patterns of injury, morphologies, mechanisms, management principles, and outcomes at 9 months postinjury were recorded and analyzed.

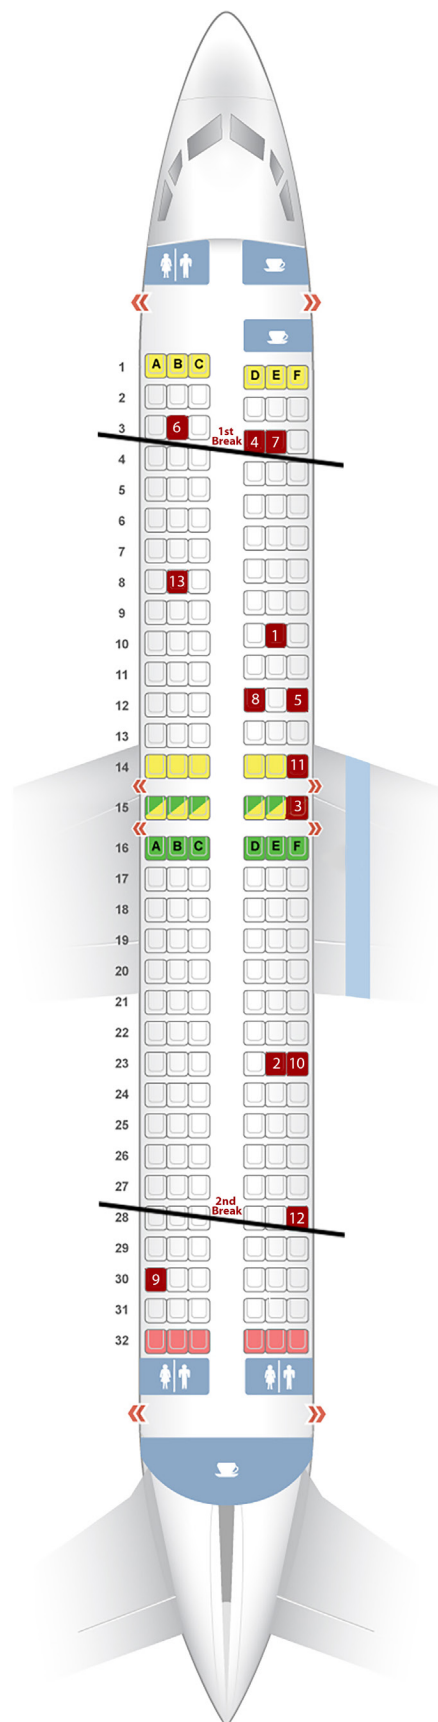
**Figure 2.** Seat layout of the flight showing the sections of the aircraft (marked in black lines as first and second break) and seat numbers of passengers who sustained spinal injuries (marked in red, patient ID as given in Table 1).

165 passengers who survived. More than 100 of them were injured and taken to multiple hospitals and major tertiary care centers around the vicinity of the site of accident. Our center received 47 patients, including both of the pilots who were brought dead. Of the 44 survivors, 13 patients (29.5%), including 4 women and 9 men, were identified to have spinal injuries of varying severity (Table 2). In our case series, almost all of the patients were wearing a seat belt at the time of the accident, and their seat layout is shown in Figure 2.

at the time of incident or secondary as the patients were pulled out of the jammed seats and shifted to hospital in available vehicles other than ambulances without spine board is something to ponder upon. Analyzing the severity of injury with the seating position, it was found that majority of patients with severe injuries were seated in the front third of the plane. Though conclusions cannot be made with this evidence, suggestions to improve the energy absorbing capacity of the seats in the front half of the plane could help in preventing severe injuries in future air crash events. Attempts by flight engineers to design better seat belts, similar to the crew seat supports with 4-point contact rather than the present 2-point contact seat belts would be helpful in prevention of flexion distraction injuries. Trials to lower the gravitational force in vertical deceleration phase of accident could be game changing in the future.

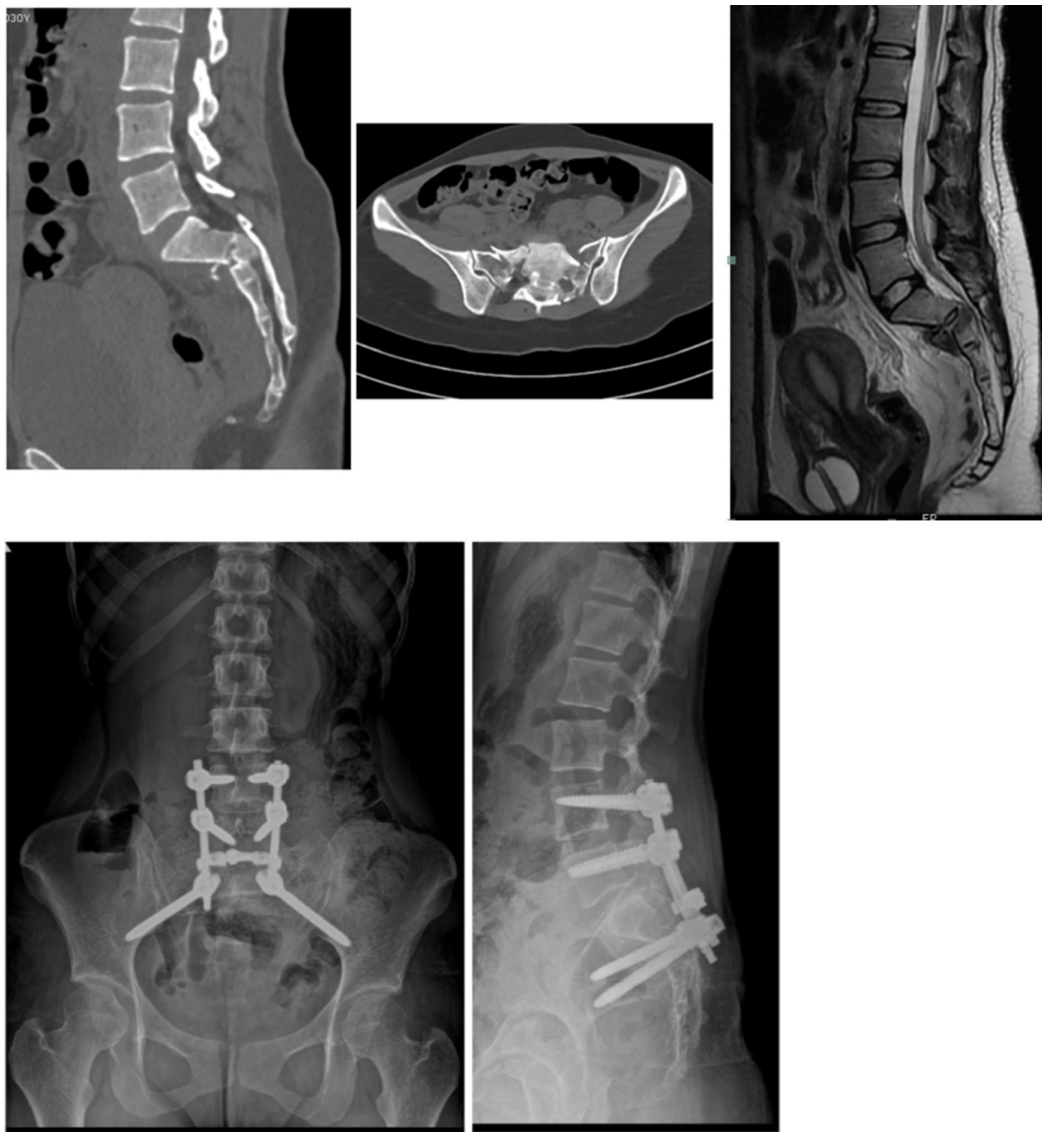
**Figure 3.** A 26-year-old woman sustained an uncommon injury (patient ID No. 2) and presented with American Spinal Injury Association (ASIA) grade B injury including bowel and bladder deficits. Computed tomography image/magnetic resonance imaging showed “H”-shaped fracture of the sacrum with sacropelvic dissociation. She underwent spinopelvic fixation with decompression of S2 foramina. She started weight-bearing mobilization at as early as 4 weeks and recovered completely to ASIA grade E, including full recovery of bowel and bladder control.

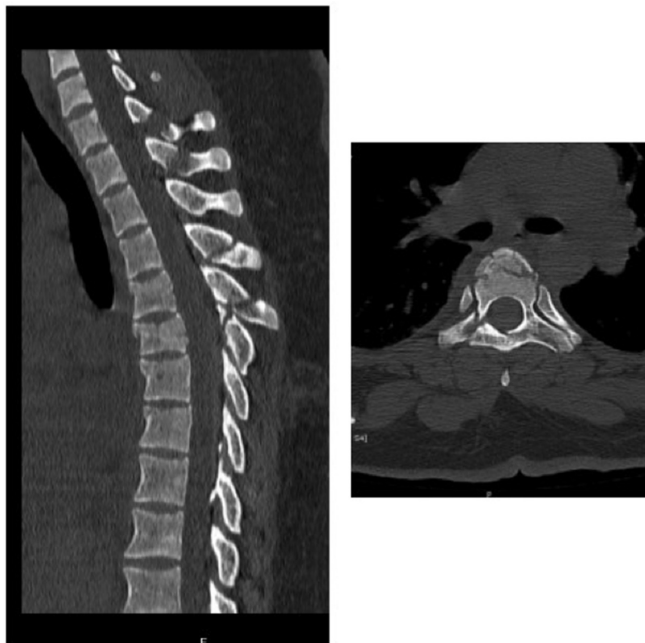
**Figure 5.** Case illustration of conservatively managed patient (patient ID No. 9 in Table 1): 24-year-old woman with multilevel dorsal level compression fractures with injuries of spinous processes, American Spinal Injury Association grade E.

9	Compression fracture T3, T4, T5, T6, and T7, spinous process fracture C7, T1, T2, T5, and T6 (Figure 5)	B1	Conservative	-	6	ASIA grade E	ASIA grade E	Mild back pain while lifting weight
10	T12 superior endplate impacted compression fracture	A1	Conservative	-	8	ASIA grade E	ASIA grade E	Able to do all activities, returned to work
11	Fracture right transverse process of L5	A1	Conservative	-	5	ASIA grade E	ASIA grade E	Able to do all activities, returned to work
12	Contusion cervical spine, traumatic upper trunk brachial plexopathy (C5, C6)	-	Conservative physiotherapy	-	18	Left shoulder abduction grade 0/5, grip strength weak	Good motor recovery	On physiotherapy, difficulty in lifting object with left upper limb
13	L5 vertebrae body burst fracture	A3	Conservative	-	21	ASIA grade E	ASIA grade E	Started walking with support, not able to do job
