## Retrieval analysis of motion preserving spinal devices and periprosthetic tissues

Steven M. Kurtz, Marla Steinbeck, Allyson Ianuzzi, André van Ooij, Ilona M. Punt, Jorge Isaza and E.R.S. Ross

*Int J Spine Surg* 2009, 3 (4) 161-177

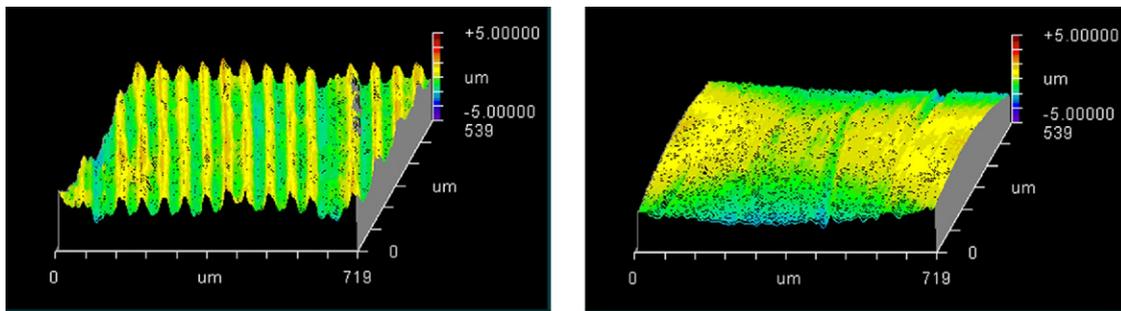
Figure 1 illustrates the surface topography obtained from the unworn and worn surface regions of a retrieved polyethylene disc replacement component. The unworn polyethylene surface is dominated by machining marks that are on the order of several microns in amplitude (Fig. 1, left).

Fig. 1. White light interferometry images of an unworn (left) and worn (right) polyethylene implant surface.

Initially, microscopic evidence of adhesive/abrasive wear is detected by the erosion and removal of machining marks, along with the presence of fine scratches (Fig. 1, right).

As demonstrated in Figures 1 and 2, surface characterization using white light interferometry provides useful information about the wear mechanisms in total disc replacements. Furthermore, by quantitatively analyzing the surface data, the roughness and waviness can be quantified and compared with as-manufactured components, thereby providing insight into the magnitude of surface changes that occur in vivo.<sup>8–10</sup> Ultimately, quantitative measurements of implant surfaces are used to validate in vitro and computational models that seek to simulate in vivo wear processes.

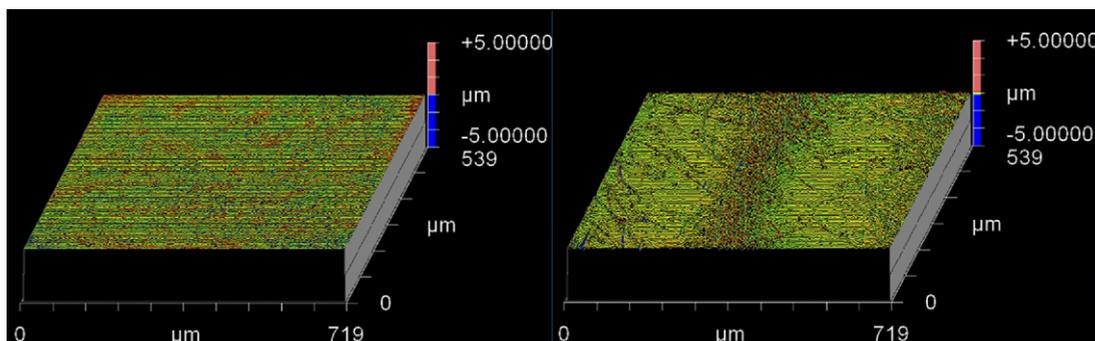
The surface topography of a retrieved CoCr alloy disc replacement is shown in Figure 2. The unworn CoCr surface is usually relatively flat and featureless, aside from microscopic scratches generated during the final polishing stage of the manufacturing process (Fig. 2, left). In a region of wear, the CoCr surface has evidence of localized, microscopic scratches with a characteristic length scale that is larger than the residual features from polishing (Fig. 2, right).

Fig. 2. White light interferometry images of an unworn (left) and worn (right) metal-on-metal implant surface.

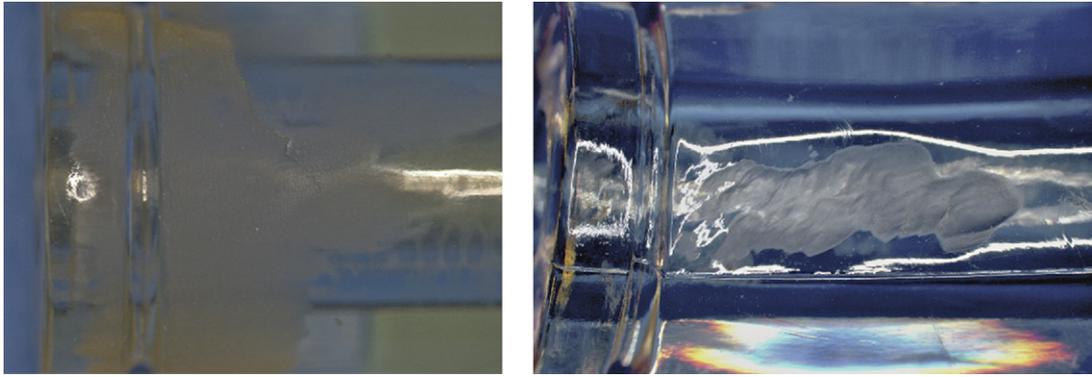
Fig. 3. Abrasive wear observed on polymeric components from retrieved Dynesys systems, implanted 1.1 (left) and 1 (right) years.

components of the implant contact surrounding bony structures (Fig. 3).

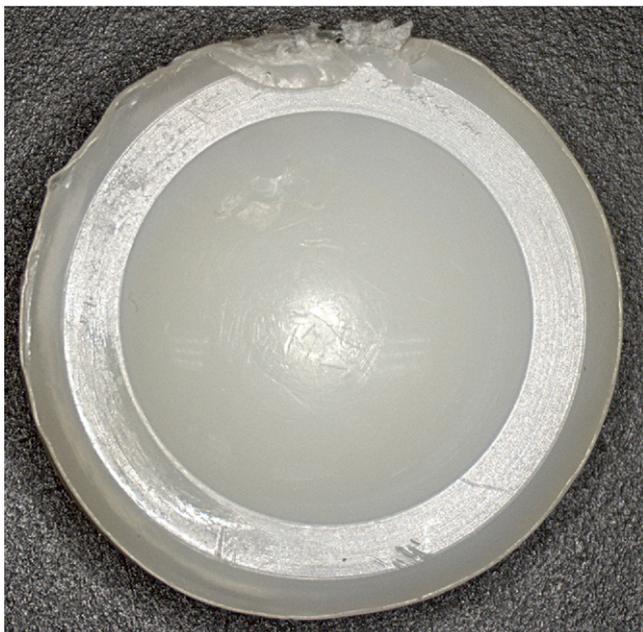
Fig. 4. Microscopic, multidirectional scratches and crisscrossing wear paths at the dome of a retrieved polyethylene total disc replacement that was implanted 6.2 years.

During retrieval analysis, the pattern of scratches on an implant, whether macroscopic or microscopic, provide clues to the kinematics (motion) of the surfaces while they were contact in vivo. The microscopic multidirectional scratches and crisscrossing wear paths at the dome of a retrieved polyethylene TDR (Fig. 4) are consistent with the type of microscopic abrasive wear mechanisms previously observed in retrieved hip replacement components.<sup>12,13</sup> By matching comparable regions of damage on 2 opposing bearing surfaces, it is further possible to infer the orientation of the components while they were in contact.

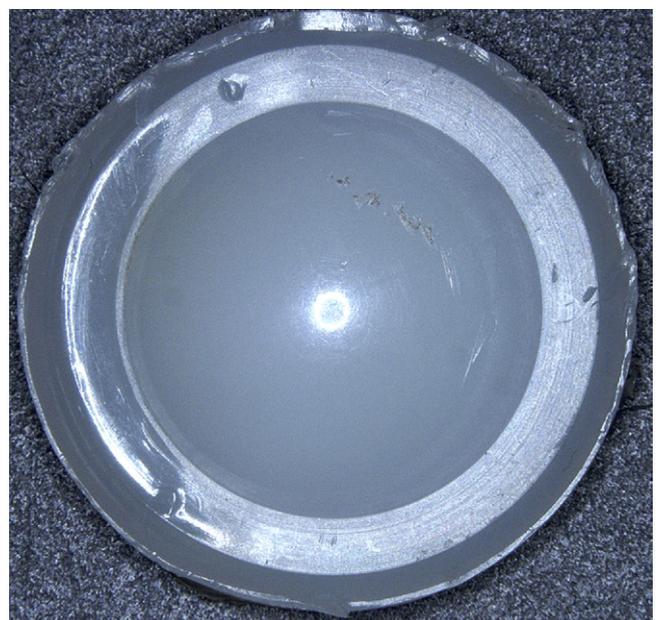
Typically encountered with polyethylene disc components, burnishing gives the polymer surface a polished, glossy appearance (Fig. 5). At a microscopic length scale, burnishing is associated with an adhesive wear mechanism, whereby the polyethylene surface wear occurs by adhesion to the metallic counterface. Highly magnified images of a burnished wear zone from a retrieved total disc replacement are shown in Figure 5, and as noted also show evidence of scratching which denotes the presence of abrasion. For this reason, the dominant wear mechanism in metal-on-polyethylene articulations is considered to be a combination of adhesion and abrasion, as seen in total joint replacements.<sup>12,13</sup>

Fig. 5. Burnishing observed on the dome of the polyethylene component of a retrieved total disc replacement.

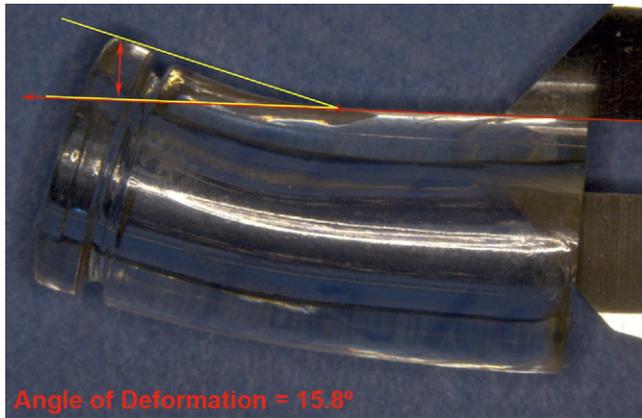
Fig. 6. Polycarbonate urethane component of a retrieved Dynesys system that was implanted for 1 year, demonstrating evidence of permanent bending along the length in response to off-axis compressive loading.

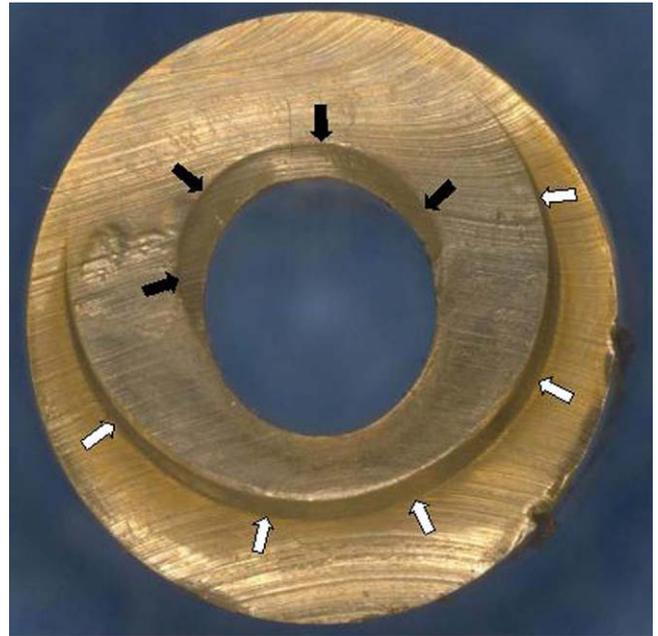
In spine motion preserving devices, macroscopic surface deformation has been observed in components that undergo compression in vivo. Polycarbonate urethane spacers used in the Dynesys system undergo deformation due to cold flow of the material, the compressive load applied during the surgery and subsequent loading in vivo, which results in permanent bending of the implant and indentations from the supporting polyaxial screws (Figs. 6 and 7, respectively). Additional deformation of soft polymer components may occur from interaction with other components from the implant; eg, the cord component that passes through the center of the polyurethane spacer in the Dynesys system (Fig. 7).

Fig. 7. Indentations observed in the spacer component from a retrieved Dynesys system that was implanted for 1.9 years. *Black arrows* denote deformation from the cord, while *white arrows* indicate deformation from the supporting pedicle screw.

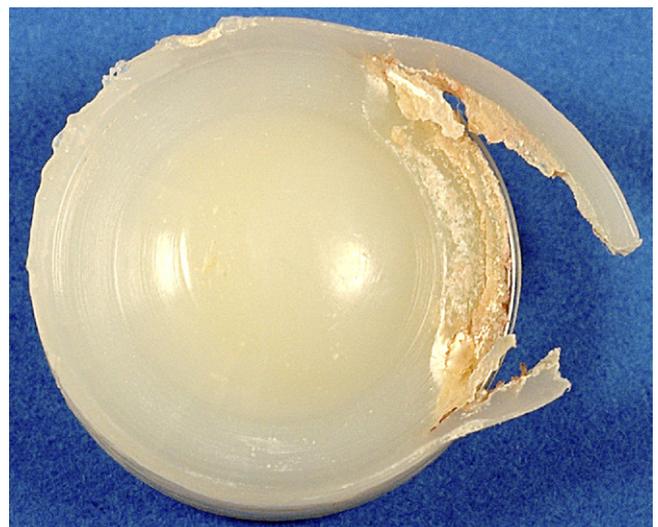
from full-thickness rim fracture (Fig. 8) to more benign radial crack formation (Fig. 9). In our retrieval studies of the Charité, radial cracks have been observed in 19 out of 38 implants examined thus far.<sup>15</sup> Similarly, transverse cracks have been observed in 14 out of 38 retrieved implants.<sup>15</sup> In most cases, fatigue fracture is related to impingement by the metallic endplates. Fractures have also been observed in polymer components of posterior devices such as the Dynesys (Fig. 10).

Fig. 8. Fatigue-related full-thickness rim fracture observed in a retrieved Charité implant that was implanted for 16.1 years.

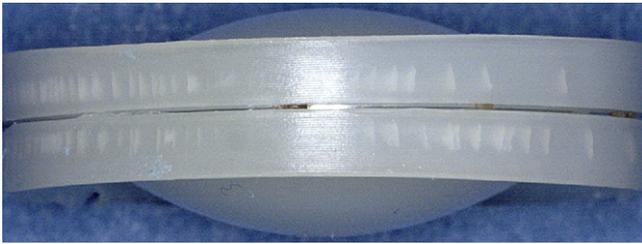
Fig. 9. Fatigue-related radial rim cracking observed in a retrieved Charité prosthesis that was implanted for 5.3 years.

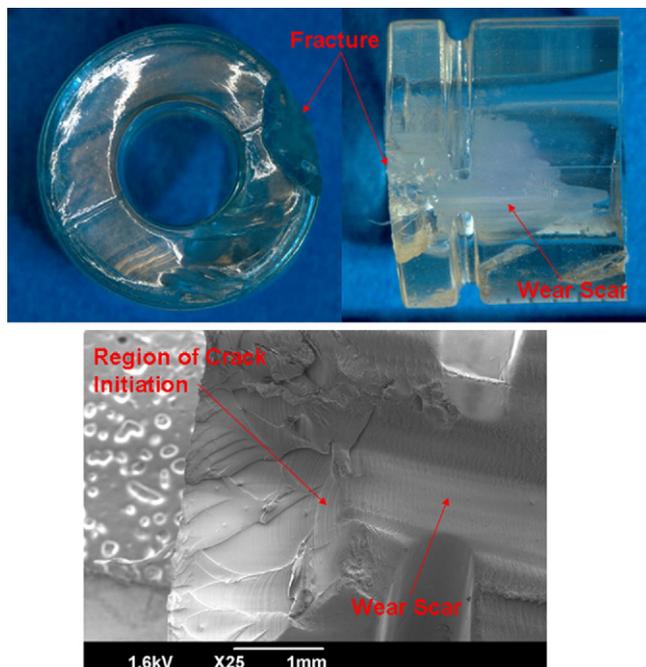
Fig. 10. Optical microscopy and SEM analysis of a fatigue-fractured spacer from a retrieved Dynesys system that was implanted for 1.1 years.

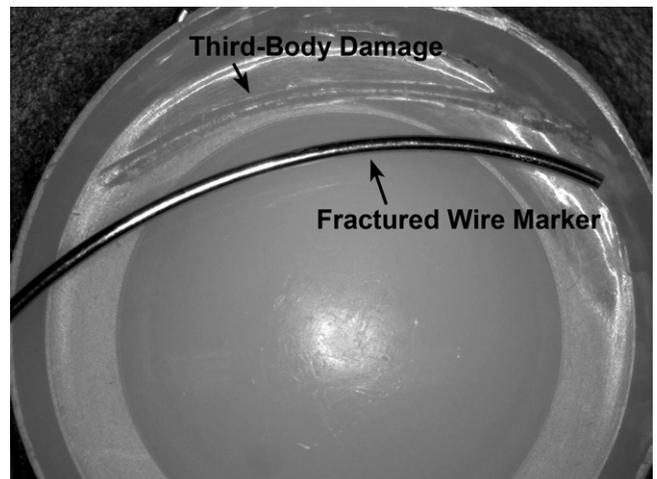
Embedded debris is an unusual but noteworthy damage mode for disc replacements. We have observed embedded debris in which a fractured radiographic wire marker became trapped between the rim and a metallic endplate (Fig. 11). The clinical significance of this wear mode is unknown

Fig. 11. Third-body damage caused by a fractured radiographic wire marker in a 12.7 year implanted component, which depicts rim damage in the polyethylene core.

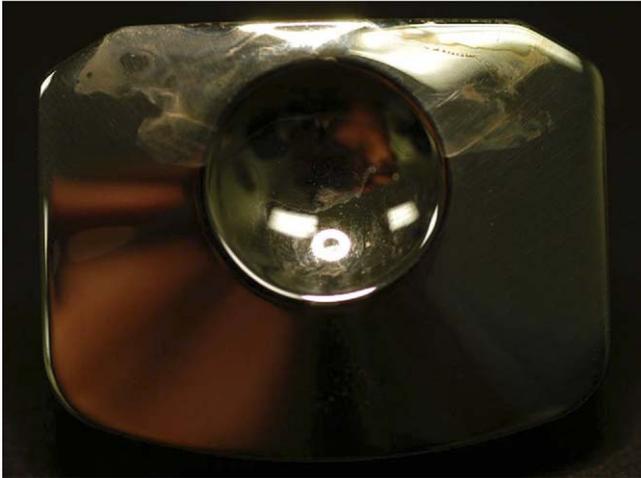
Fig. 12. Biofilm observed in CoCr alloy, metal-on-metal total disc replacement.

In vivo changes in chemistry may also occur with metallic components. In metal-on-metal hip implants fabricated from CoCr alloys, tribochemical deposits have been observed on the surface of retrieved implants.<sup>19</sup> These carbon and oxygen rich surface layers, which have a smoky or hazy appearance, are attributed to joint fluids which become fused to the bearing surface. The biofilms are thought to have a beneficial effect, by providing a solid lubricant for the articulating surface. We have observed comparable biofilms on retrieved CoCr alloy, metal-on-metal disc replacement components (Fig. 12), suggesting that a similar mechanism may be occurring.<sup>20</sup>

alluded to, we have successfully employed EDS to analyze biofilms on the surface of retrieved metal-on-metal implants fabricated from CoCr alloys.<sup>20</sup> These EDS analyses have enabled us to confirm that carbon- and oxygen-rich tribochemical reactions can occur on both the concave and convex sides of metal-on-metal articulations in the spine. Further studies with an additional number of retrieved implants are necessary to determine the incidence of biofilms on CoCr alloy implants, as well as for disc replacements produced from stainless steel or metallo-ceramic alloy composites.

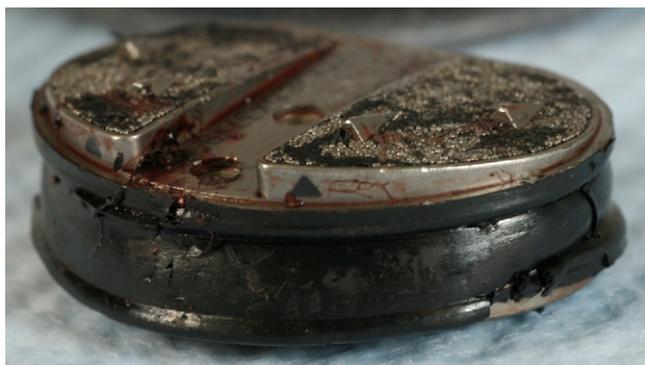
Fig. 13. Retrieved Acroflex.

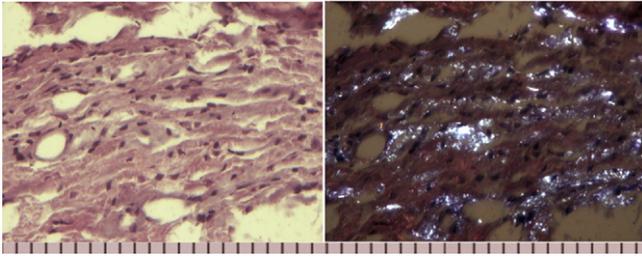
Fig. 14. TDR tissue sections stained with hematoxylin and eosin and imaged with brightfield (left) and polarized light (right) microscopy. The polarized image is of tissue retrieved at the time of revision surgery (9.2 yr) from a patient who received a pre-1998 Charité TDR implant. The PE debris is white and the score is 3 (range, 0–3). Scale interval represents 0.01 mm.

Tissue particle load was scored in 5 images from 0 (none visible) to 3 (elevated load,  $N \geq 100$ ), and the 5 scores summed. Tissue PE particle volume for pre-1998 TDRs (Fig. 14) was significantly greater than post-1998 TDRs (Figs. 15 and 16) (Student *t* test,  $P < .001$ ). Tissue samples

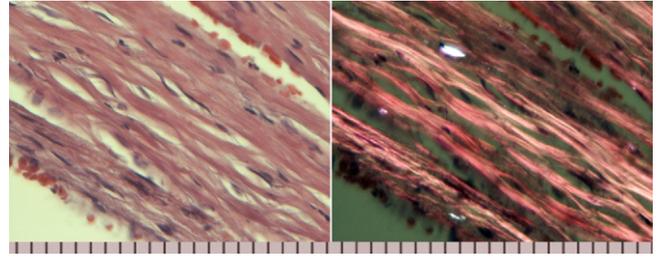
Fig. 15. TDR tissue sections stained with hematoxylin and eosin and imaged with brightfield (left) and polarized light (right) microscopy. The polarized image is of tissue retrieved at the time of revision surgery (2.2 yr) from a patient who received a post-1998 Charité TDR implant. The PE debris is white and the score is 1 (range, 0–3). Scale interval represents 0.01 mm.

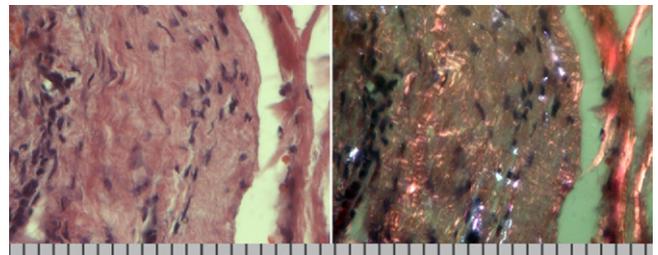
Fig. 16. TDR tissue sections stained with hematoxylin and eosin and imaged with brightfield (left) and polarized light (right) microscopy. The polarized image is of tissue retrieved at the time of revision surgery (2.2 yr) from the same patient (Fig. 15) who received a post-1998 Charité TDR implant. The PE debris is white and the score is 2 (range, 0–3). Scale interval represents 0.01 mm.

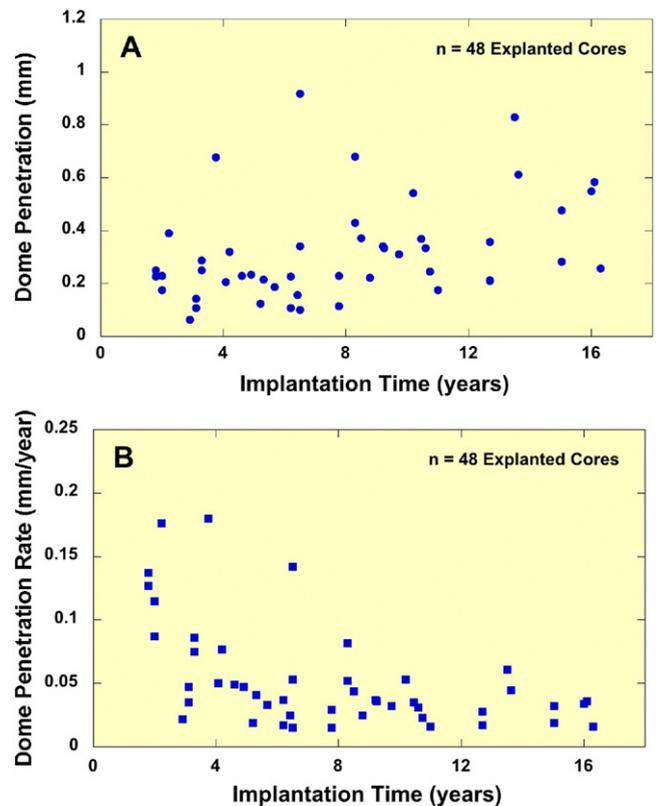
Fig. 17. A significant correlation was observed between implantation time and (A) penetration (Spearman's Rho = 0.42,  $p = 0.003$ ) and (B) penetration rate (Spearman's Rho =  $-0.53$ ,  $p = 0.0001$ ) in retrieved Charité implants. (Adapted with permission.<sup>15</sup>)

wear patterns.<sup>15</sup> Significant correlations were observed between implantation time and penetration and penetration rate (Fig. 17). The dome of the components typically exhibited burnishing, which was consistent with the multidirectional wear observed in hip replacements, whereas the rim frequently showed evidence of radial and transverse cracking (19/38 and 14/38 retrievals, respectively), often produced by impingement. The rim damage modes of plastic deformation, delamination, and cracking were similar to those associated with knee components. The published Charité retrieval literature provide crucial long-term in vivo wear data for validation of spine wear simulators, as well as for in vitro biomechanical testing.

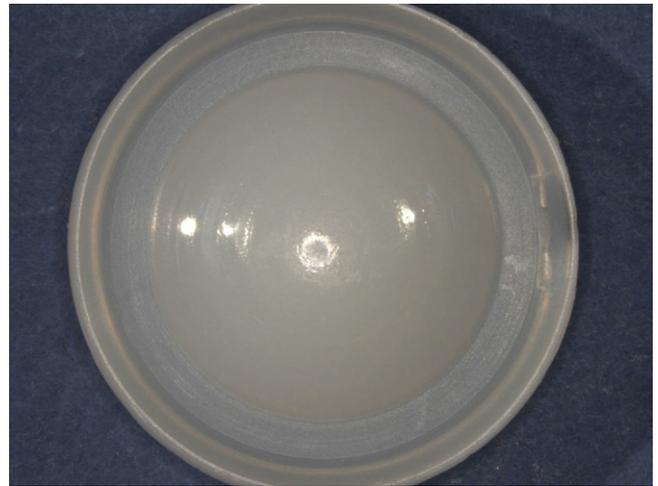
Fig. 18. Charité components tested using ISO wear testing protocols incorporating coupled motions exhibited regional burnishing and wear at a rate of 0.124 mm/Mcycles.

rates of the Charité with simulator wear rates.<sup>81</sup> It was hypothesized that the wear mechanisms of the retrievals would be more accurately simulated by ISO protocols with coupled motion, as compared with ASTM-type protocols that resulted in linear motion. Researchers analyzed dome wear rate and surface morphology of 41 Charité (SBIII) explants from 35 patients (71% female). The cores were implanted for 7.5 years (range, 1.8–16.3). Twelve Charité wear-tested cores and 6 controls were also examined. Six cores were tested according to an ASTM-type protocol for 10 million cycles<sup>82</sup>; 3 additional cores were unloaded and soaked. Six cores were tested according to the ISO protocol for 2 million cycles with 3 loaded and soaked controls. All of the cores in this study were produced by the same manufacturer (Link, Germany). The explanted cores typically exhibited burnishing or evidence of adhesive/abrasive dome wear, consistent with multidirectional motion. The wear rate of the explants, obtained by correlation of dome height with implantation time, was 0.023 mm/year. The ASTM-tested cores exhibited unidirectional abrasive wear at a rate of 0.007 mm/Mcycles. The ISO-tested cores exhibited regional burnishing and wear at a rate of 0.124 mm/Mcycles (Fig. 18). Thus, the ISO protocol generated wear surface morphology that was closer to the retrievals than the ASTM-type protocol, and 1 million cycles of the ISO protocol corresponded, on average, to about 5.6 years of clinical wear. The findings from this study further suggest that the ISO protocol provides a useful starting point for clinical validation of spine wear simulations incorporating lumbar polyethylene TDRs.
