Retrieval analysis of motion preserving spinal devices and periprosthetic tissues

Steven M. Kurtz, Marla Steinbeck, Allyson Ianuzzi, André van Ooij, Ilona M. Punt, Jorge Isaza and E.R.S. Ross

Int J Spine Surg 2009, 3 (4) 161-177

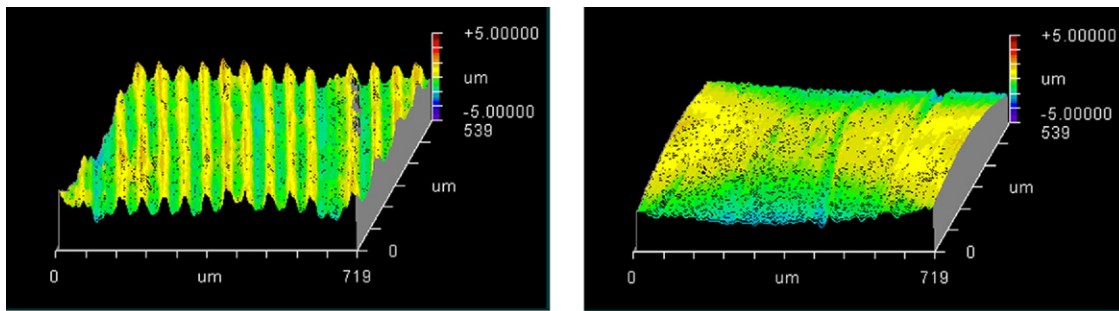
Fig. 1. White light interferometry images of an unworn (left) and worn (right) polyethylene implant surface.

Figure 1 illustrates the surface topography obtained from the unworn and worn surface regions of a retrieved polyethylene disc replacement component. The unworn polyethylene surface is dominated by machining marks that are on the order of several microns in amplitude (Fig. 1, left).

Initially, microscopic evidence of adhesive/abrasive wear is detected by the erosion and removal of machining marks, along with the presence of fine scratches (Fig. 1, right).

As demonstrated in Figures 1 and 2, surface characterization using white light interferometry provides useful information about the wear mechanisms in total disc replacements. Furthermore, by quantitatively analyzing the surface data, the roughness and waviness can be quantified and compared with as-manufactured components, thereby providing insight into the magnitude of surface changes that occur in vivo.^{8–10} Ultimately, quantitative measurements of implant surfaces are used to validate in vitro and computational models that seek to simulate in vivo wear processes.

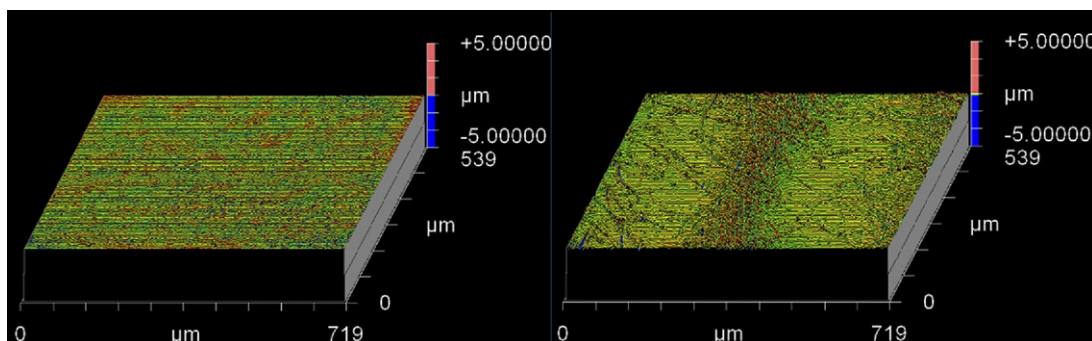
Fig. 2. White light interferometry images of an unworn (left) and worn (right) metal-on-metal implant surface.

The surface topography of a retrieved CoCr alloy disc replacement is shown in Figure 2. The unworn CoCr surface is usually relatively flat and featureless, aside from microscopic scratches generated during the final polishing stage of the manufacturing process (Fig. 2, left). In a region of wear, the CoCr surface has evidence of localized, microscopic scratches with a characteristic length scale that is larger than the residual features from polishing (Fig. 2, right).

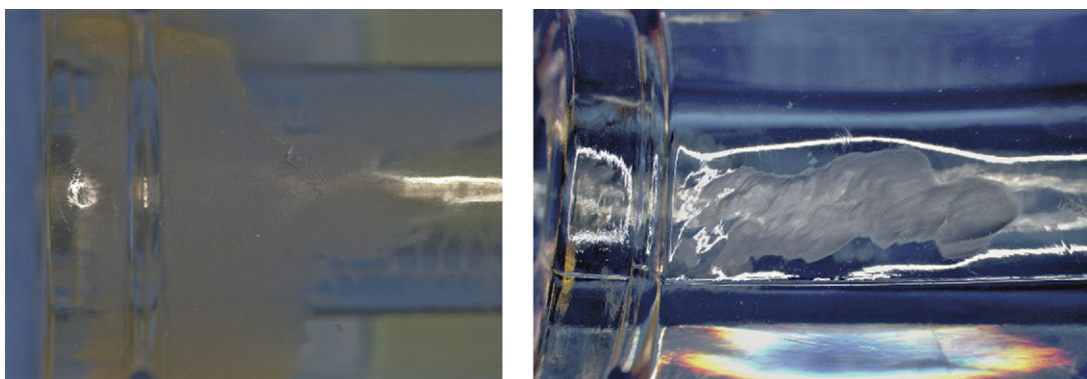
Fig. 3. Abrasive wear observed on polymeric components from retrieved Dynesys systems, implanted 1.1 (left) and 1 (right) years.

components of the implant contact surrounding bony structures (Fig. 3).

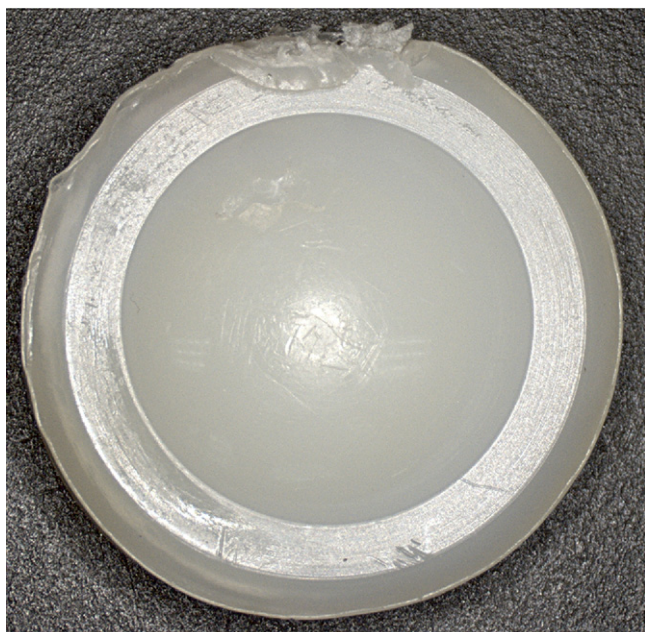
Fig. 4. Microscopic, multidirectional scratches and crisscrossing wear paths at the dome of a retrieved polyethylene total disc replacement that was implanted 6.2 years.

During retrieval analysis, the pattern of scratches on an implant, whether macroscopic or microscopic, provide clues to the kinematics (motion) of the surfaces while they were contact in vivo. The microscopic multidirectional scratches and crisscrossing wear paths at the dome of a retrieved polyethylene TDR (Fig. 4) are consistent with the type of microscopic abrasive wear mechanisms previously observed in retrieved hip replacement components.^{12,13} By matching comparable regions of damage on 2 opposing bearing surfaces, it is further possible to infer the orientation of the components while they were in contact.

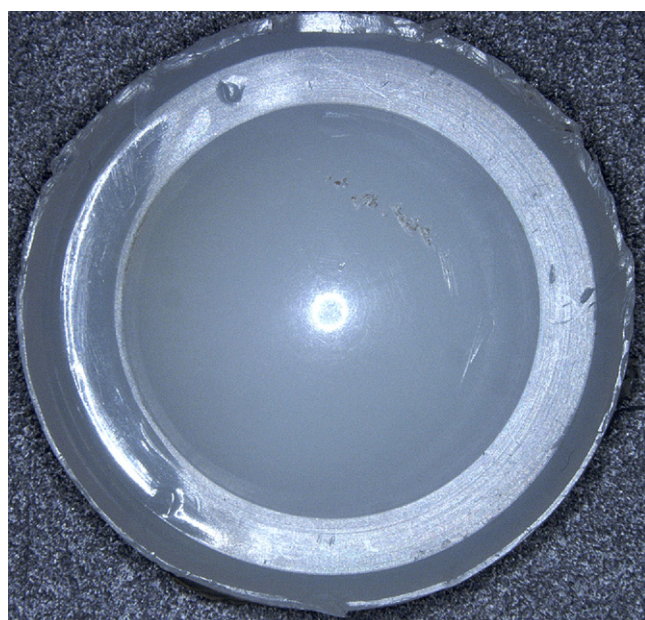
Fig. 5. Burnishing observed on the dome of the polyethylene component of a retrieved total disc replacement.

Typically encountered with polyethylene disc components, burnishing gives the polymer surface a polished, glossy appearance (Fig. 5). At a microscopic length scale, burnishing is associated with an adhesive wear mechanism, whereby the polyethylene surface wear occurs by adhesion to the metallic counterface. Highly magnified images of a burnished wear zone from a retrieved total disc replacement are shown in Figure 5, and as noted also show evidence of scratching which denotes the presence of abrasion. For this reason, the dominant wear mechanism in metal-on-polyethylene articulations is considered to be a combination of adhesion and abrasion, as seen in total joint replacements.^{12,13}

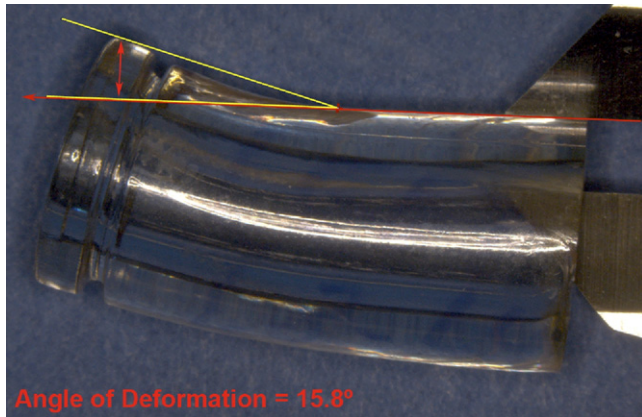
Fig. 6. Polycarbonate urethane component of a retrieved Dynesys system that was implanted for 1 year, demonstrating evidence of permanent bending along the length in response to off-axis compressive loading.

In spine motion preserving devices, macroscopic surface deformation has been observed in components that undergo compression in vivo. Polycarbonate urethane spacers used in the Dynesys system undergo deformation due to cold flow of the material, the compressive load applied during the surgery and subsequent loading in vivo, which results in permanent bending of the implant and indentations from the supporting polyaxial screws (Figs. 6 and 7, respectively). Additional deformation of soft polymer components may occur from interaction with other components from the implant; eg, the cord component that passes through the center of the polyurethane spacer in the Dynesys system (Fig. 7).

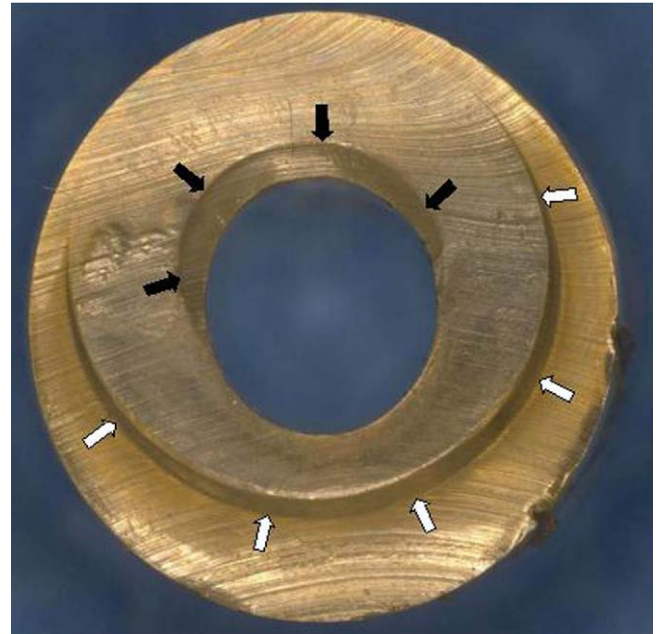
Fig. 7. Indentations observed in the spacer component from a retrieved Dynesys system that was implanted for 1.9 years. Black arrows denote deformation from the cord, while white arrows indicate deformation from the supporting pedicle screw.

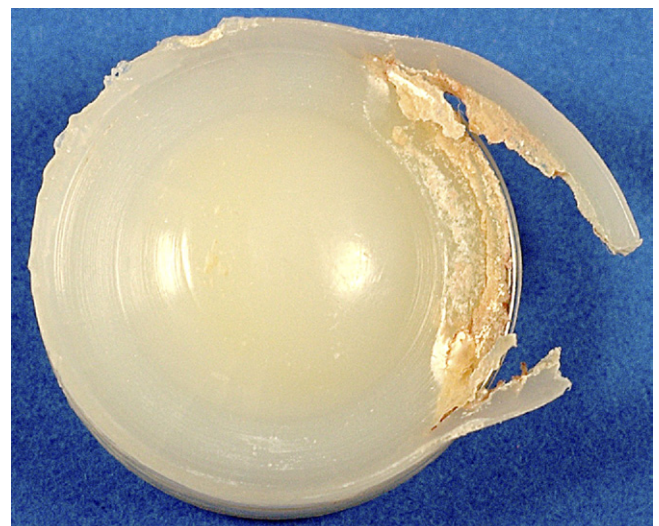
Fig. 8. Fatigue-related full-thickness rim fracture observed in a retrieved Charité implant that was implanted for 16.1 years.

from full-thickness rim fracture (Fig. 8) to more benign radial crack formation (Fig. 9). In our retrieval studies of the Charité, radial cracks have been observed in 19 out of 38 implants examined thus far.¹⁵ Similarly, transverse cracks have been observed in 14 out of 38 retrieved implants.¹⁵ In most cases, fatigue fracture is related to impingement by the metallic endplates. Fractures have also been observed in polymer components of posterior devices such as the Dynesys (Fig. 10).

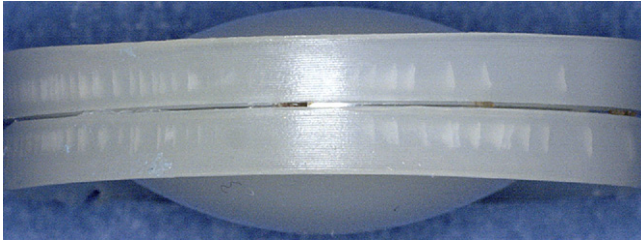
Fig. 9. Fatigue-related radial rim cracking observed in a retrieved Charité prosthesis that was implanted for 5.3 years.

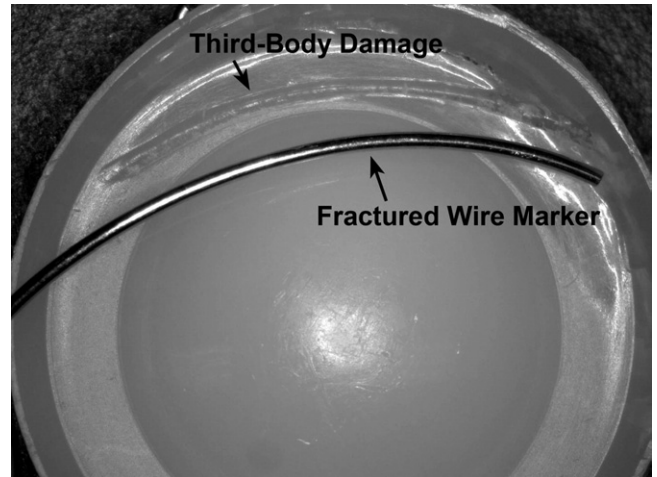
Fig. 11. Third-body damage caused by a fractured radiographic wire marker in a 12.7 year implanted component, which depicts rim damage in the polyethylene core.

Embedded debris is an unusual but noteworthy damage mode for disc replacements. We have observed embedded debris in which a fractured radiographic wire marker became trapped between the rim and a metallic endplate (Fig. 11). The clinical significance of this wear mode is unknown

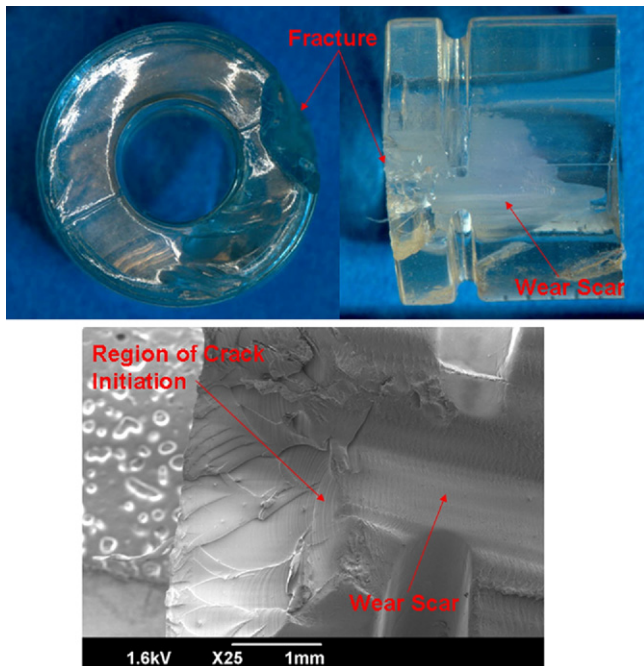
Fig. 10. Optical microscopy and SEM analysis of a fatigue-fractured spacer from a retrieved Dynesys system that was implanted for 1.1 years.

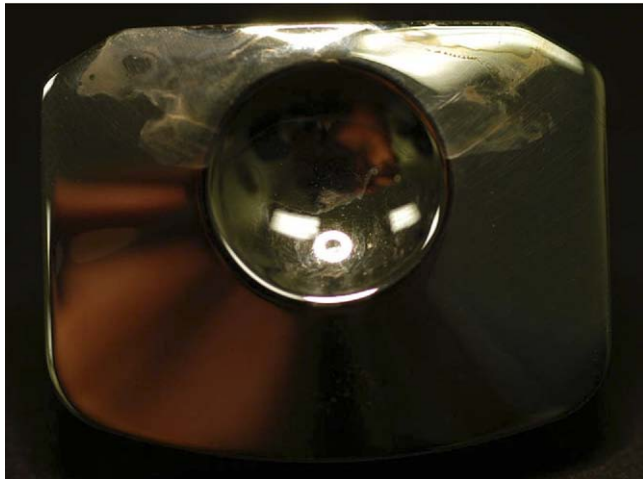
Fig. 12. Biofilm observed in CoCr alloy, metal-on-metal total disc replacement.

In vivo changes in chemistry may also occur with metallic components. In metal-on-metal hip implants fabricated from CoCr alloys, tribochemical deposits have been observed on the surface of retrieved implants.¹⁹ These carbon and oxygen rich surface layers, which have a smoky or hazy appearance, are attributed to joint fluids which become fused to the bearing surface. The biofilms are thought to have a beneficial effect, by providing a solid lubricant for the articulating surface. We have observed comparable biofilms on retrieved CoCr alloy, metal-on-metal disc replacement components (Fig. 12), suggesting that a similar mechanism may be occurring.²⁰

alluded to, we have successfully employed EDS to analyze biofilms on the surface of retrieved metal-on-metal implants fabricated from CoCr alloys.²⁰ These EDS analyses have enabled us to confirm that carbon- and oxygen-rich tribochemical reactions can occur on both the concave and convex sides of metal-on-metal articulations in the spine. Further studies with an additional number of retrieved implants are necessary to determine the incidence of biofilms on CoCr alloy implants, as well as for disc replacements produced from stainless steel or metallo-ceramic alloy composites.

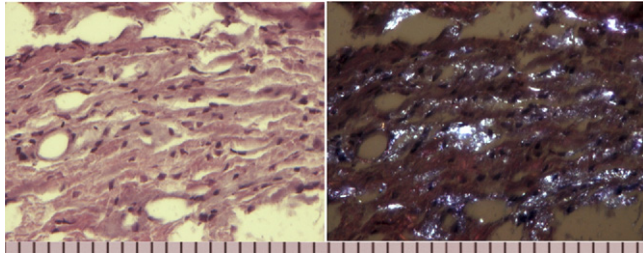
Fig. 14. TDR tissue sections stained with hematoxylin and eosin and imaged with brightfield (left) and polarized light (right) microscopy. The polarized image is of tissue retrieved at the time of revision surgery (9.2 yr) from a patient who received a pre-1998 Charité TDR implant. The PE debris is white and the score is 3 (range, 0–3). Scale interval represents 0.01 mm.

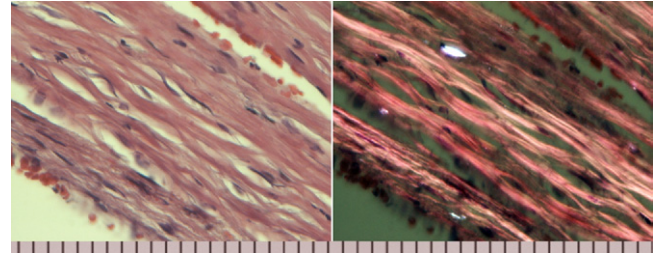
Fig. 15. TDR tissue sections stained with hematoxylin and eosin and imaged with brightfield (left) and polarized light (right) microscopy. The polarized image is of tissue retrieved at the time of revision surgery (2.2 yr) from a patient who received a post-1998 Charité TDR implant. The PE debris is white and the score is 1 (range, 0–3). Scale interval represents 0.01 mm.

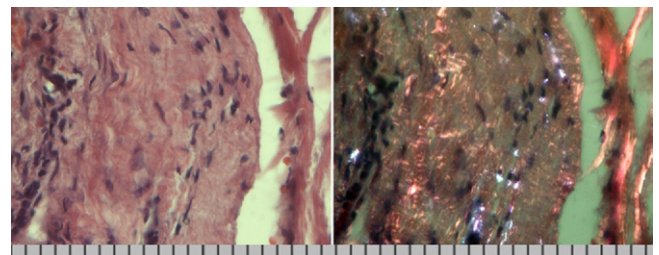
Fig. 16. TDR tissue sections stained with hematoxylin and eosin and imaged with brightfield (left) and polarized light (right) microscopy. The polarized image is of tissue retrieved at the time of revision surgery (2.2 yr) from the same patient (Fig. 15) who received a post-1998 Charité TDR implant. The PE debris is white and the score is 2 (range, 0–3). Scale interval represents 0.01 mm.

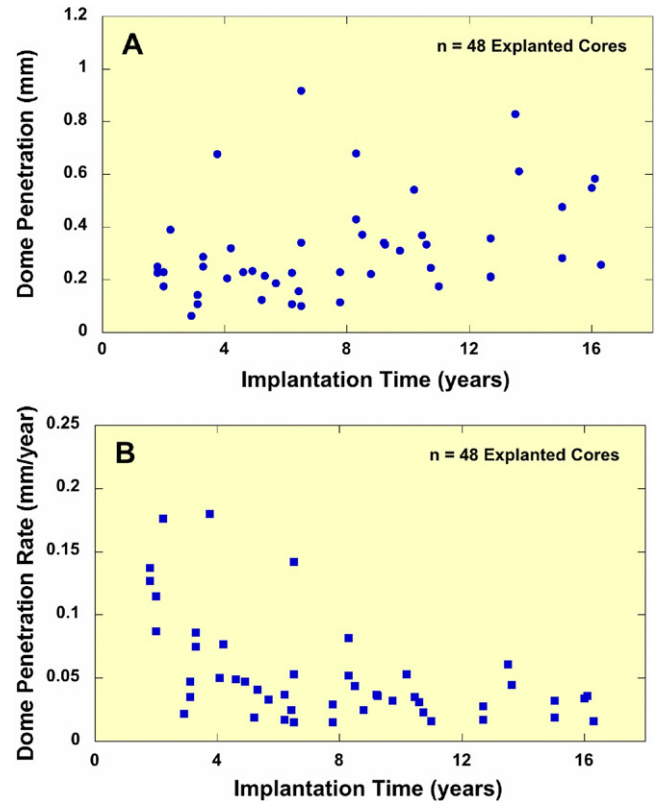
Fig. 17. A significant correlation was observed between implantation time and (A) penetration (Spearman's Rho = 0.42, $p = 0.003$) and (B) penetration rate (Spearman's Rho = -0.53, $p = 0.0001$) in retrieved Charité implants. (Adapted with permission.¹⁵)

wear patterns.¹⁵ Significant correlations were observed between implantation time and penetration and penetration rate (Fig. 17). The dome of the components typically exhibited burnishing, which was consistent with the multidirectional wear observed in hip replacements, whereas the rim frequently showed evidence of radial and transverse cracking (19/38 and 14/38 retrievals, respectively), often produced by impingement. The rim damage modes of plastic deformation, delamination, and cracking were similar to those associated with knee components. The published Charité retrieval literature provide crucial long-term in vivo wear data for validation of spine wear simulators, as well as for in vitro biomechanical testing.

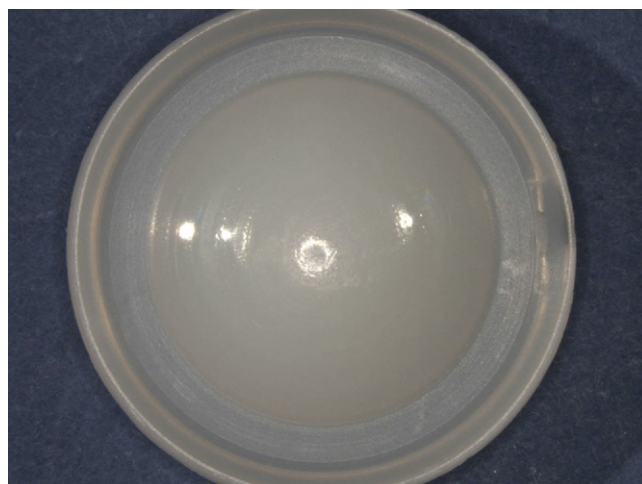
Fig. 18. Charité components tested using ISO wear testing protocols incorporating coupled motions exhibited regional burnishing and wear at a rate of 0.124 mm/Mcycles.

rates of the Charité with simulator wear rates.⁸¹ It was hypothesized that the wear mechanisms of the retrievals would be more accurately simulated by ISO protocols with coupled motion, as compared with ASTM-type protocols that resulted in linear motion. Researchers analyzed dome wear rate and surface morphology of 41 Charité (SBIII) explants from 35 patients (71% female). The cores were implanted for 7.5 years (range, 1.8–16.3). Twelve Charité wear-tested cores and 6 controls were also examined. Six cores were tested according to an ASTM-type protocol for 10 million cycles⁸²; 3 additional cores were unloaded and soaked. Six cores were tested according to the ISO protocol for 2 million cycles with 3 loaded and soaked controls. All of the cores in this study were produced by the same manufacturer (Link, Germany). The explanted cores typically exhibited burnishing or evidence of adhesive/abrasive dome wear, consistent with multidirectional motion. The wear rate of the explants, obtained by correlation of dome height with implantation time, was 0.023 mm/year. The ASTM-tested cores exhibited unidirectional abrasive wear at a rate of 0.007 mm/Mcycles. The ISO-tested cores exhibited regional burnishing and wear at a rate of 0.124 mm/Mcycles (Fig. 18). Thus, the ISO protocol generated wear surface morphology that was closer to the retrievals than the ASTM-type protocol, and 1 million cycles of the ISO protocol corresponded, on average, to about 5.6 years of clinical wear. The findings from this study further suggest that the ISO protocol provides a useful starting point for clinical validation of spine wear simulations incorporating lumbar polyethylene TDRs.
