Painless squeaking following cervical disc replacement: A case report

Int J Spine Surg 2015, 9 ()

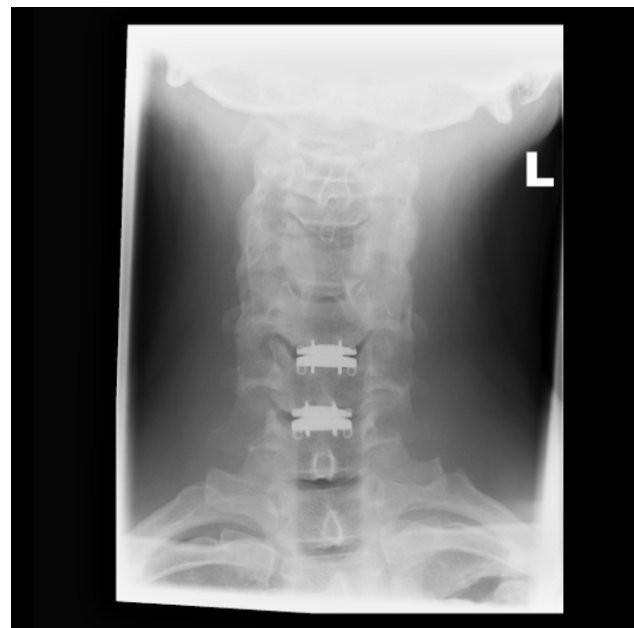
Fig. 1.

We investigated this phenomenon with plain radiographs of the cervical spine, MRI, Focussed CT scan and EMG Studies. These all confirmed excellent implant position and no further nerve root impingement. No explanation as to the cause of squeaking was elicited from these investigations. Below are the AP and Lateral radiographs of the patient at 24 months (Figure 1 & Figure 2).

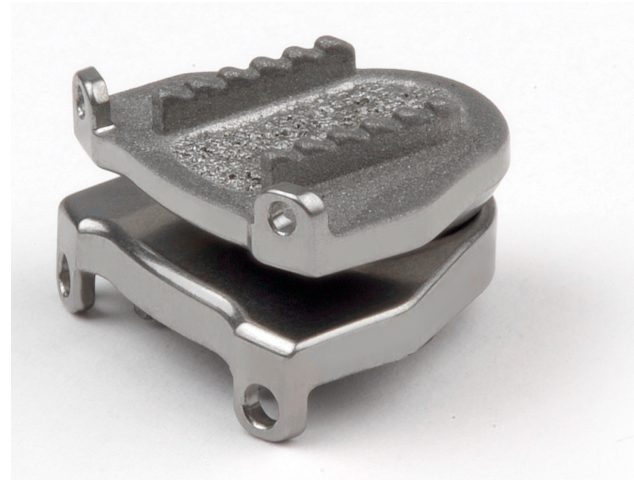
The PRESTIGE LP arthroplasty (Medtronic Sofamor Danek) is a fifth generation device based on the Bristol-Cummins disc. The Bristol-Cummins disc is a ball and socket, metal on metal design used in Europe during the early 1990s. The Bristol-Cummins disc was modified to the PRESTIGE I disc (Medtronic Sofamor Danek) in 1998, to the PRESTIGE II disc (Medtronic Sofamor Danek) in 1999, to the PRESTIGE ST device in 2002, and ultimately to the PRESTIGE LP device. The Bristol-Cummins disc, the PRESTIGE I, the PRESTIGE II, and the PRESTIGE ST devices are all stainless steel implants that use vertebral body screws to fix their position in the inter-space. The PRESTIGE LP disc is an artificial, cervical, titanium and ceramic composite disc which uses rails to provide initial friction against migration of the implant and a plasma spray coating on its superior and inferior surfaces to allow bony in-growth from the vertebral endplates onto the device³ (Figure 3).

Fig. 3. Prestige LP prosthesis.

It also reassuring that no other significant complication occurred in the early post operative period or subsequently over the 3 years of follow up. This suggests that no major mechanical defect or technical surgical error had occurred to cause the phenomenon. If the outcome had been less favourable or if further case reports emerge in the future it may be prudent to contact the manufacturers of the Prestige LP disc to avoid any potential adverse outcomes for patients. We hypothesise that a number of factors interacted in this case which may include the design characteristics of the Prestige LP disc itself resulting in this squeaking phenomenon.
