Retrieval analysis of motion preserving spinal devices and periprosthetic tissues

Int J Spine Surg 2009, 3 (4) 161-177

Abstract

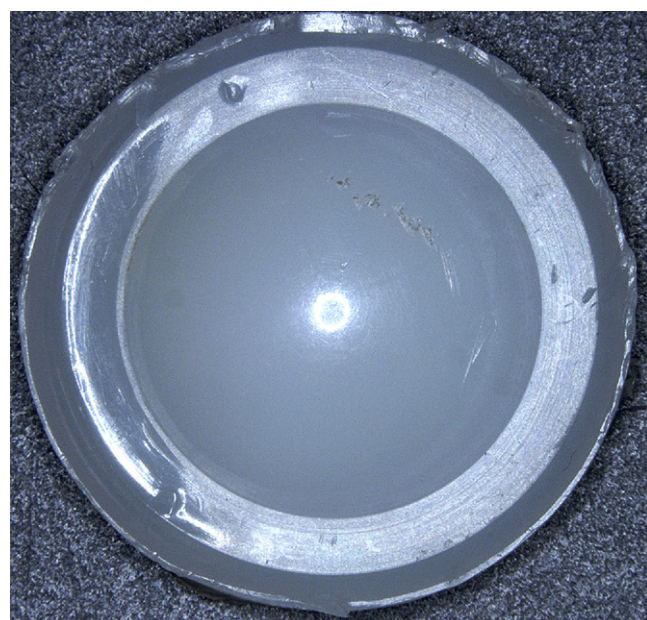
Typically encountered with polyethylene disc components, burnishing gives the polymer surface a polished, glossy appearance (Fig. 5). At a microscopic length scale, burnishing is associated with an adhesive wear mechanism, whereby the polyethylene surface wear occurs by adhesion to the metallic counterface. Highly magnified images of a burnished wear zone from a retrieved total disc replacement are shown in Figure 5, and as noted also show evidence of scratching which denotes the presence of abrasion. For this reason, the dominant wear mechanism in metal-on-polyethylene articulations is considered to be a combination of adhesion and abrasion, as seen in total joint replacements.^{12,13}

Fig. 5. Burnishing observed on the dome of the polyethylene component of a retrieved total disc replacement.

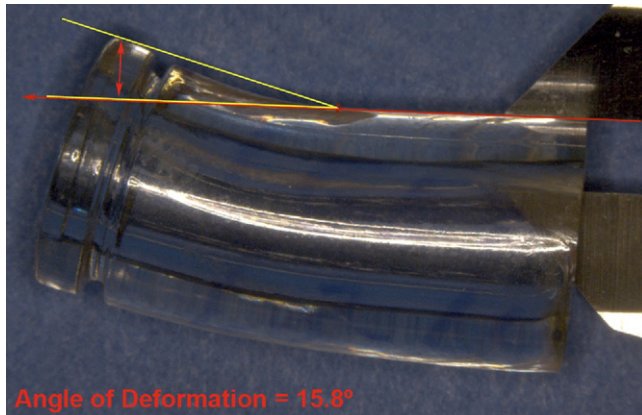
Fig. 6. Polycarbonate urethane component of a retrieved Dynesys system that was implanted for 1 year, demonstrating evidence of permanent bending along the length in response to off-axis compressive loading.

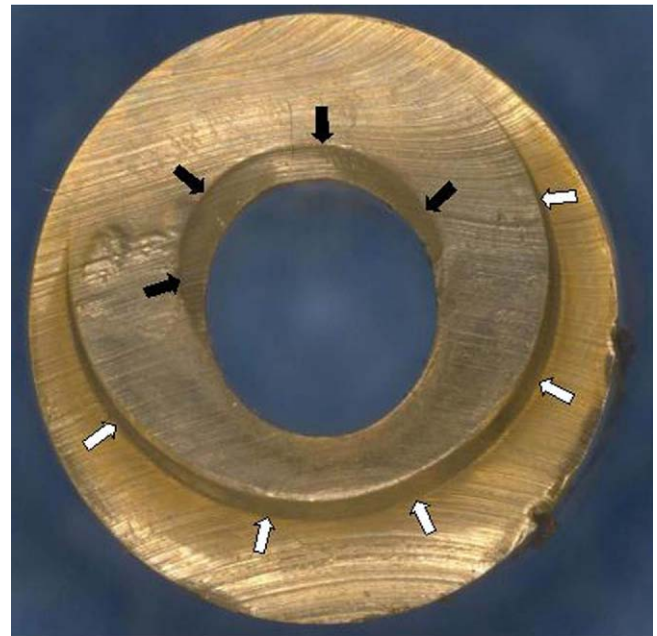
In spine motion preserving devices, macroscopic surface deformation has been observed in components that undergo compression in vivo. Polycarbonate urethane spacers used in the Dynesys system undergo deformation due to cold flow of the material, the compressive load applied during the surgery and subsequent loading in vivo, which results in permanent bending of the implant and indentations from the supporting polyaxial screws (Figs. 6 and 7, respectively). Additional deformation of soft polymer components may occur from interaction with other components from the implant; eg, the cord component that passes through the center of the polyurethane spacer in the Dynesys system (Fig. 7).

Fig. 7. Indentations observed in the spacer component from a retrieved Dynesys system that was implanted for 1.9 years. Black arrows denote deformation from the cord, while white arrows indicate deformation from the supporting pedicle screw.

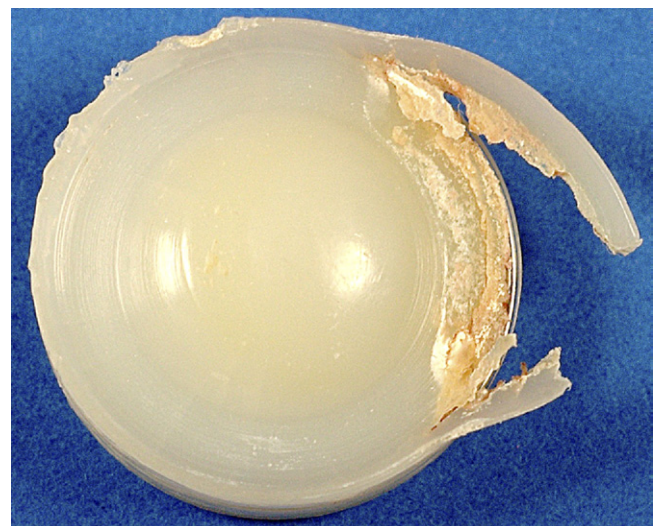
from full-thickness rim fracture (Fig. 8) to more benign radial crack formation (Fig. 9). In our retrieval studies of the Charité, radial cracks have been observed in 19 out of 38 implants examined thus far.¹⁵ Similarly, transverse cracks have been observed in 14 out of 38 retrieved implants.¹⁵ In most cases, fatigue fracture is related to impingement by the metallic endplates. Fractures have also been observed in polymer components of posterior devices such as the Dynesys (Fig. 10).

Fig. 8. Fatigue-related full-thickness rim fracture observed in a retrieved Charité implant that was implanted for 16.1 years.

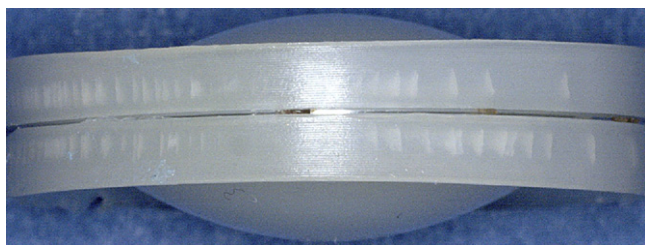
Fig. 9. Fatigue-related radial rim cracking observed in a retrieved Charité prosthesis that was implanted for 5.3 years.

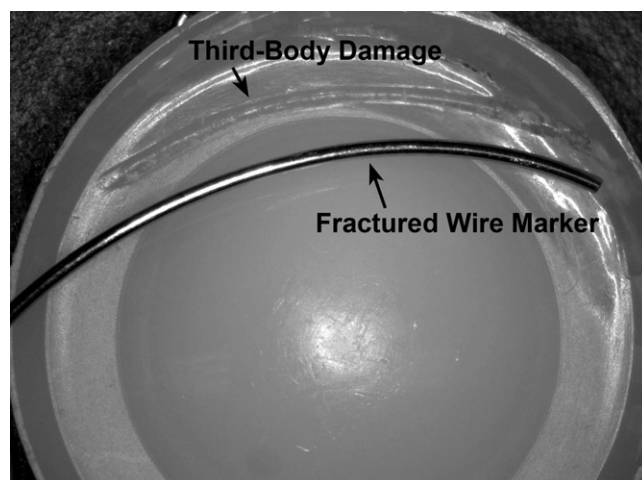
Embedded debris is an unusual but noteworthy damage mode for disc replacements. We have observed embedded debris in which a fractured radiographic wire marker became trapped between the rim and a metallic endplate (Fig. 11). The clinical significance of this wear mode is unknown

Fig. 11. Third-body damage caused by a fractured radiographic wire marker in a 12.7 year implanted component, which depicts rim damage in the polyethylene core.

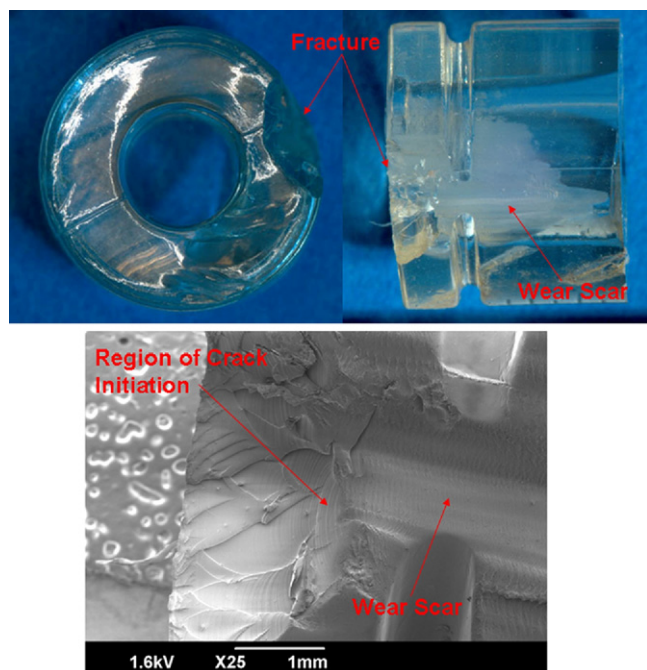
Fig. 10. Optical microscopy and SEM analysis of a fatigue-fractured spacer from a retrieved Dynesys system that was implanted for 1.1 years.

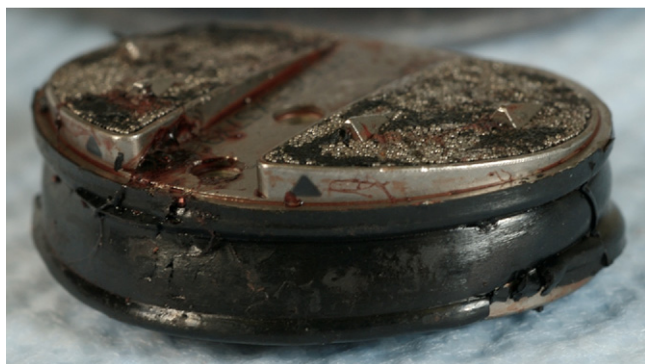
Because nonfusion spinal implants have articulating components, there is the risk of wear particle generation from the bearing surface, which could lead to inflammatory reactions that have been well documented in the large joint orthopedic literature.³⁴ Even if the motion preserving implant does not include a bearing surface, surface fatigue, unanticipated impingement with adjacent bone, metal ion release, and leachable constituent extraction are all potential mechanisms for stimulating an adverse biological response. For example, the Acroflex was a one-piece artificial disc design that, over several generations of design spanning the

Fig. 13. Retrieved Acroflex.

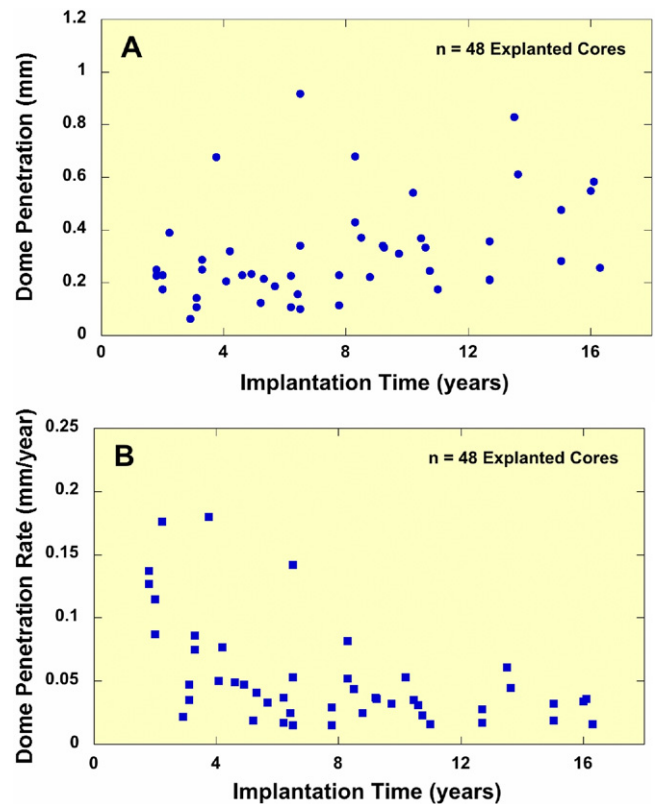
Fig. 17. A significant correlation was observed between implantation time and (A) penetration (Spearman's Rho = 0.42, $p = 0.003$) and (B) penetration rate (Spearman's Rho = -0.53, $p = 0.0001$) in retrieved Charité implants. (Adapted with permission.¹⁵)

wear patterns.¹⁵ Significant correlations were observed between implantation time and penetration and penetration rate (Fig. 17). The dome of the components typically exhibited burnishing, which was consistent with the multidirectional wear observed in hip replacements, whereas the rim frequently showed evidence of radial and transverse cracking (19/38 and 14/38 retrievals, respectively), often produced by impingement. The rim damage modes of plastic deformation, delamination, and cracking were similar to those associated with knee components. The published Charité retrieval literature provide crucial long-term in vivo wear data for validation of spine wear simulators, as well as for in vitro biomechanical testing.

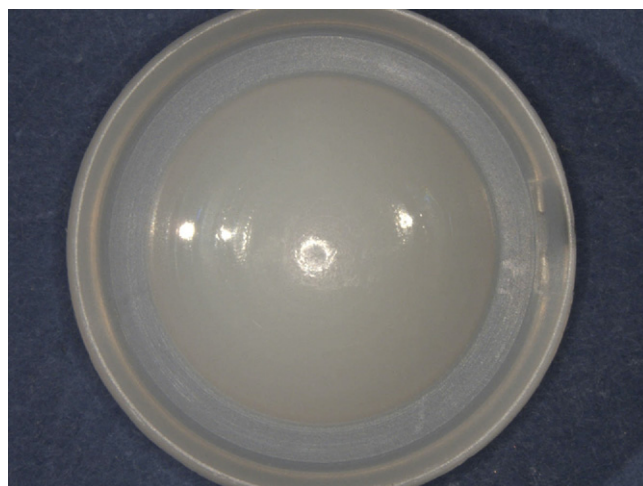
Fig. 18. Charité components tested using ISO wear testing protocols incorporating coupled motions exhibited regional burnishing and wear at a rate of 0.124 mm/Mcycles.

rates of the Charité with simulator wear rates.⁸¹ It was hypothesized that the wear mechanisms of the retrievals would be more accurately simulated by ISO protocols with coupled motion, as compared with ASTM-type protocols that resulted in linear motion. Researchers analyzed dome wear rate and surface morphology of 41 Charité (SBIII) explants from 35 patients (71% female). The cores were implanted for 7.5 years (range, 1.8–16.3). Twelve Charité wear-tested cores and 6 controls were also examined. Six cores were tested according to an ASTM-type protocol for 10 million cycles⁸²; 3 additional cores were unloaded and soaked. Six cores were tested according to the ISO protocol for 2 million cycles with 3 loaded and soaked controls. All of the cores in this study were produced by the same manufacturer (Link, Germany). The explanted cores typically exhibited burnishing or evidence of adhesive/abrasive dome wear, consistent with multidirectional motion. The wear rate of the explants, obtained by correlation of dome height with implantation time, was 0.023 mm/year. The ASTM-tested cores exhibited unidirectional abrasive wear at a rate of 0.007 mm/Mcycles. The ISO-tested cores exhibited regional burnishing and wear at a rate of 0.124 mm/Mcycles (Fig. 18). Thus, the ISO protocol generated wear surface morphology that was closer to the retrievals than the ASTM-type protocol, and 1 million cycles of the ISO protocol corresponded, on average, to about 5.6 years of clinical wear. The findings from this study further suggest that the ISO protocol provides a useful starting point for clinical validation of spine wear simulations incorporating lumbar polyethylene TDRs.
