## Retrieval analysis of motion preserving spinal devices and periprosthetic tissues

Steven M. Kurtz, Marla Steinbeck, Allyson Ianuzzi, André van Ooij, Ilona M. Punt, Jorge Isaza and E.R.S. Ross

*Int J Spine Surg* 2009, 3 (4) 161-177

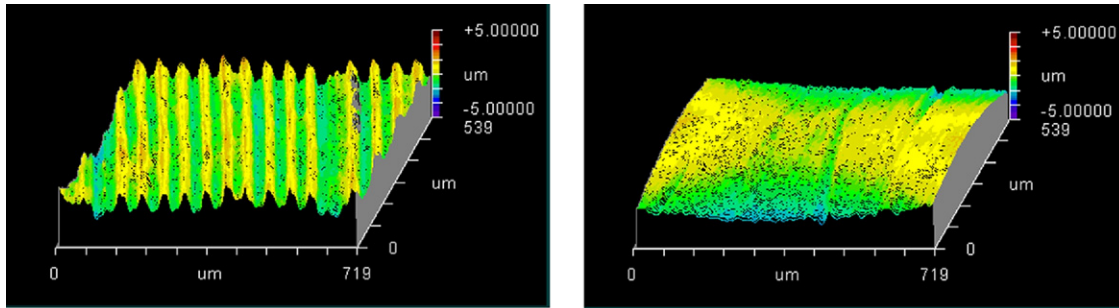
Figure 1 illustrates the surface topography obtained from the unworn and worn surface regions of a retrieved polyethylene disc replacement component. The unworn polyethylene surface is dominated by machining marks that are on the order of several microns in amplitude (Fig. 1, left).

Fig. 1. White light interferometry images of an unworn (left) and worn (right) polyethylene implant surface.

Initially, microscopic evidence of adhesive/abrasive wear is detected by the erosion and removal of machining marks, along with the presence of fine scratches (Fig. 1, right).

As demonstrated in Figures 1 and 2, surface characterization using white light interferometry provides useful information about the wear mechanisms in total disc replacements. Furthermore, by quantitatively analyzing the surface data, the roughness and waviness can be quantified and compared with as-manufactured components, thereby providing insight into the magnitude of surface changes that occur in vivo.<sup>8–10</sup> Ultimately, quantitative measurements of implant surfaces are used to validate in vitro and computational models that seek to simulate in vivo wear processes.

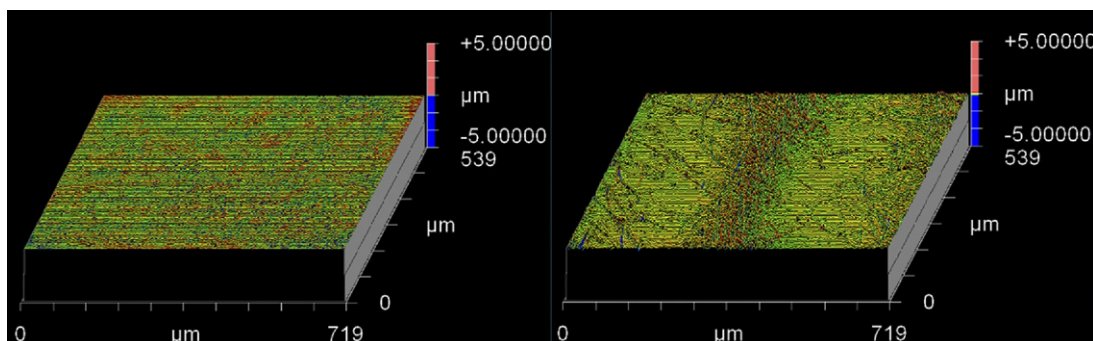
The surface topography of a retrieved CoCr alloy disc replacement is shown in Figure 2. The unworn CoCr surface is usually relatively flat and featureless, aside from microscopic scratches generated during the final polishing stage of the manufacturing process (Fig. 2, left). In a region of wear, the CoCr surface has evidence of localized, microscopic scratches with a characteristic length scale that is larger than the residual features from polishing (Fig. 2, right).

Fig. 2. White light interferometry images of an unworn (left) and worn (right) metal-on-metal implant surface.

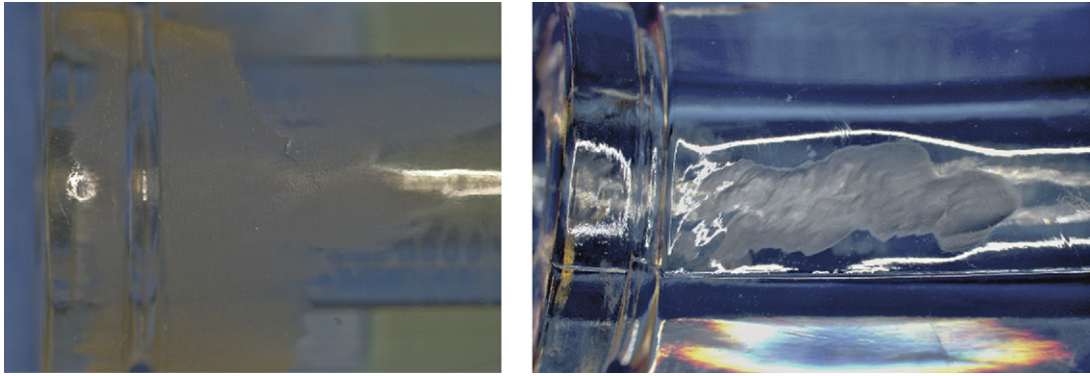
Fig. 3. Abrasive wear observed on polymeric components from retrieved Dynesys systems, implanted 1.1 (left) and 1 (right) years.

components of the implant contact surrounding bony structures (Fig. 3).

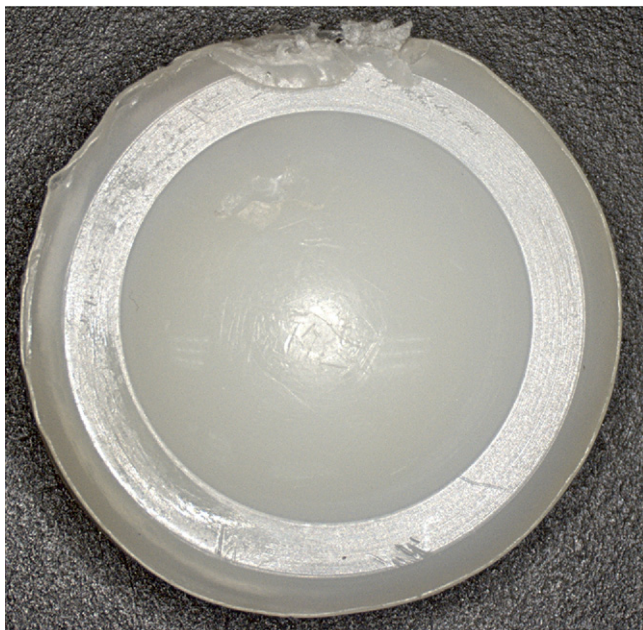
Fig. 4. Microscopic, multidirectional scratches and crisscrossing wear paths at the dome of a retrieved polyethylene total disc replacement that was implanted 6.2 years.

During retrieval analysis, the pattern of scratches on an implant, whether macroscopic or microscopic, provide clues to the kinematics (motion) of the surfaces while they were contact in vivo. The microscopic multidirectional scratches and crisscrossing wear paths at the dome of a retrieved polyethylene TDR (Fig. 4) are consistent with the type of microscopic abrasive wear mechanisms previously observed in retrieved hip replacement components.<sup>12,13</sup> By matching comparable regions of damage on 2 opposing bearing surfaces, it is further possible to infer the orientation of the components while they were in contact.

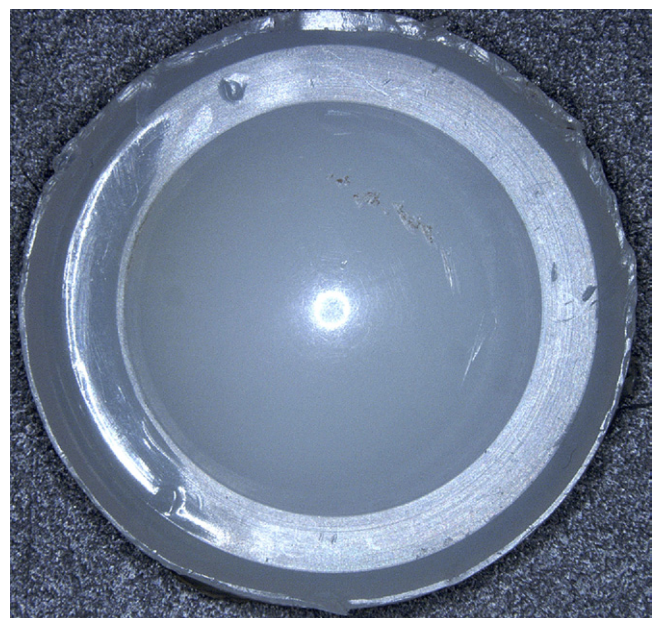
Typically encountered with polyethylene disc components, burnishing gives the polymer surface a polished, glossy appearance (Fig. 5). At a microscopic length scale, burnishing is associated with an adhesive wear mechanism, whereby the polyethylene surface wear occurs by adhesion to the metallic counterface. Highly magnified images of a burnished wear zone from a retrieved total disc replacement are shown in Figure 5, and as noted also show evidence of scratching which denotes the presence of abrasion. For this reason, the dominant wear mechanism in metal-on-polyethylene articulations is considered to be a combination of adhesion and abrasion, as seen in total joint replacements.<sup>12,13</sup>

Fig. 5. Burnishing observed on the dome of the polyethylene component of a retrieved total disc replacement.

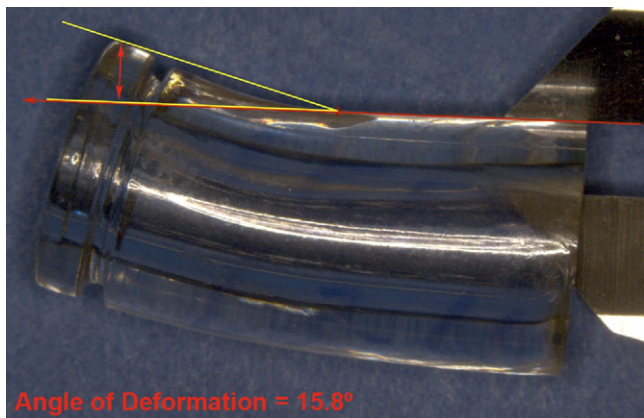
Fig. 6. Polycarbonate urethane component of a retrieved Dynesys system that was implanted for 1 year, demonstrating evidence of permanent bending along the length in response to off-axis compressive loading.

In spine motion preserving devices, macroscopic surface deformation has been observed in components that undergo compression in vivo. Polycarbonate urethane spacers used in the Dynesys system undergo deformation due to cold flow of the material, the compressive load applied during the surgery and subsequent loading in vivo, which results in permanent bending of the implant and indentations from the supporting polyaxial screws (Figs. 6 and 7, respectively). Additional deformation of soft polymer components may occur from interaction with other components from the implant; eg, the cord component that passes through the center of the polyurethane spacer in the Dynesys system (Fig. 7).

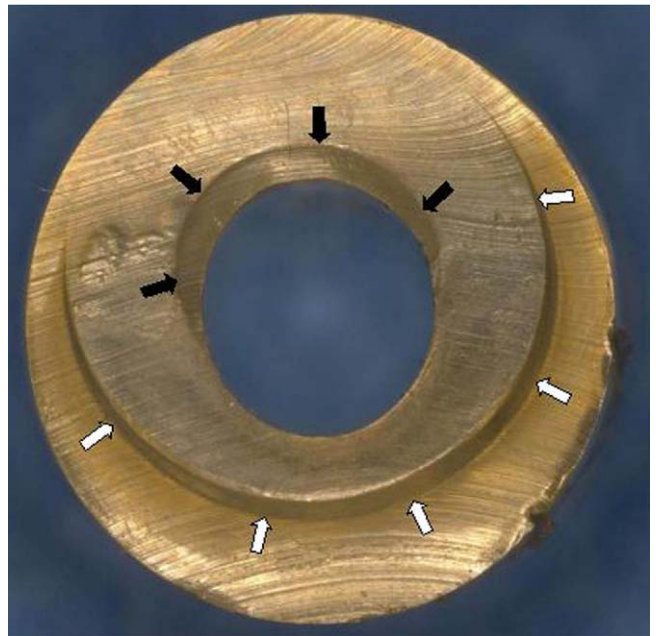
Fig. 7. Indentations observed in the spacer component from a retrieved Dynesys system that was implanted for 1.9 years. *Black arrows* denote deformation from the cord, while *white arrows* indicate deformation from the supporting pedicle screw.

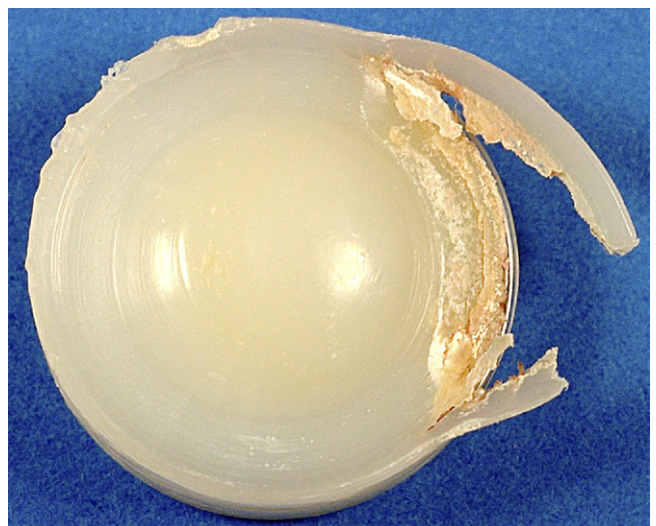
from full-thickness rim fracture (Fig. 8) to more benign radial crack formation (Fig. 9). In our retrieval studies of the Charité, radial cracks have been observed in 19 out of 38 implants examined thus far.<sup>15</sup> Similarly, transverse cracks have been observed in 14 out of 38 retrieved implants.<sup>15</sup> In most cases, fatigue fracture is related to impingement by the metallic endplates. Fractures have also been observed in polymer components of posterior devices such as the Dynesys (Fig. 10).

Fig. 8. Fatigue-related full-thickness rim fracture observed in a retrieved Charité implant that was implanted for 16.1 years.

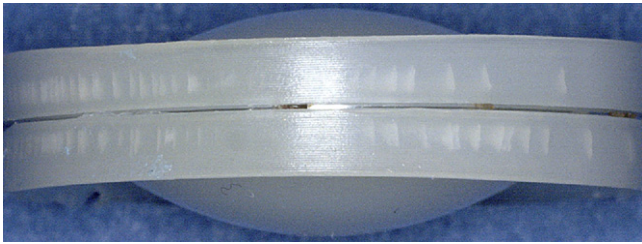
Fig. 9. Fatigue-related radial rim cracking observed in a retrieved Charité prosthesis that was implanted for 5.3 years.

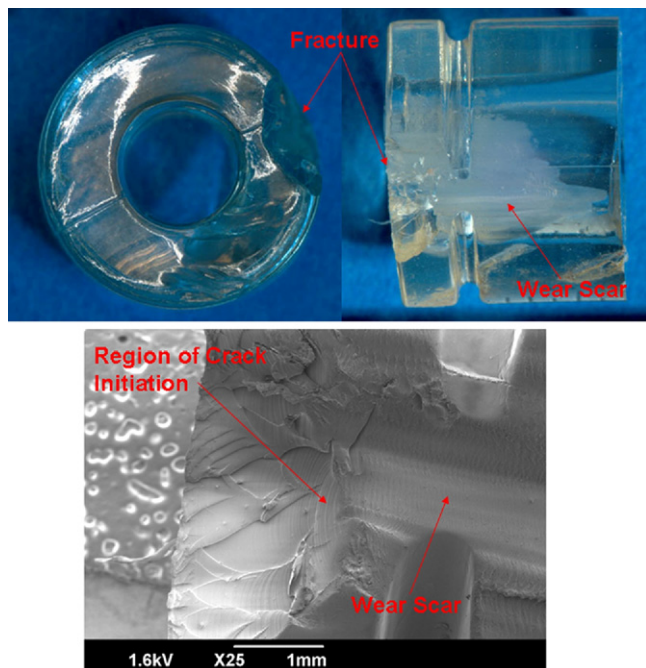
Fig. 10. Optical microscopy and SEM analysis of a fatigue-fractured spacer from a retrieved Dynesys system that was implanted for 1.1 years.

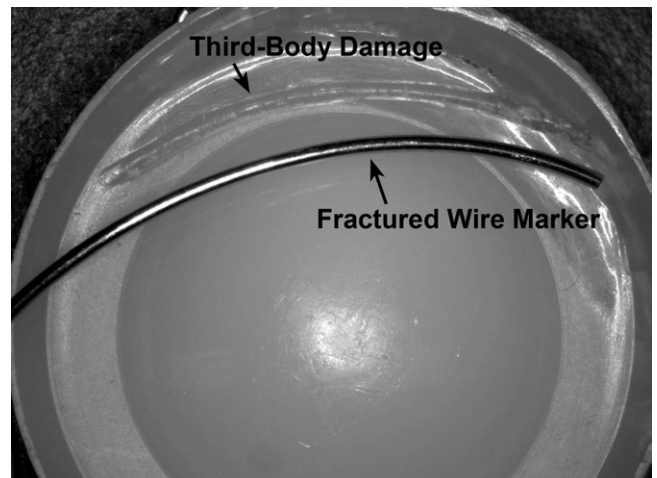
Embedded debris is an unusual but noteworthy damage mode for disc replacements. We have observed embedded debris in which a fractured radiographic wire marker became trapped between the rim and a metallic endplate (Fig. 11). The clinical significance of this wear mode is unknown

Fig. 11. Third-body damage caused by a fractured radiographic wire marker in a 12.7 year implanted component, which depicts rim damage in the polyethylene core.

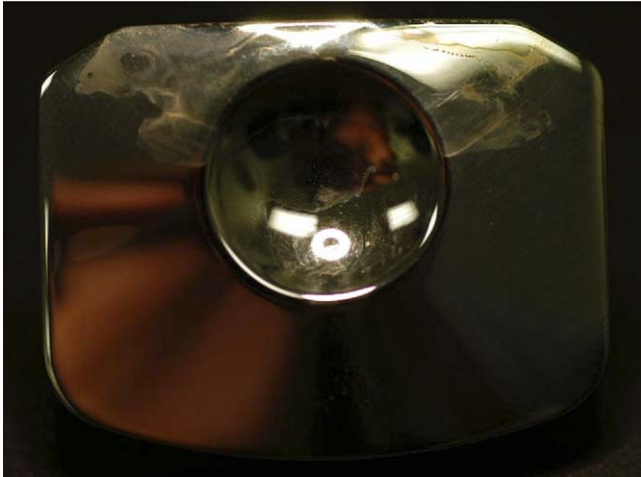
Fig. 12. Biofilm observed in CoCr alloy, metal-on-metal total disc replacement.

In vivo changes in chemistry may also occur with metallic components. In metal-on-metal hip implants fabricated from CoCr alloys, tribochemical deposits have been observed on the surface of retrieved implants.<sup>19</sup> These carbon and oxygen rich surface layers, which have a smoky or hazy appearance, are attributed to joint fluids which become fused to the bearing surface. The biofilms are thought to have a beneficial effect, by providing a solid lubricant for the articulating surface. We have observed comparable biofilms on retrieved CoCr alloy, metal-on-metal disc replacement components (Fig. 12), suggesting that a similar mechanism may be occurring.<sup>20</sup>

alluded to, we have successfully employed EDS to analyze biofilms on the surface of retrieved metal-on-metal implants fabricated from CoCr alloys.<sup>20</sup> These EDS analyses have enabled us to confirm that carbon- and oxygen-rich tribochemical reactions can occur on both the concave and convex sides of metal-on-metal articulations in the spine. Further studies with an additional number of retrieved implants are necessary to determine the incidence of biofilms on CoCr alloy implants, as well as for disc replacements produced from stainless steel or metallo-ceramic alloy composites.

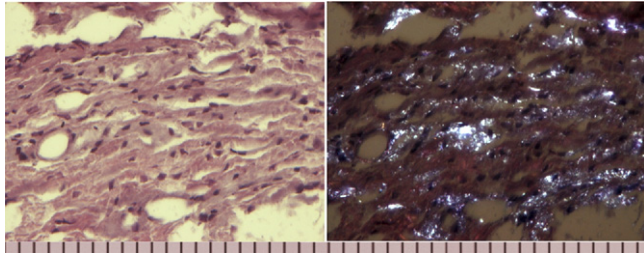
Fig. 14. TDR tissue sections stained with hematoxylin and eosin and imaged with brightfield (left) and polarized light (right) microscopy. The polarized image is of tissue retrieved at the time of revision surgery (9.2 yr) from a patient who received a pre-1998 Charité TDR implant. The PE debris is white and the score is 3 (range, 0–3). Scale interval represents 0.01 mm.

Tissue particle load was scored in 5 images from 0 (none visible) to 3 (elevated load,  $N \geq 100$ ), and the 5 scores summed. Tissue PE particle volume for pre-1998 TDRs (Fig. 14) was significantly greater than post-1998 TDRs (Figs. 15 and 16) (Student *t* test,  $P < .001$ ). Tissue samples

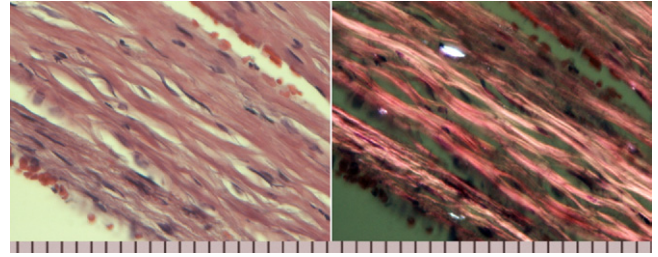
Fig. 15. TDR tissue sections stained with hematoxylin and eosin and imaged with brightfield (left) and polarized light (right) microscopy. The polarized image is of tissue retrieved at the time of revision surgery (2.2 yr) from a patient who received a post-1998 Charité TDR implant. The PE debris is white and the score is 1 (range, 0–3). Scale interval represents 0.01 mm.

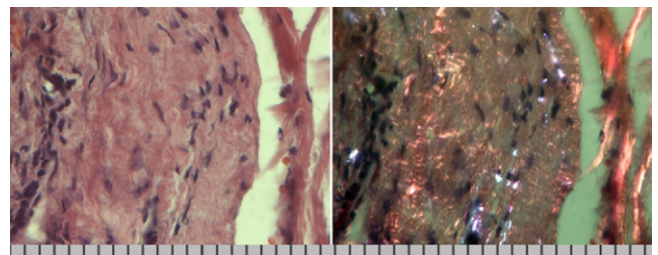
Fig. 16. TDR tissue sections stained with hematoxylin and eosin and imaged with brightfield (left) and polarized light (right) microscopy. The polarized image is of tissue retrieved at the time of revision surgery (2.2 yr) from the same patient (Fig. 15) who received a post-1998 Charité TDR implant. The PE debris is white and the score is 2 (range, 0–3). Scale interval represents 0.01 mm.

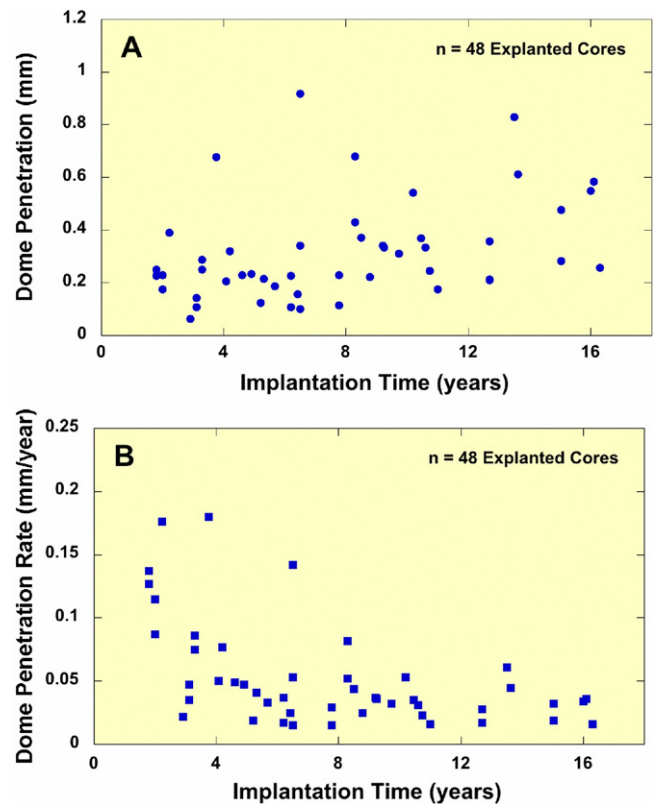
Fig. 17. A significant correlation was observed between implantation time and (A) penetration (Spearman's Rho = 0.42,  $p = 0.003$ ) and (B) penetration rate (Spearman's Rho =  $-0.53$ ,  $p = 0.0001$ ) in retrieved Charité implants. (Adapted with permission.<sup>15</sup>)

wear patterns.<sup>15</sup> Significant correlations were observed between implantation time and penetration and penetration rate (Fig. 17). The dome of the components typically exhibited burnishing, which was consistent with the multidirectional wear observed in hip replacements, whereas the rim frequently showed evidence of radial and transverse cracking (19/38 and 14/38 retrievals, respectively), often produced by impingement. The rim damage modes of plastic deformation, delamination, and cracking were similar to those associated with knee components. The published Charité retrieval literature provide crucial long-term in vivo wear data for validation of spine wear simulators, as well as for in vitro biomechanical testing.

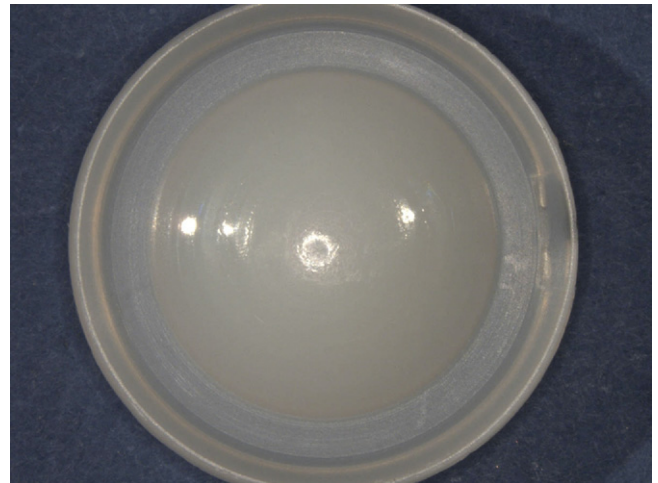
Fig. 18. Charité components tested using ISO wear testing protocols incorporating coupled motions exhibited regional burnishing and wear at a rate of 0.124 mm/Mcycles.

rates of the Charité with simulator wear rates.<sup>81</sup> It was hypothesized that the wear mechanisms of the retrievals would be more accurately simulated by ISO protocols with coupled motion, as compared with ASTM-type protocols that resulted in linear motion. Researchers analyzed dome wear rate and surface morphology of 41 Charité (SBIII) explants from 35 patients (71% female). The cores were implanted for 7.5 years (range, 1.8–16.3). Twelve Charité wear-tested cores and 6 controls were also examined. Six cores were tested according to an ASTM-type protocol for 10 million cycles<sup>82</sup>; 3 additional cores were unloaded and soaked. Six cores were tested according to the ISO protocol for 2 million cycles with 3 loaded and soaked controls. All of the cores in this study were produced by the same manufacturer (Link, Germany). The explanted cores typically exhibited burnishing or evidence of adhesive/abrasive dome wear, consistent with multidirectional motion. The wear rate of the explants, obtained by correlation of dome height with implantation time, was 0.023 mm/year. The ASTM-tested cores exhibited unidirectional abrasive wear at a rate of 0.007 mm/Mcycles. The ISO-tested cores exhibited regional burnishing and wear at a rate of 0.124 mm/Mcycles (Fig. 18). Thus, the ISO protocol generated wear surface morphology that was closer to the retrievals than the ASTM-type protocol, and 1 million cycles of the ISO protocol corresponded, on average, to about 5.6 years of clinical wear. The findings from this study further suggest that the ISO protocol provides a useful starting point for clinical validation of spine wear simulations incorporating lumbar polyethylene TDRs.
