Retrieval analysis of motion preserving spinal devices and periprosthetic tissues

Steven M. Kurtz, Marla Steinbeck, Allyson Ianuzzi, André van Ooij, Ilona M. Punt, Jorge Isaza and E.R.S. Ross

Int J Spine Surg 2009, 3 (4) 161-177

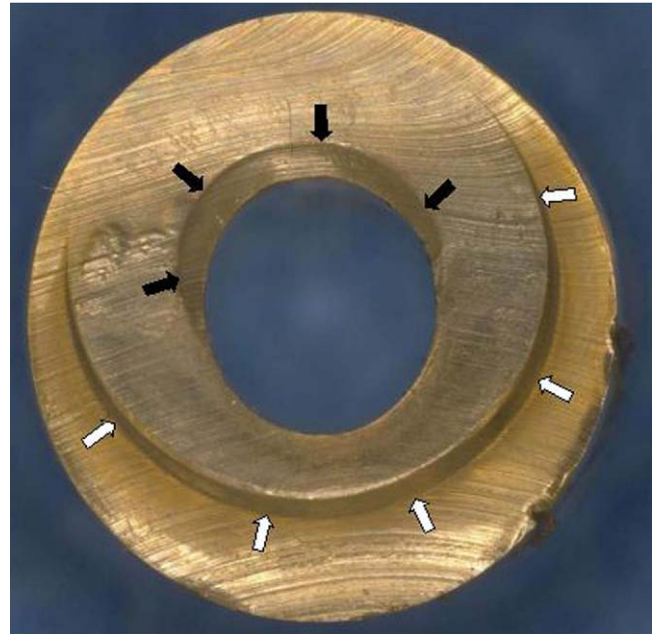
In spine motion preserving devices, macroscopic surface deformation has been observed in components that undergo compression in vivo. Polycarbonate urethane spacers used in the Dynesys system undergo deformation due to cold flow of the material, the compressive load applied during the surgery and subsequent loading in vivo, which results in permanent bending of the implant and indentations from the supporting polyaxial screws (Figs. 6 and 7, respectively). Additional deformation of soft polymer components may occur from interaction with other components from the implant; eg, the cord component that passes through the center of the polyurethane spacer in the Dynesys system (Fig. 7).

Fig. 7. Indentations observed in the spacer component from a retrieved Dynesys system that was implanted for 1.9 years. *Black arrows* denote deformation from the cord, while *white arrows* indicate deformation from the supporting pedicle screw.

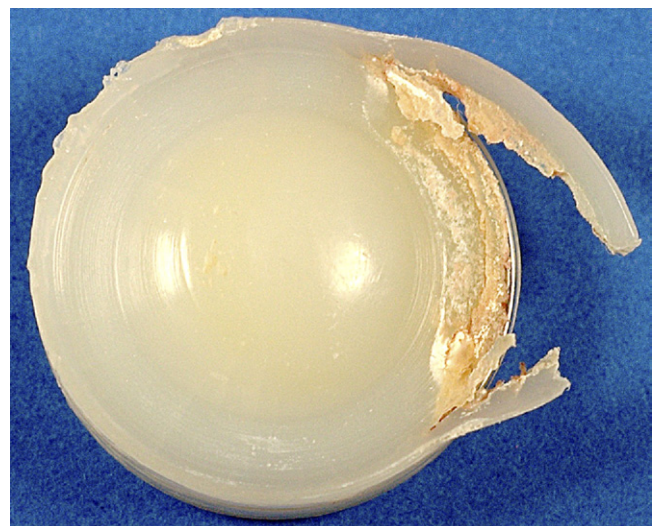
from full-thickness rim fracture (Fig. 8) to more benign radial crack formation (Fig. 9). In our retrieval studies of the Charité, radial cracks have been observed in 19 out of 38 implants examined thus far.¹⁵ Similarly, transverse cracks have been observed in 14 out of 38 retrieved implants.¹⁵ In most cases, fatigue fracture is related to impingement by the metallic endplates. Fractures have also been observed in polymer components of posterior devices such as the Dynesys (Fig. 10).

Fig. 8. Fatigue-related full-thickness rim fracture observed in a retrieved Charité implant that was implanted for 16.1 years.

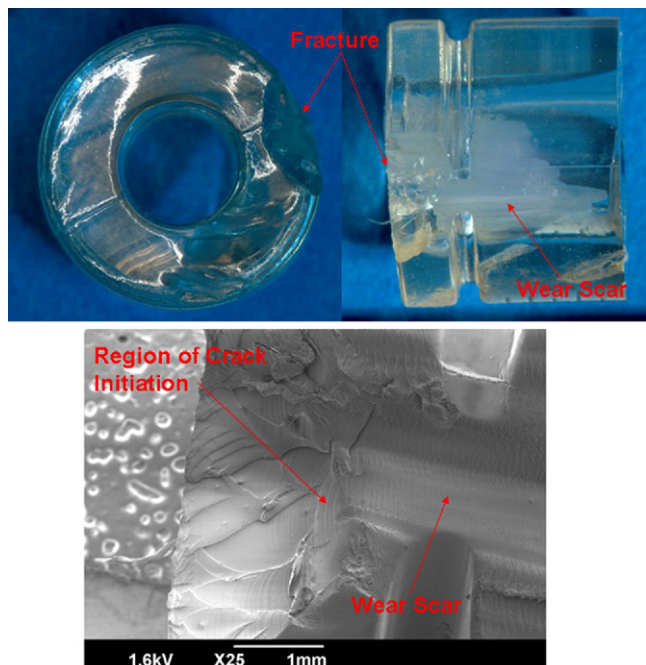
Fig. 10. Optical microscopy and SEM analysis of a fatigue-fractured spacer from a retrieved Dynesys system that was implanted for 1.1 years.

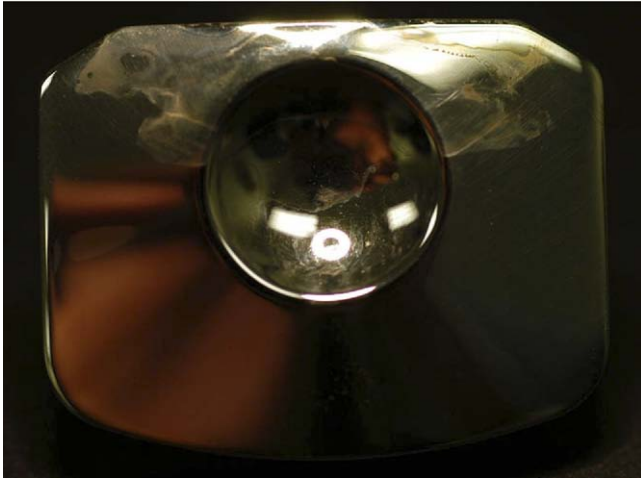
Fig. 12. Biofilm observed in CoCr alloy, metal-on-metal total disc replacement.

In vivo changes in chemistry may also occur with metallic components. In metal-on-metal hip implants fabricated from CoCr alloys, tribochemical deposits have been observed on the surface of retrieved implants.¹⁹ These carbon and oxygen rich surface layers, which have a smoky or hazy appearance, are attributed to joint fluids which become fused to the bearing surface. The biofilms are thought to have a beneficial effect, by providing a solid lubricant for the articulating surface. We have observed comparable biofilms on retrieved CoCr alloy, metal-on-metal disc replacement components (Fig. 12), suggesting that a similar mechanism may be occurring.²⁰

alluded to, we have successfully employed EDS to analyze biofilms on the surface of retrieved metal-on-metal implants fabricated from CoCr alloys.²⁰ These EDS analyses have enabled us to confirm that carbon- and oxygen-rich tribochemical reactions can occur on both the concave and convex sides of metal-on-metal articulations in the spine. Further studies with an additional number of retrieved implants are necessary to determine the incidence of biofilms on CoCr alloy implants, as well as for disc replacements produced from stainless steel or metallo-ceramic alloy composites.

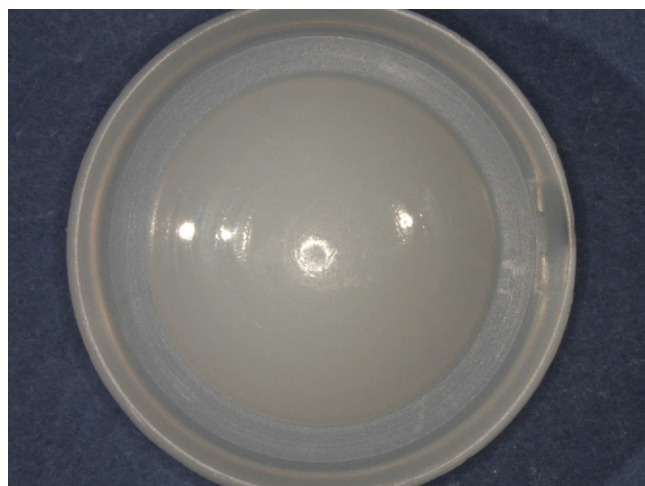
Fig. 18. Charité components tested using ISO wear testing protocols incorporating coupled motions exhibited regional burnishing and wear at a rate of 0.124 mm/Mcycles.

rates of the Charité with simulator wear rates.⁸¹ It was hypothesized that the wear mechanisms of the retrievals would be more accurately simulated by ISO protocols with coupled motion, as compared with ASTM-type protocols that resulted in linear motion. Researchers analyzed dome wear rate and surface morphology of 41 Charité (SBIII) explants from 35 patients (71% female). The cores were implanted for 7.5 years (range, 1.8–16.3). Twelve Charité wear-tested cores and 6 controls were also examined. Six cores were tested according to an ASTM-type protocol for 10 million cycles⁸²; 3 additional cores were unloaded and soaked. Six cores were tested according to the ISO protocol for 2 million cycles with 3 loaded and soaked controls. All of the cores in this study were produced by the same manufacturer (Link, Germany). The explanted cores typically exhibited burnishing or evidence of adhesive/abrasive dome wear, consistent with multidirectional motion. The wear rate of the explants, obtained by correlation of dome height with implantation time, was 0.023 mm/year. The ASTM-tested cores exhibited unidirectional abrasive wear at a rate of 0.007 mm/Mcycles. The ISO-tested cores exhibited regional burnishing and wear at a rate of 0.124 mm/Mcycles (Fig. 18). Thus, the ISO protocol generated wear surface morphology that was closer to the retrievals than the ASTM-type protocol, and 1 million cycles of the ISO protocol corresponded, on average, to about 5.6 years of clinical wear. The findings from this study further suggest that the ISO protocol provides a useful starting point for clinical validation of spine wear simulations incorporating lumbar polyethylene TDRs.
